A STATISTICAL EVALUATION OF DAMAGE TO BUILDINGS IN THE THESSALONIKI, GREECE EARTHQUAKE OF JUNE 20, 1978

G. PENELIS¹, D. SARIGIANNIS², E. STAVRAKAKIS¹, K. STYLIANIDIS¹

¹Department of Civil Engineering, University of Thessaloniki,
Thessaloniki, Greece

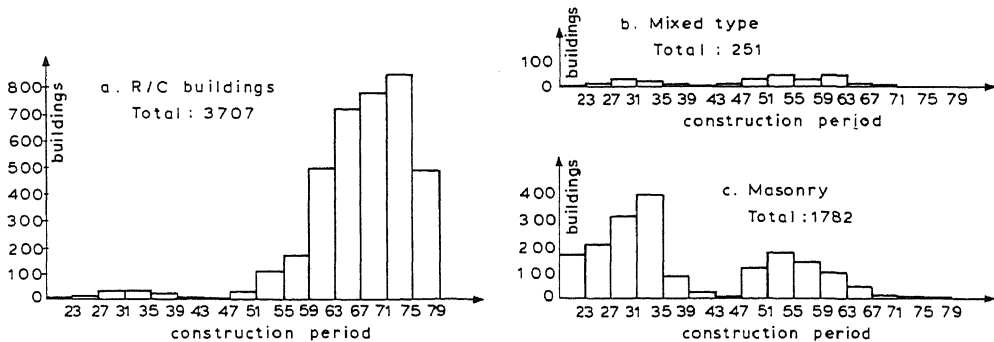
Fig. 1 Building construction activity versus time

of R/C frames and masonry bearing walls was used. Masonry infills is the rule for the partitionings. In Fig. 1 construction activities versus time are shown.
