SEISMIC CAPACITY AND RESPONSE OF A REINFORCED CONCRETE SCHOOL BUILDING IN MEXICO CITY WHICH SUFFERED THE EARTHQUAKE OF 1985

Shunsuke SUGANO ¹ Hiroaki ETO ²
Toshiyuki NOJI ³ and Kazuo TAMURA ⁴

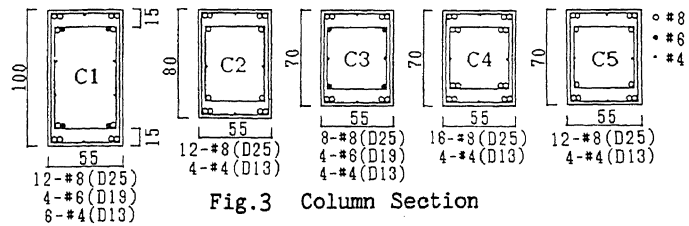
Fig.3 Column Section

medical students. This building was composed of two blocks E and W. They were structurally identical except six months' difference of completion and the difference of measured concrete strength. The Block W had higher strength of concrete (36Mpa) than that of another block (25Mpa). They located on Transition Zone and the subsoil is consisted of soft clay of 16m thick (Fig.2). The building is consisted of moment-resisting frames of columns and flat slab systems called "Losa Plana". It should be noted that the grouped longitudinal reinforcements were arranged at each corner of a column (Fig.3).

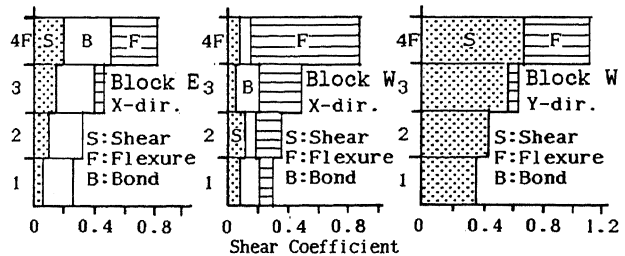
Fig.9 Failure Mode and Strength of Columns

The obtained failure mode and corresponding capacity of columns are plotted in Fig.9. It is noted for longitudinal frames that the mode of bond-splitting is predominant throughout the stories of Block E, while that of flexure is predominant except the bottom story of Block W. The different failure mode is resulted mainly from the difference of concrete strength. The mode of shear failure is remarkable in transverse frames of both blocks. As shown in Fig.10, yield hinges are formed in each frame on each direction, except both the top and bottom stories, at the end of column capital of the floor system or at the portion where some reinforcements of joist beams are cut off. The obtained lateral force capacity was around 0.2 in terms of the base shear coefficient in each block and for each direction (Fig.11). Thus, it is suggested that columns of longitudinal frames may fail by the bond-splitting and the flexural compression in Blocks E and W, respectively. This corresponds to the features of the observed damage. It is also indicated that the building might consist of the "weak-beam" type structural system, though the observed damage was remarkable in columns.

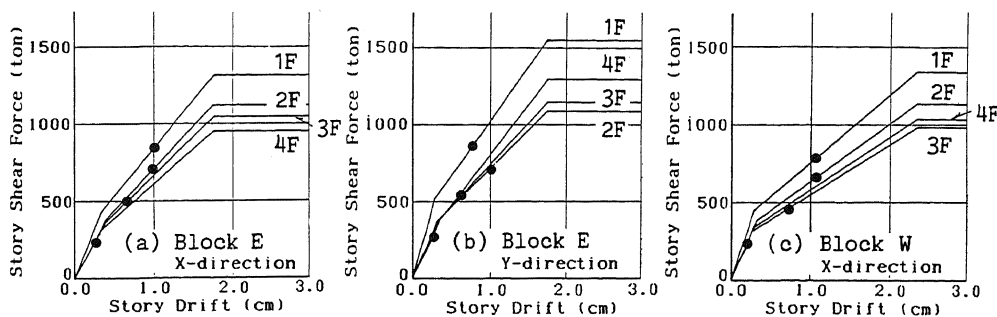
Fig.15 Maximum Response

Maximum responses to the simulated ground motion are plotted in Figs.15 to 18. The obtained results are summarized as follows. 1) The maximum story drift (1F or 2F) is estimated to be approximately 1 cm or 0.33% to the story height, which could lead to moderate or partially severe damage to the structure, though it is much less than the yield displacement. The displacements at upper stories (3F and 4F) are minor. These results agree well with the feature of the observed damage. 2) The strengthening by concrete walls leads to very minor displacement even to motions of twice the intensity of the simulated motion. 3) When most columns are reinforced, the structure is able to resist even an earthquake motion of twice the intensity of the simulated earthquake without brittle failures.
