SEISMIC STRENGTHENING OF PALO ALTO CIVIC CENTER

Roland SHARPE¹ and Edgar UGARTE²

SUMMARY

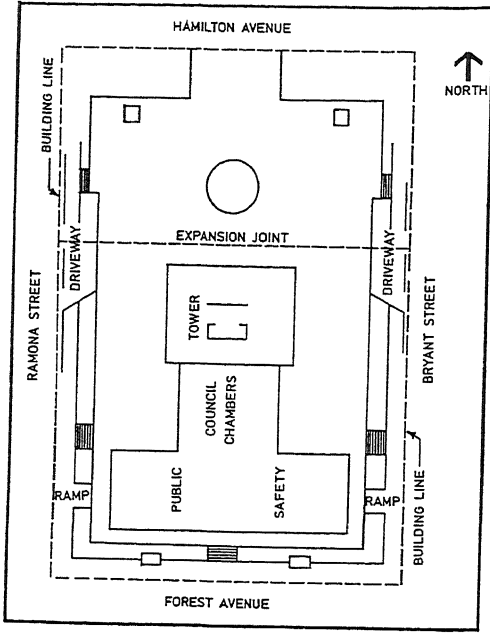
FIGURE 3. PALO ALTO CIVIC CENTER PODIUM LEVEL

The initial design and construction for the building was in general accordance with the 1961 Uniform Building Code. The building consists of an 85-foot square eight-floor tower supported on a three-story below-grade parking garage 242 by 272 ft. in plan (see Fig. 2 and 3), with elevators serving all floors. The tower is constructed with reinforced cast in place concrete columns and walls, and post-stressed slabs and girders. The garage is constructed with reinforced concrete columns and exterior walls with post-stressed concrete slabs and girders. An expansion/contraction joint divides the garage into two parts.

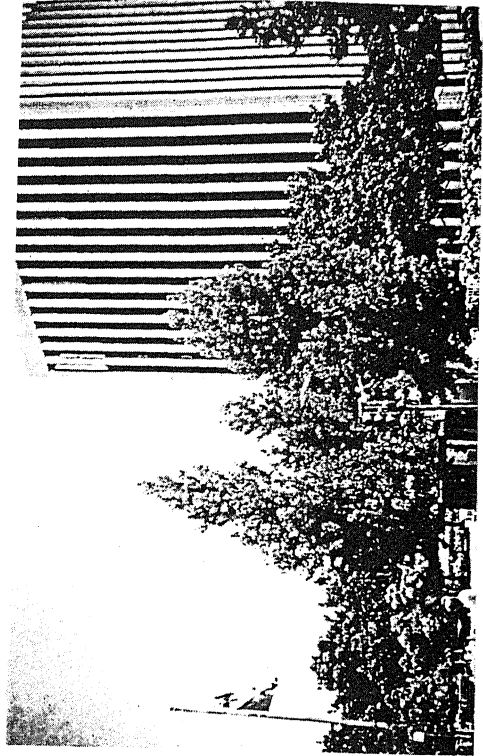
FIGURE 4. SCHEMATIC SECTION LOOKING NORTH

The tower's exterior cladding is precast concrete facade columns with window walls in between. Tower story heights are 12 feet except for 23 high for the first and the eighth stories (see Fig. 4). The parking story heights vary from 10.00 ft to 13.75 ft. Lateral force resistance was provided by the walls of the elevator shaft and the exit stairways, and the rear wall of the restroom areas
