12-4-9

## SEISMIC RETROFIT OF A RC BUILDING: A CASE STUDY

A twelve-story reinforced concrete frame building located in Mexico City was repaired and strengthened after suffering extensive damage during a moderate earthquake that shook the city in 1979. The building suffered no damage during the great Michoacan Earthquake that rocked Mexico City on 19 September 1985, even though the shaking was much greater than that in 1979. Forced vibration tests and analytical studies were conducted on the building to determine why the building behaved so well during this earthquake. Results indicate that the steel braced frames that were attached to the building strengthened it, and they stiffened the structure, moving its natural period away from the predominant ground period of 2.0 sec.

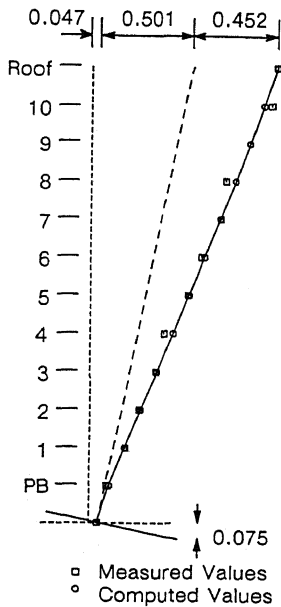
Fig. 5 Measured and Computed E-W Mode Shape

Results of Vibration Testing of the Durango Building Forced vibration tests of the building were conducted during January 1987. The building was shaken using two eccentric mass vibration generators, owned by the California Institute of Technology, that were mounted on the roof of the structure. The measured natural frequencies and damping values for the first five modes of the vibration are listed in Table 2. The mode shapes for the first E-W mode and first N-S mode are shown in Figs. 5 and 6, respectively. Prior to the addition of the new walls and frames, the period of the building in the E-W direction was measured to be about 1.85 sec. for ambient levels of vibration. Thus, the steel frames increased the stiffness of the building considerably as indicated by the current period of 1.26 sec. The low damping in the E-W direction is also an indication that the steel frame dominates the response in this direction. Since the period of the site is thought to be about 2.0 sec., the stiffening effect of the steel frame which shifted the period of the building away from the danger region was a major cause of the excellent behavior during the 1985 earthquake. One surprising result of the test was the relatively large amount of foundation compliance present for the building in both directions of vibration. The translation and rotation of the base contributed over 50% of the roof motion. This is the result of having a very stiff building founded on very soft soil.

Results of Analytical Studies A three-dimensional analytical model of the building was developed. All of the reinforced concrete beams and columns of the original building as well as the new steel frames and infill walls were included in the model. Linear horizontal and vertical springs were placed at the base of the model under each column to simulate the flexible soil condition at the site. The properties of the foundation springs were adjusted until the analytical predictions of the first two mode shapes and frequencies of vibration for the model matched those measured during the forced vibration tests. The analytical and measured results for both directions are shown in Figs. 5 and 6.
