DAMAGE FEATURE OF SEWAGE PIPES CAUSED BY THE NIHON-KAI-CHUBU EARTHQUAKE OF 1983

Kazuhiko KAWASHIMA, Naomi OBINATA and Takashi KANOH

Earthquake Engineering Division, Earthquake Disaster Prevention
Department, Ministry of Construction, Tsukuba Science City, Japan

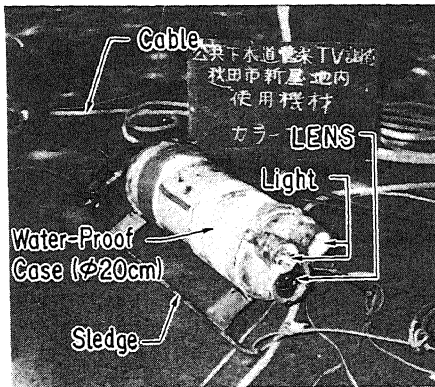
After the Nihon-kai-chubu Earthquake of 1983 (Earthquake Magnitude 7.7), in addition to the two methods, small TV cameras as shown in Fig.1 were used for damage surveys. They are installed in water proof case placed on sledge, and are pulled by strings from manhole. Self-crawling TV cameras were also used. By rotating the lens, some camera can inspect side wall of pipe as well as forward

Fig. 1 Small TV Camera Used for Inspection of Pipe Damage

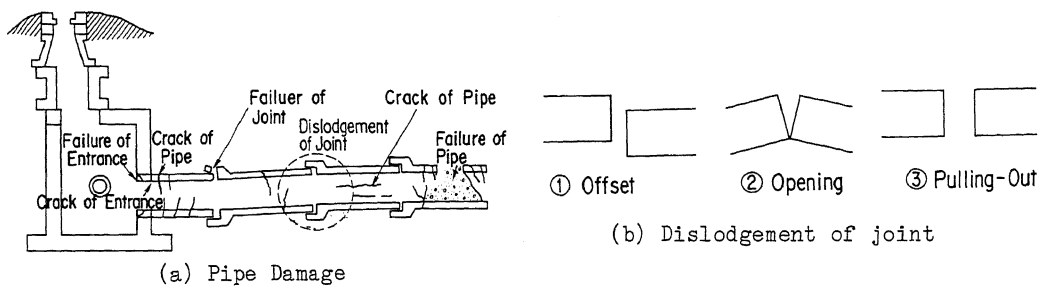
Definition of Damage Fig.3 represents typical damage of pipe as well as manhole. Damage occurs at pipe itself and at joint. Damage of pipe itself in a form of crash, cut and crack is defined here as "damage of pipe". The damage of pipe can further be classified into "damage of mainbody of pipe", "damage of joint" and "damage at connection with manhole". Damage degree was divided into "failure (significant damage)" and "crack (moderate damage)". Dislodgement at joint is also defined as "offset", "opening" and "pulling-out" (refer to Fig.3).

Fig. 3 Definition of Pipe Damage and Dislodgement at Joint
