# March 11, 2011 M=9.0 Great East Japan earthquake: The story of a retrofitted building damaged and repaired

**M. Çelebi.** Earthquake Science Center, USGS, Menlo Park, Ca. 94025, USA

I. Okawa & T. Kashima Building Research Institute, Tsukuba, Japan

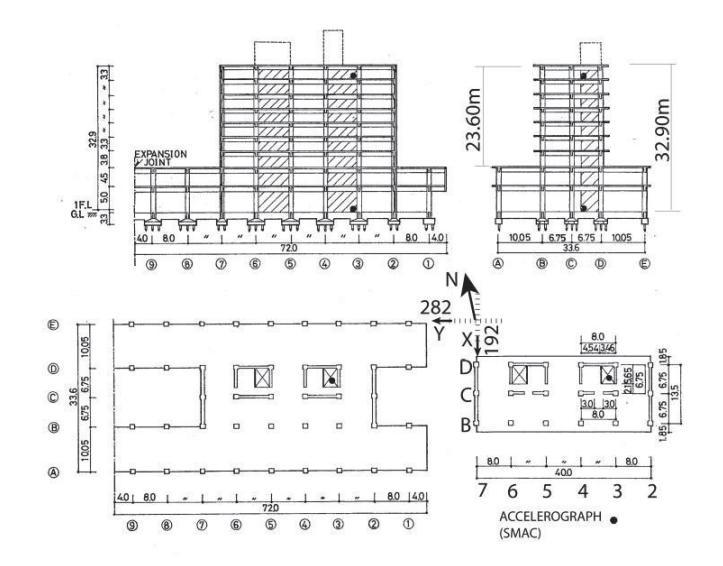
Two vertical sections and two plan views of the building are shown in Figure 2. Starting on the 3rd floor, the plan area of the building reduces from 33.6mx72.0m to13.5mx40.0m. The figure also shows approximate locations and orientations of the horizontal channels of the two tri-axial seismic instruments deployed by Building Research Institute (BRI), Tsukuba, Japan. These two tri-axial instruments provide very sparse coverage in terms of understanding the behavior and performance of the building. Details of BRI strong-motion deployments and data are at http://smo.kenken.go.jp/ (last visited August 5, 2011). The two tri-axial instruments are vertically aligned near one of the walls. It is important to mention that a separate array is also deployed in the building, which serves as a real-time seismic health monitoring system for researchers of Tohoku University (Motosaka and others, 2004). This additional array comprises tri-axial accelerometers at each of the 1st, 5th and 9Th floors. Data from this privately owned system is not publically available. This system, as well as temporary deployments of additional sensors, have been used by Tohoku University researchers to record several sets of ambient and/or microtremor data during different times. Such ambient and/or microtremor data have been used to infer torsional response characteristics as well as variation of the frequencies with amplitude of shaking (Motosaka, 2009, Motosaka and others, 2004) during different physical conditions of the building. In this study, only BRI earthquake data obtained with the two tri-axial accelerometers are used (http://smo.kenken.go.jp).

Figure 2. Vertical sections and typical plans. key column lines of the plan view of the tower, heights of the tower and complete building are highlighted. Approximate locations of the two tri-axial sensor/recorders are shown by solid circles. SMAC is a trademark of strong-motion accelerograph manufactured in Japan<sup>3</sup>. Arrows indicate the positive directions of the horizontal components of the sensors as X(192) and Y(282). Figure modified from Shiga and others (1981.

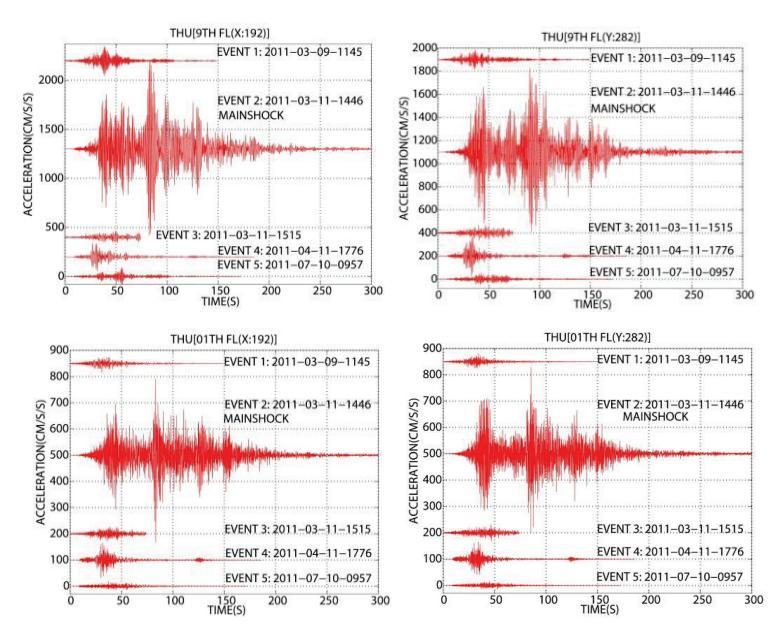
Beginning in 1987 and through July 15, 2011, THU building responses from 172 events have been recorded. In this paper, records from only five events are used: one pre-mainshock that serves as a baseline, the mainshock, and 3 aftershocks to illustrate the immediate post-earthquake state and the state after repairs. Details about these events and the corresponding peak accelerations at the 1st and 9th floors of the building are summarized in Table 1. Horizontal components of the records from the five events are presented in Figure 4.

Figure 4. Horizontal acceleration records in the X (left column) and Y (right column) directions at the 9<sup>th</sup> (top row) and 1st (bottom row) floors of the building for the 5 events. Note that within each frame the amplitudes are normalized by the largest PGA, but the scaling varies frame-to-frame in order to provide the maximum resolution of acceleration within each frame.

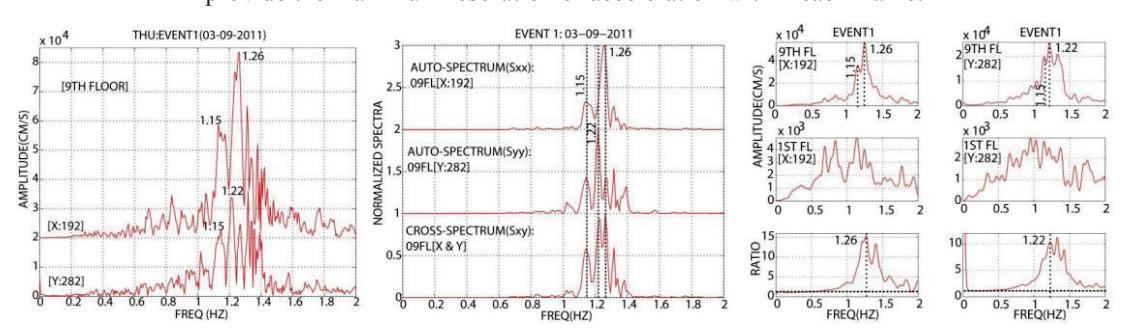
To establish baseline dynamic characteristics of the building shortly before the mainshock, data from Event 1 are used. In Figure 5 (Left), amplitude spectra of the two orthogonal horizontal acceleration time series at the 9th floor are shown. Several peaks are observed. The frequency at 1.26 Hz appears in the spectrum of accelerations in the X-direction and the one at 1.22 Hz appears in the spectrum of acceleration. The frequency at ~1.15Hz appears in both spectra. From this observation, it is difficult to distinguish with certainty which frequency belongs to which mode of the building. Better clarification is provided by Figure 5 (right) which shows the auto-spectra of and cross-spectrum between the same 9th floor orthogonal accelerations. With improved confidence, the 1.26 Hz and 1.22 Hz frequencies are the translational frequencies in the X- and Y-directions. The 1.15 Hz frequency that appears in all three spectra is most likely a torsional frequency<sup>4</sup>.

Figure 5. (Left) Amplitude spectra of orthogonal horizontal accelerations at the 9th floor of the building. (Center) Auto-spectra of and cross-spectrum between the same two accelerations. (Right) Amplitude spectra and spectral ratios of the two orthogonal horizontal accelerations (Event 1) at the 9th floor and 1st floor do not allow determination of torsional frequency. Note the differing scales of amplitude spectra. Note also that the spectral

ratio is  $\sim$ 1 up to 0.7 Hz, indicating that there are no structural frequencies within that range.

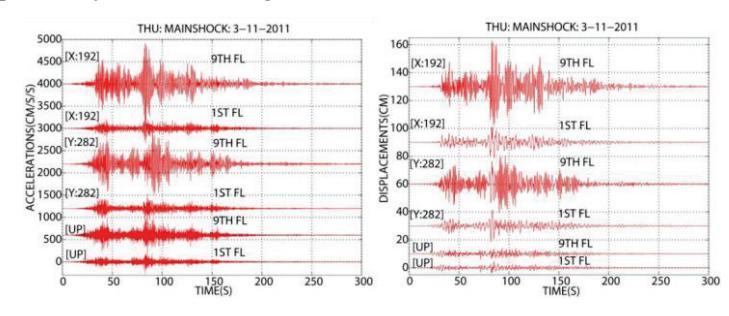
The accelerations recorded by the two tri-axial instruments during the mainshock (Event 2) and the displacements computed by double integration of these time series are shown in Figure 6.

Figure 6. Time-history plots of all six channels of accelerations (left) recorded during the mainshock and computed displacements (right).

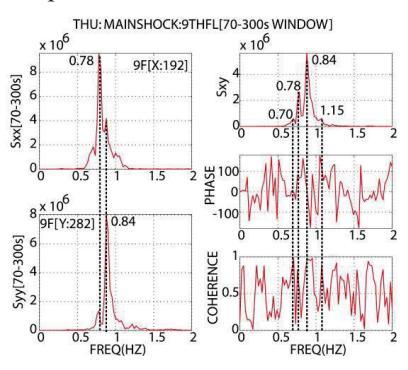
The possibility of identifying torsional frequencies was explored for the 70-300 second window (presumably after damage occurred) of the orthogonal accelerations at the 9th floor. Auto-spectra (Sxx and Syy) and cross-spectrum (Sxy) as well as phase angle and coherency plots of the two orthogonal channels at the 9th floor are shown in Figure 9. From the auto-spectra, the fundamental frequencies in the X and Y directions are again clearly identified as 0.78 and 0.84 Hz with high coherency. However, two additional frequencies at 0.7 Hz and 1.15 Hz also appear in the cross-spectrum. Of these, the 0.70 Hz frequency has  $0^{\circ}$  phase and the 1.15Hz frequency has  $\sim 180^{\circ}$  phase. Both have relatively high coherencies. One possible explanation is that there may be two torsional modes – one at 0.70 Hz corresponding to the part of the building above the third floor where the plan, and therefore the stiffness, changes drastically, and where concentrated damage was observed, and the other at 1.15Hz for the total building. Another possibility is that one may be first torsional mode and the other second.

Again, lack of additional strategically deployed channels of sensors prevents straightforward and reliable identification of torsional frequencies.

Figure 9. Auto-spectra, cross-spectrum, phase angle and coherency of and between the two orthogonal motions at the 9th floor for the 70-300 second window of accelerations.
