# Lessons Learned from the 2008 Wenchuan Earthquake and Recent Research on Seismic Design of Highway Bridges

**WANG Dongsheng, SUN Zhiguo, ZHAI Xuebin**

*Institute of Road and Bridge Engineering, Dalian Maritime University, China*

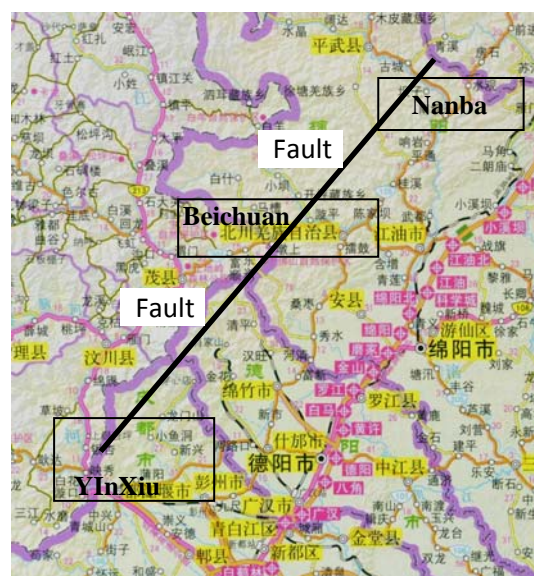
**Fig.1** Scopes of seismic damage bridge in Wenchuan earthquake

Figure 1 illustrates the traffic distribution of the earthquake zone. The investigation almost covers the main fault of Wenchuan earthquake: Yingxiu-Beichuan fault.
