# Seismic vulnerability of churches in Faial and Pico islands, Azores

**J. M. Magalhães, R. Vicente, T. Ferreira, A. Costa & H. Varum**  
*University of Aveiro, Portugal*

**15 WCEE**  
LISBOA 2012

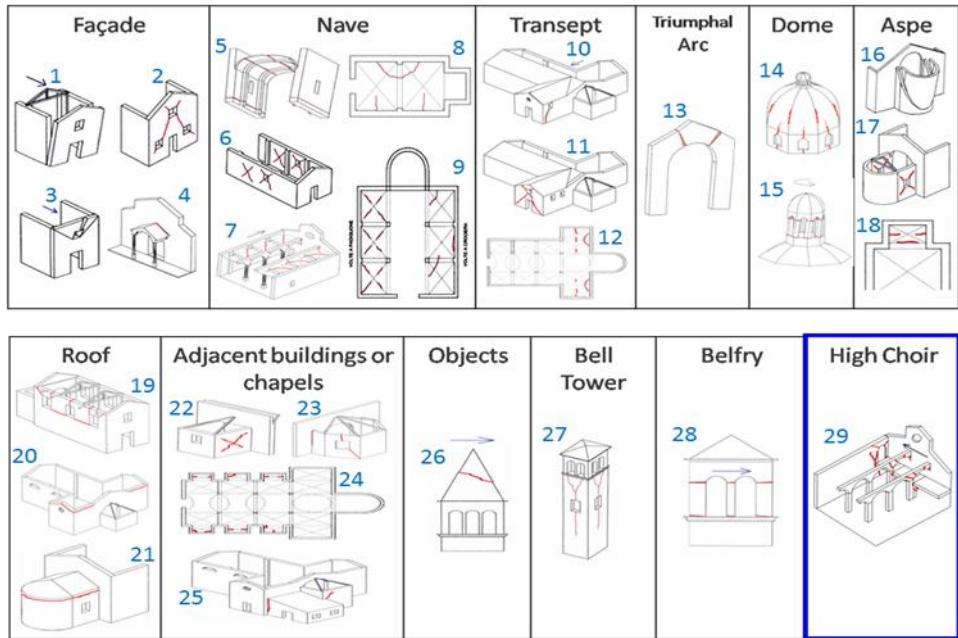
**Figure 4.** Damage mechanisms (adapted from *Linee Guida*, 2006).

The study of this macro-element is extremely important due the register of serious damages (Figure 3) that may result from its interaction with other parts of the structure, for example, the sidewalls, arches that support the structure or the façade. For this reason it was introduced as the 29th damage mechanism on the methodology corresponding to this macro-element. Figure 4 presents all the damage mechanisms considered in this work.
