2011 Sikkim Earthquake: Effects on Building Stocks and Perspective on Growing Seismic Risk

D.C. Rai, G. Mondal, V. Singhal, N. Parool, & T. Pradhan

Dept. of Civil Engineering, Indian Institute of Technology Kanpur, India

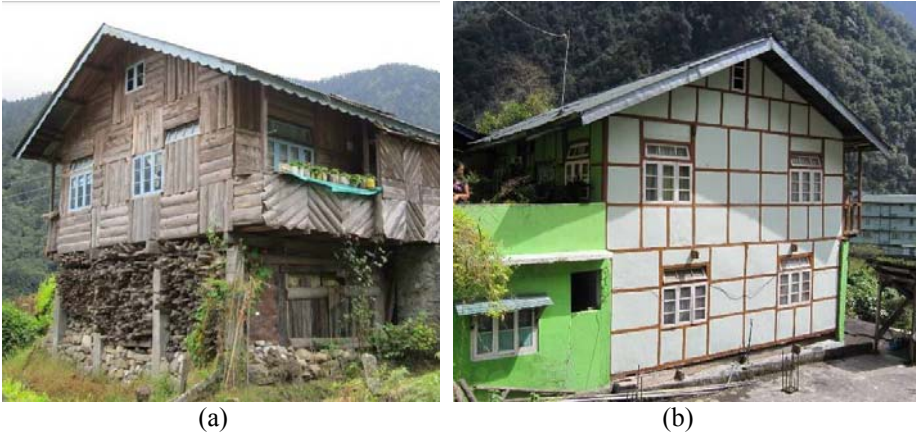
Traditional construction in Sikkim mostly consists of *Shing-Khim* (meaning wooden house) and *Ikra* houses (Fig. 4.1a-b). Such houses were constructed using locally available materials. These practices had been observed throughout the affected area and were more in number in Northern districts. *Shing-Khim* houses are single storey structures consisting of wooden planks connected by steel flats with

bolts and nails. However, *Ikra* houses are one to two storey timber framed structure filled with specially prepared panels. Infill panels are prepared by bamboo splints woven together with wooden frame and plastered with cement/mud mortar on both faces to have a finished look. In *Shing-Khim* and *Ikra* construction, the superstructure is generally supported on wooden post and an exterior basement wall of R/R masonry was provided for thermal insulation. However, in many cases these houses are constructed on RC columns or simply rested on grade. Pitched roofs made of asbestos or corrugated galvanized iron sheets (CGI) on wooden truss are common in this area because of incessant rain throughout the year with an average annual rainfall of about 3000 mm. Table 4.1 summarises the building typologies which has evolved in Sikkim over the years.

Figure 4.1 Types of Buildings in Sikkim (a) *Shing-Khim* house (b) *Ikra* house
