# Damage to Steel Educational Facilities in the 2011 East Japan Earthquake: Part 2 Damage to Minor Structural Components and Damage due to the Tsunami

On 11 March 2011, the strong ground motion and tsunami caused by the East Japan Earthquake, which occurred off the coast of Miyagi Prefecture, induced extensive damage along the Pacific coast. A series of reconnaissance on steel educational facilities were conducted in Iwate, Miyagi, Fukushima, Ibaraki, Chiba, and Tochigi prefectures from April to June 2011. In this paper, the damage to roof braces, non-structural components and foundation as well as the damage due to the tsunami are discussed. The typical types of damage observed are introduced along with their distribution of occurrence

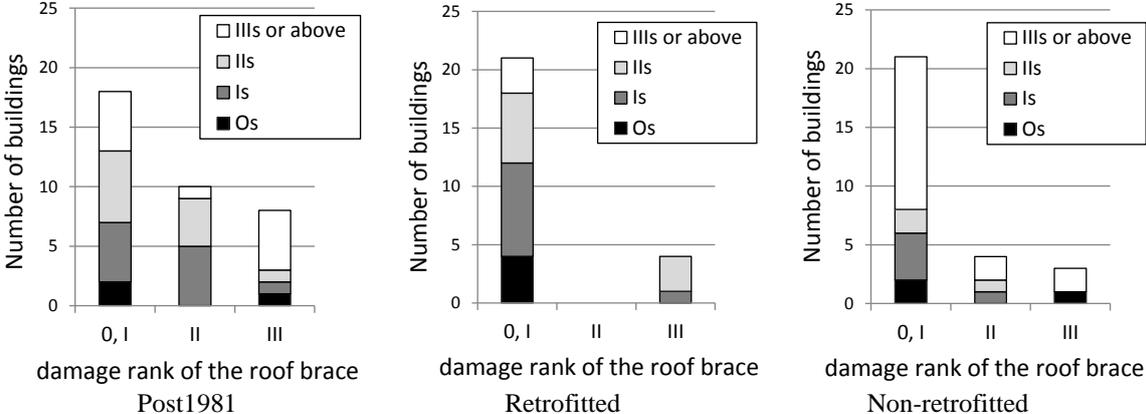
Figure 2.5. Damage distribution of the roof braces

Figure 2.5 shows the distribution of the damage rank of the roof braces with respect to each group. The bar corresponding to each roof brace damage rank is shaded according to the damage rank of the horizontal force resisting system. The damage rank of the horizontal force resisting system is defined as the maximum damage rank among the column bases, the diagonal braces, the beams, and the columns. In the “Post 1981” group, the roof bracing damage ranks O and I account for 48% and rank II for 30%. The percentage of rank II damage is higher than in other groups. In the “Retrofitted” group, the roof bracing damage ranks O and I account for 82% and damage rank II wasn’t observed. The damage rank III accounts for 18%, and the roof braces which existed before the retrofit fractured in these buildings. Because the buildings of the “Retrofitted” group are believed to have been retrofitted according to the updated retrofit standard, the roof braces conceivably had sufficient strength, which resulted in slight less damage compared to the “Post 1981” group. In the “Non-retrofitted” group, the damage ranks O and I account for 77%. This percentage is similar to that of the “Retrofitted” group. However, 63% of the buildings with roof damage ranks O and I in the “Non-retrofitted” group have a horizontal force resisting system damage rank of IVs or Vs. This may imply that the damage to the roof structure was reduced only because the shear force applied to the roof structure was conceivably lower than that of the other groups due to an early failure of the horizontal force resisting system.

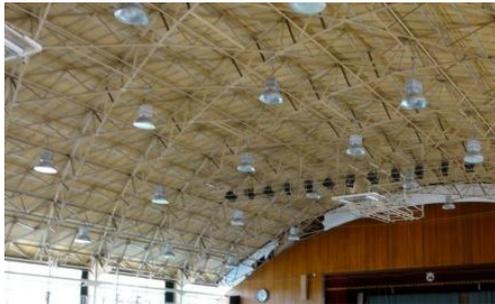
**Figure 2.11.** Roof structure

In general, the roof with a 3-dimensional structure has sufficient stiffness and strength to withstand damage from severe earthquakes. Only one gymnasium in the “Retrofitted” group has a damage rank above I. Its roof structure is composed of several arch-shaped trusses crossing each other diagonally as shown in Figure 2.11. The buckling of several truss components was observed as shown in Figure 2.12. The cause of the damage is still under investigation, but the damage of the buildings near the site lead one to believe that the seismic input exceeded the demanded level.

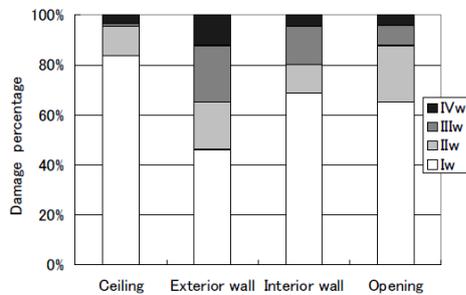
**Figure 3.1.** Damage distribution of non-structural components

In this section, the damage to non-structural components due to ground motion in 173 buildings is discussed. The damage rank of the non-structural components, such as the exterior/interior walls, the ceiling, and the openings, are determined based on the criteria given by the guideline for post-earthquake damage evaluation, issued by the Japan Building Disaster Prevention Association (2001). This is shown in Table 3.1. A damage rank of Iw includes the case where there is no damage. Figure 3.1 shows the damage rank distribution of the various non-structural components.

The damage to the interior of most steel buildings has been slight, as can be read from Figure 3.1. The types of damage that occurred were cracking and falling off of mortared walls as in Figure 3.9 and peeling or falling of boards from boarded walls as in Figure 3.10.

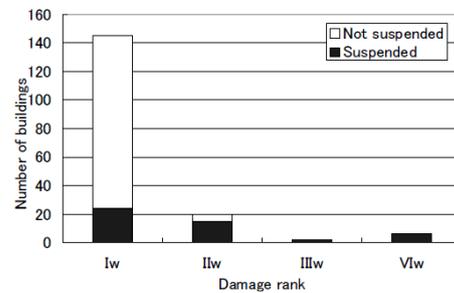
**Figure 3.2.** Damage to the ceiling with regards to the existence of a suspended ceiling

The vulnerability of suspended ceilings has been mentioned for a long time. Since suspended ceilings are fairly heavy, the inertial force under earthquake acceleration is large. When the connections, which suspend the ceilings, are not strong enough, the ceilings have a danger of falling. The damage observed in the survey reinforces this claim. In Figure 3.1, the ceilings which had a rank IIw or higher damage were those suspended. From Figure 3.2, which shows the damage rank with respect to whether or not the ceiling is suspended, one clearly sees that little or no damage occurs if the ceiling is not suspended. The majority of buildings without a suspended ceiling are gymnasiums. Such a gymnasium is shown in Figure 2.11. On the other hand, 5 of the 8 buildings with a rank IIIw or IVw damage are gymnasiums with suspended ceilings, which imply that suspended ceilings in gymnasiums can be vulnerable to strong ground motions. Figure 3.5 shows the complete fall of the ceiling of a gymnasium which suffered a rank 7 earthquake based on the Japanese Meteorological Agency seismic intensity scale. Figure 3.6 shows partial falling of ceiling boards in a classroom.

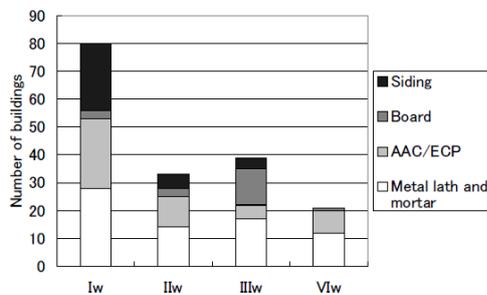
**Figure 3.3.** Damage to the exterior wall with regard to their type

The types of damage observed in the exterior walls depend strongly on the material and method of construction. These were organized into 4 groups: “sidings” (metal siding, plastic siding), “boards” (asbestos cement board, plaster board, calcium silicate board), “AAC/EPC” (Autoclaved Aerated Concrete(AAC) panel, Extruded Cement Panel (ECP) ), and “metal lath and mortar”. The distribution of the damage rank organized into the 4 groups is shown in Figure 3.3. “Metal lath and mortar” and “panels” combined make up most of the severe rank IVw damage. “Metal lath and mortar” exterior walls are extremely vulnerable to damage, since they have a lower deformation capacity compared to the steel structure, and may completely fall off as in Figure 3.7. The same can be said about exterior

walls using AAC panels fixed to the structure without a mechanism to allow deformation. On the other hand, “sidings” have a high deformation capacity and generally had slight or no damage. Even in the worst case, as shown in Figure 3.8, there is only some out of plane deformation. Figure 3.4 shows the year of construction of the buildings with respect to the type of exterior wall. The use of metal lath and mortar was popular in the 1960s and 70s, but because of the reason stated above, its usage has declined. The use of boards has also declined and they seem to have been replaced by siding.

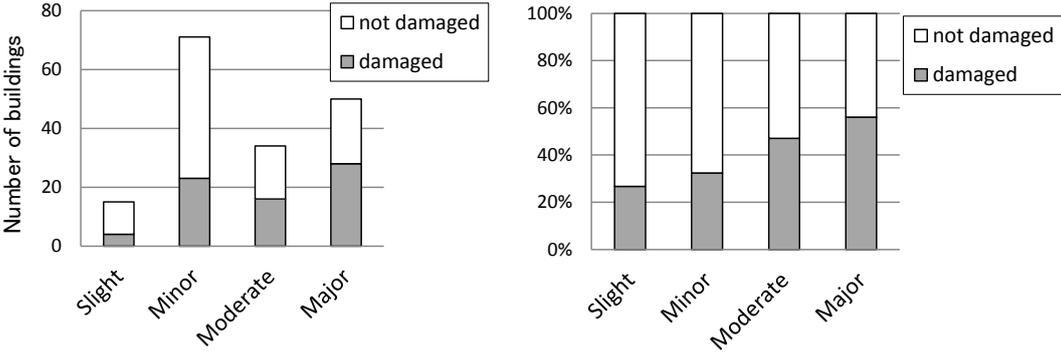
Figure 4.1. Distribution of foundation damage

Figure 4.1 shows the distribution of the damage rank of the entire building, with the ones with a damaged foundation shaded in grey. 40% of the buildings had damaged foundations. 23% of the buildings ranked as "slight damage" and 57% of the buildings ranked as "major damage" had damaged foundations. The more severe the damage rank is the higher the ratio of foundation damage.

The cause of the damage to the foundation was categorized into 2 groups. One is landslide of sloped sites and the other is subsidence of flat sites. The former caused about 80% of the damage in the building's ranked as "moderate damage" or above. The latter was observed around a river or a pond.

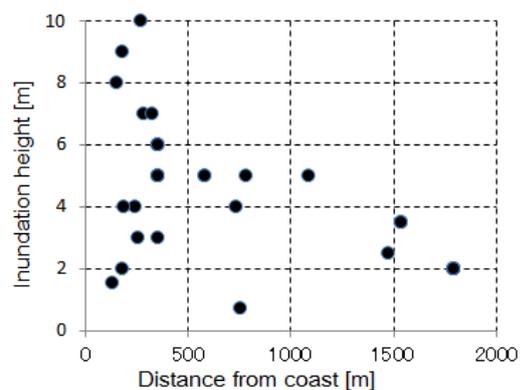
**Figure 5.2.** Relationship between the distance from the coast and the inundation height

In this section, the damage due to the tsunami of 43 buildings is discussed. These buildings include 20 gymnasiums, 13 classroom buildings, and some storehouses. 86% of the total buildings are of the S-type structure. Figure 5.1 shows the location of the damaged buildings. They are all located within 2 km of water. Figure 5.2 shows the relationship between the inundation height and the distance from the coast. The inundation height decreases according to the distance.
