# Performance of masonry buildings during the 2011 Lorca earthquake

**L. Hermanns, A. Fraile, E. Alarcón & R. Álvarez** *Universidad Politécnica de Madrid, España*

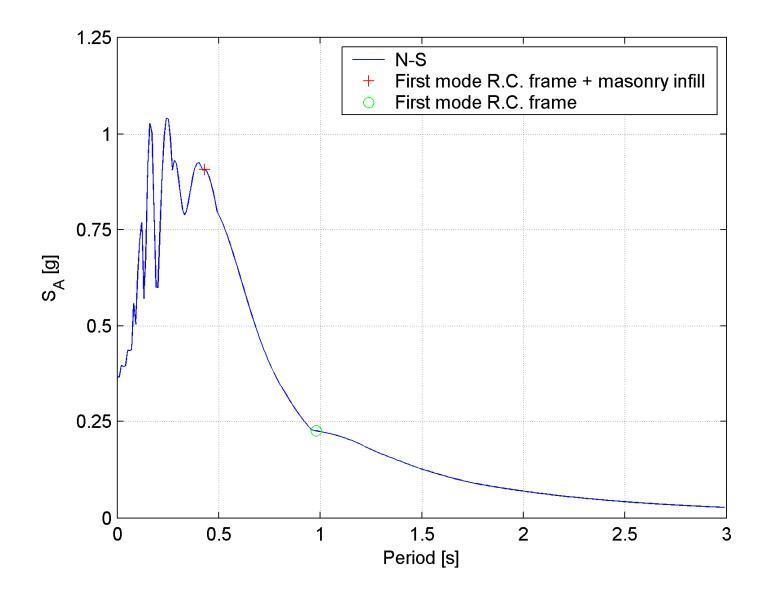
Figure 6. Response spectrum of the N-S component of the 2011 Lorca earthquake

The reduction in period increases the base shear force by a factor of 3. The majority of the base shear force is taken by the masonry wall corresponding to its contribution to the overall stiffness. In this particular example the shear wall at ground level takes approximately 2.8 MN i.e. 2/3 of the total base shear force. The resulting average tangential stresses are higher than 4 N/mm<sup>2</sup> exceeding clearly the

strength of conventional masonry. The intact infill panel reduces the fundamental period of the structure which results in considerable seismic forces that finally cause the failure of the masonry infill at a quite early stage of the earthquake. In order to study what happens after the failure of the masonry infill at ground level its stiffness is drastically reduced and the transient dynamic analysis is repeated i.e. the damaged structure is subjected to the seismic loads that result from the North-South component of the Lorca earthquake. The resulting fundamental period is 0.68 s and the maximum base shear force reaches 2.5 MN.

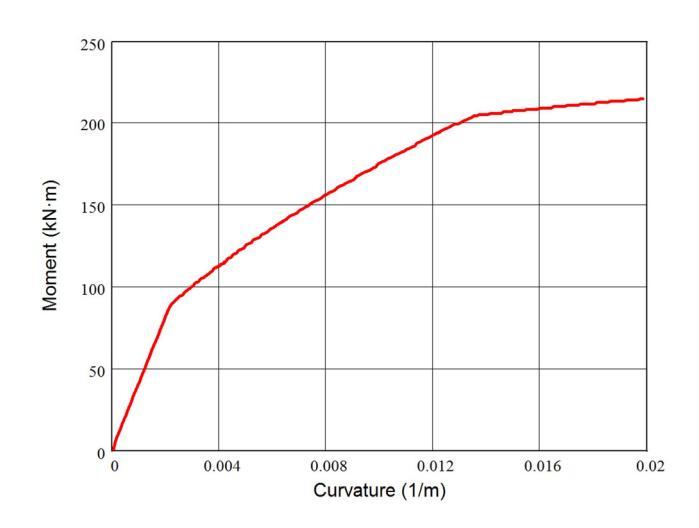
Figure 7. Moment-curvature diagram of the compressed column

The maximum value reaches 215 kNm. Based on equilibrium considerations of the capacity design method, see Figure 8, and considering a floor height h of 4 m, the corresponding maximum shear force is 107.5 kN.

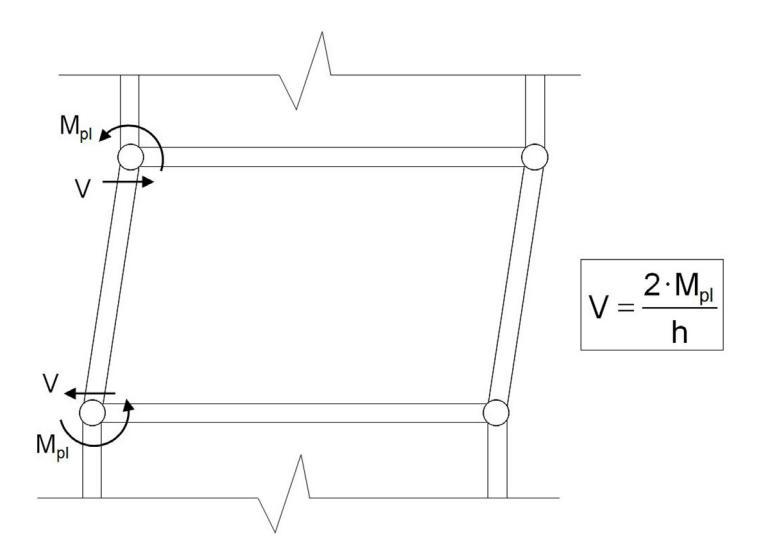
Figure 8. Estimation of the shear demand in a column

The shear capacity of this column without shear reinforcement is according to the Spanish Seismic Design Code (NCSE 2002) 182.5 kN. Considering the same limit values for the maximum moment and the shear capacity of the column a floor height of 2.36 m would be necessary to increase the shear demand to an extent that the shear capacity is exceeded when reaching the maximum moment. However, this floor height is much lower than the limit value established by the urban building standards. This means that, in general, a column shear failure may be avoided if the capacity design approach is followed and properly detailed shear reinforcement is designed and provided.

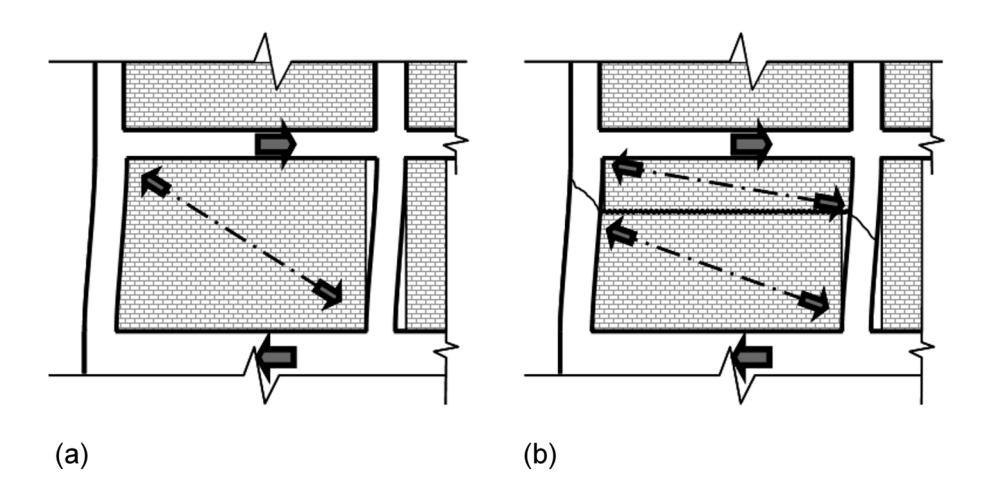
This type of failure is particularly dangerous because of the damage that is caused to the compression zone of the infill panel i.e. the load carrying strut in an equivalent strut model. If the failure results in the formation of two struts like indicated in Figure 11 b important forces act on the column sections almost at mid-floor height.

The formation of two struts may be favoured by the existence of conduits, openings or other discontinuities in the infill panel.

Figure 11. Force transmission before (Fig. 11 a) and after (Fig. 11 b) shear failure of the infill panel
