# Statistical Damage Survey of the 2010 and 2011 Christchurch Earthquakes

**T. Lai, & A. Nasser**

## SUMMARY

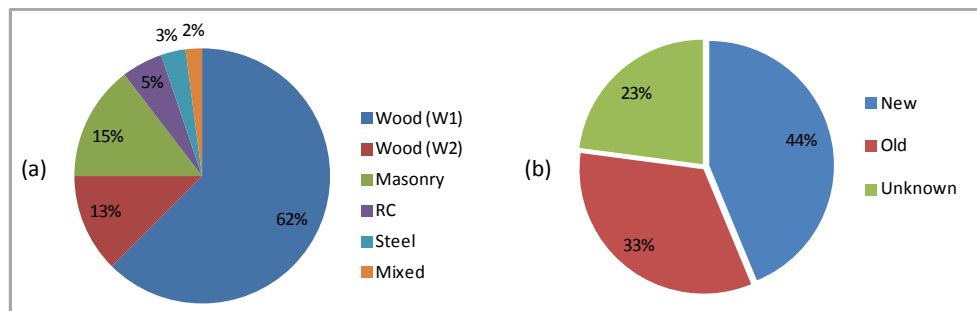
A breakdown of the construction mix, shown in Fig. 3, indicates that 75% of the building stock in this block is of wood construction (62% W1 and 13% W2) which is known to perform relatively well in earthquakes. With respect to age of the buildings, as defined in previous sections, 44% of the building stock is considered “new” and 33% is considered “old” while age of the rest is not clear from the survey. For wood and masonry buildings which collectively comprise the majority of the surveyed buildings, Fig. 4 presents the breakdown by age. It can be inferred from these figures that “new” wood construction is prevalent.

**Figure 3.** Distribution of buildings in the surveyed region a) by construction type b) by age

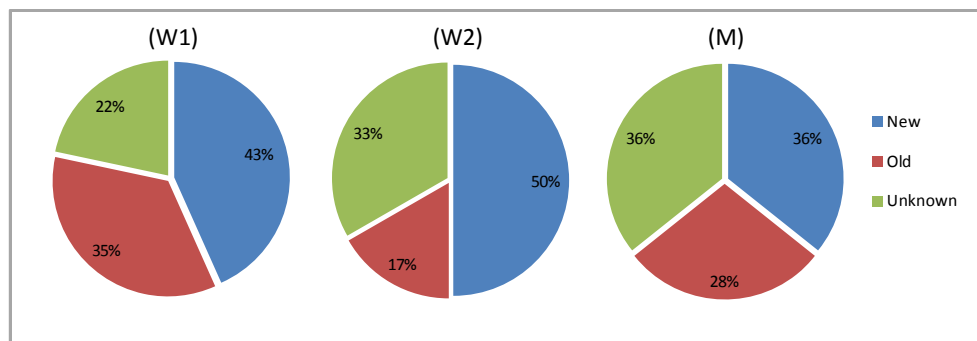
**Figure 4.** Distribution of wood and masonry structures by age
