Assessment of bridges in non liquefiable soils following Canterbury earthquakes: comparison between observations and numerical analyses

SUMMARY:

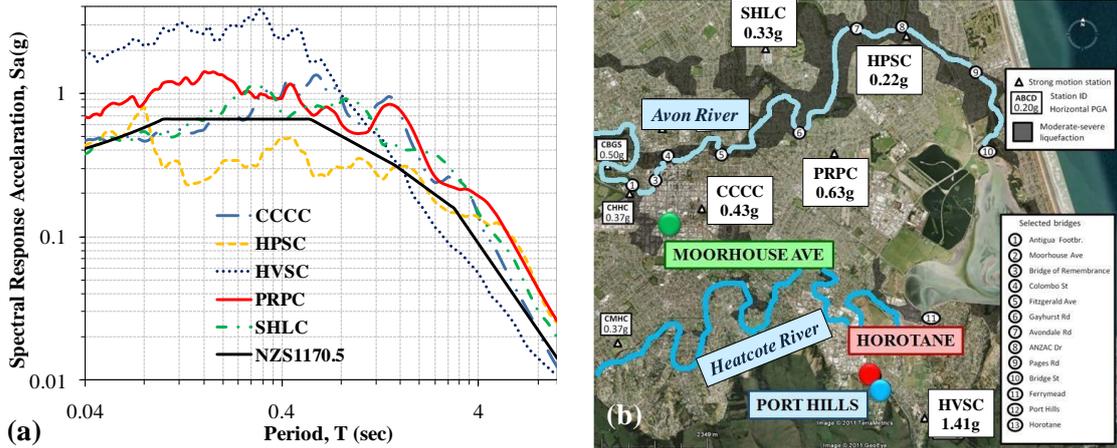
Figure 1. a) Response spectra of the geometric mean of the horizontal accelerations at strong motion station in Central and Eastern Christchurch compared to NZS1170.5 design response spectrum for Christchurch, site subsoil class D for a 500 year return period. Four letter symbols represent different strong motion stations. b) Overview of Christchurch and the surrounding region, with locations of the case studies bridges and strong motion stations.
