Investigation of Liquefaction-induced Damage to Wooden Houses in Urayasu City Caused by the Great East Japan Earthquake

Kohji Tokimatsu & Kota Katsumata

Tokyo Institute of Technology

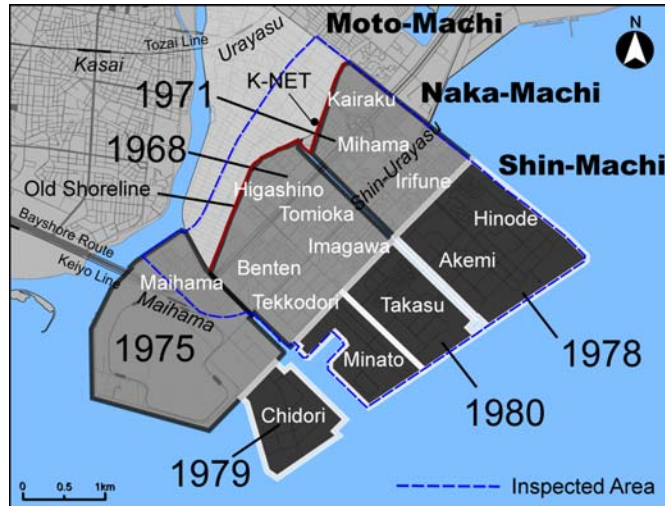
Figure 2.1. Map showing Urayasu city with reclamation year (Tokimatsu et al., 2012)

Figure 2.1 shows a map of Urayasu city, Chiba Prefecture, with the years when reclamation work was done for each area. The city consists of three towns, Moto-machi, Naka-machi and Shin-machi. The later two towns were in turns reclaimed after 1964 outside levees along the old coastline of the Moto-machi area. In the Naka-machi areas reclaimed in the first phase of the project through 1975, many houses, commercial buildings and public facilities have been built. Meanwhile, the Shin-machi areas completed in the second phase through 1980 have many high-rise condominium buildings, universities, hotels and storehouses. Vacant lots still dot areas near the coast. Sand excavated from the seabed off Urayasu was mainly used to fill the reclamation sites. A magnitude-6.7 quake that occurred off eastern Chiba Prefecture on Dec. 17, 1987 (Chibaken Toho-oki Earthquake) reportedly caused liquefaction in some parts of the city, including Kairaku, Mihama and Irifune. The altitude is 0 to 2 meters north of the old coastline of 1964, 2 to 4 meters between the 1964 coastline and the 1971

coastline to the south, and 3 to 7 meters in land reclaimed in or after 1979. The altitude is especially high in a park near a coastal levee in Akemi.

Figure 2.1 also shows with dotted line the area within which our initial reconnaissance survey was made. The survey area covers not only a part of the natural deposit on the northwest of the old coastline, including the neighborhood of Urayasu Station and K-NET Urayasu site, but also most of the reclaimed land in the city.

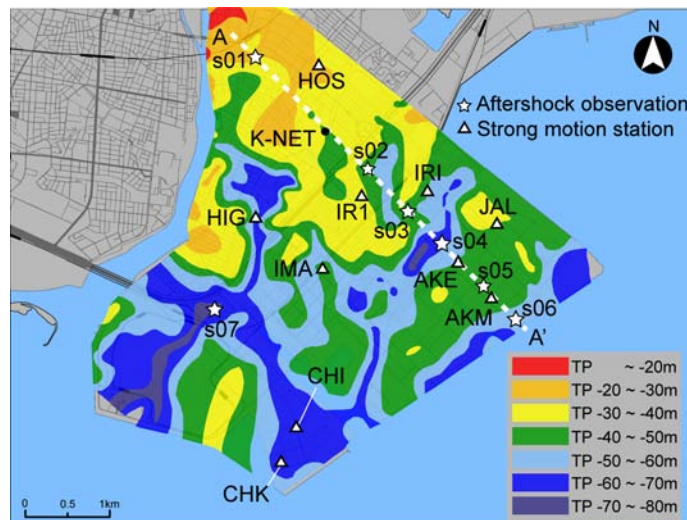
Figure 2.2. Map showing thickness of soft soil overlying Pleistocene deposit (Urayasu city, 2011b)

Figure 2.2 shows depth distribution for the sedimentation of soft soils overlying the Pleistocene deposit. Hidden valleys of about 60 meters deep exist directly below Minato, Imagawa, Akemi and Irifune areas, causing complicated changes in the thickness of soft clayey deposit in those areas. The depth of Pleistocene deposit (Ds), with N-values of 50 or greater, along the A-A' line (northwest to southeast) is about 20 meters below the sea level near the old coastline on the north side, and about 50 meters below the sea level in the area closest to the sea, showing that the depth becomes greater toward the sea (in the southeast direction). In contrast, along the northeast to southwest line, which is perpendicular to the A-A' line, the depth becomes greater towards the southwest. The reclaimed fills in the Naka-machi and Shin-machi areas are mostly deposited between the sea level and a depth of 4-8 meters.

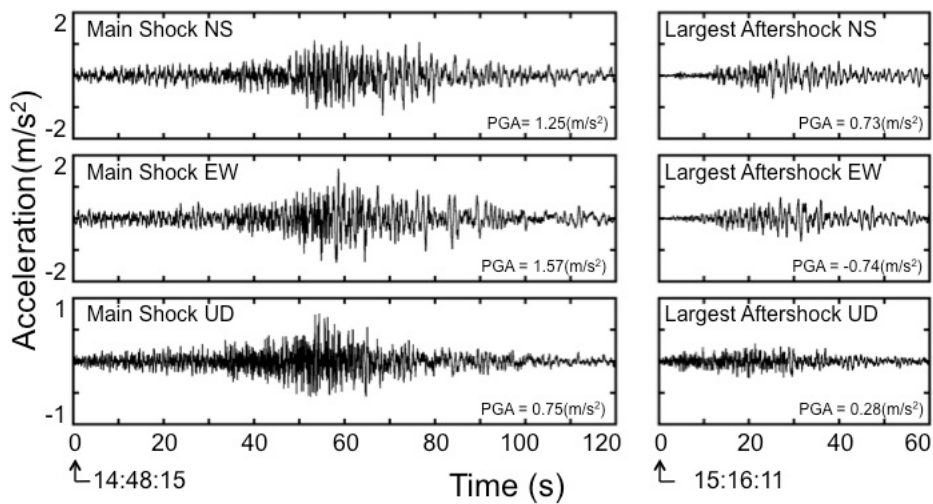
Figure 3.1. Acceleration time histories at K-NET Urayasu during the main shock and the largest aftershock

Figure 3.1 shows the acceleration time histories at K-NET Urayasu during the main shock and the largest aftershock (M7.6) that occurred in about 30 min after the main shock. The peak accelerations during the main shock and aftershock were 1.71m/s^2 and 0.80m/s^2 , respectively. No liquefaction was spotted in the neighborhood of K-NET Urayasu (CHB008).

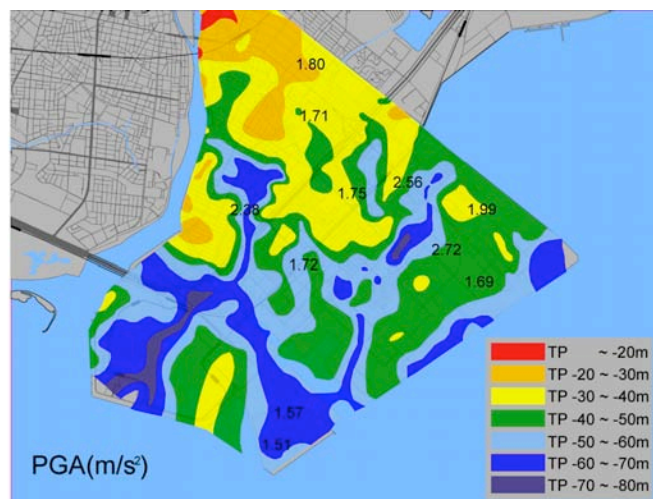
Figure 3.2. PGA recorded during the main shock (Urayasu city, 2012; Tokimatsu & Katsumata, 2012)

Figure 3.2 shows the distribution of peak ground acceleration (PGA) within the city. The peak ground acceleration varied within the city, with tendency where it is largest in the Naka-machi area.

3) Comparison of Figures 3.2, 4.1 and 4.6 shows that major liquefaction damage tended to occur just above or near buried valleys where PGA tended to be higher. Therefore, the differences in ground surface response due to differences in thickness of alluvial deposits might have affected the occurrence and extent of soil liquefaction.
