Performance of Unreinforced Masonry Structures in the 2010/2011 Canterbury Earthquake Sequence

L.M. Moon & M.C. Griffith

SUMMARY:

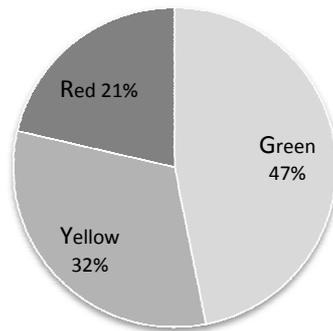
Each building was also assigned a placard colour according to observed levels of structural damage. Buildings tagged green had no observed structural damage, those tagged yellow had some structural damage but were deemed safe to enter for short periods of time, for example to remove personal possessions, and those tagged red were deemed unsafe to enter. Figure 2.2, which illustrates the distribution in placard levels, shows that nearly half of all URM buildings were observed to have no restrictions on building occupation but that roughly 1 in 5 were too unsafe to be entered at all.

Figure 2.2. Placard colours assigned to URM buildings in Christchurch after 4 September 2010

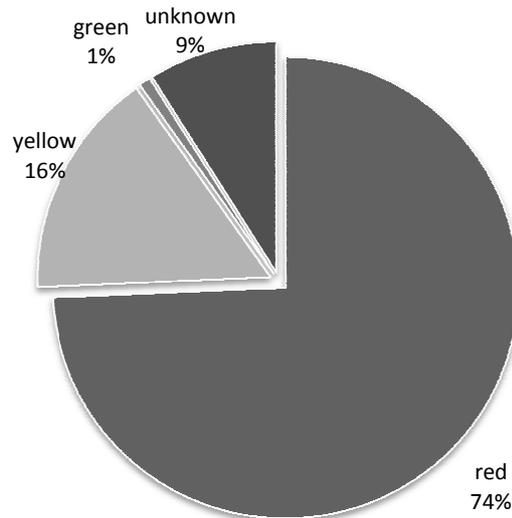
The distribution in placard levels assigned to URM buildings following the February 2011 earthquake is shown in Figure 2.3. Figure 2.3 shows a significant increase in damage levels compared to those observed after the Darfield earthquake in September (Figure 2.2) with nearly 75% of all URM buildings being classed as unsafe to enter and only 1% classed as safe to occupy.

Figure 2.3. Assigned placard levels for CBD URM building after 22 February 2011

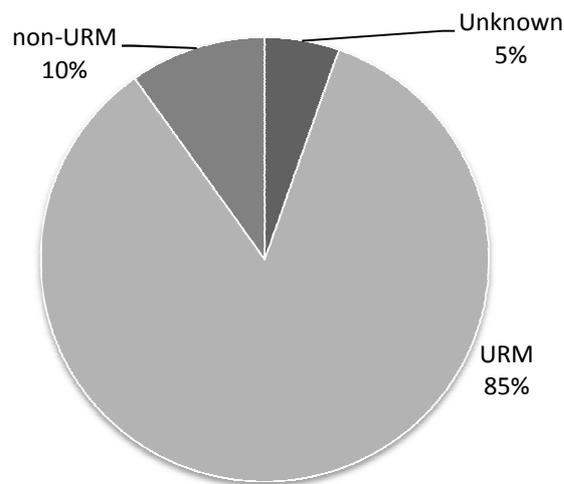
As at September 2011 85% of 224 buildings demolished were of URM construction (Figure 3.1). While in part this is due to the often more urgent nature of the demolition of URM buildings due to risk they present to the public, and the relative ease of demolition compared to taller buildings, it still highlights the poor seismic performance of URM buildings compared to other building types. By April 2012 the total number of buildings demolished, or scheduled for demolition, had increased to almost 1000, and many larger, newer structures had been demolished.

Figure 3.1. Proportion of demolished buildings which were of URM construction in September 2011.

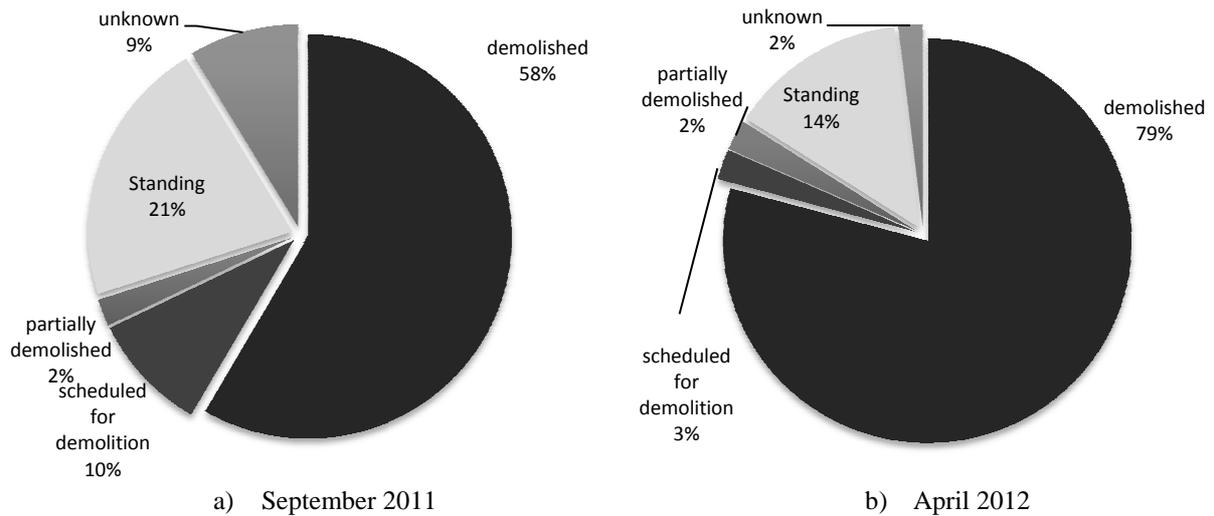
Figure 3.2(a) shows the proportion of the 368 URM buildings in the CBD demolished or scheduled for demolition at September 2011. By September 2011 over half of all URM buildings in the CBD had already been demolished, and another 10% were on the demolition list. Figure 3.2(b) shows the proportion of URM buildings in the CBD that were scheduled for demolition or had already been demolished in April 2012. As can be seen more than 80% of all URM buildings have either been demolished or are scheduled to be demolished in April 2012. It should be noted that the demolition list is updated fortnightly, so these figures are subject to change.

Figure 3.2. State of URM buildings in Christchurch CBD in September 2011 and April 2012

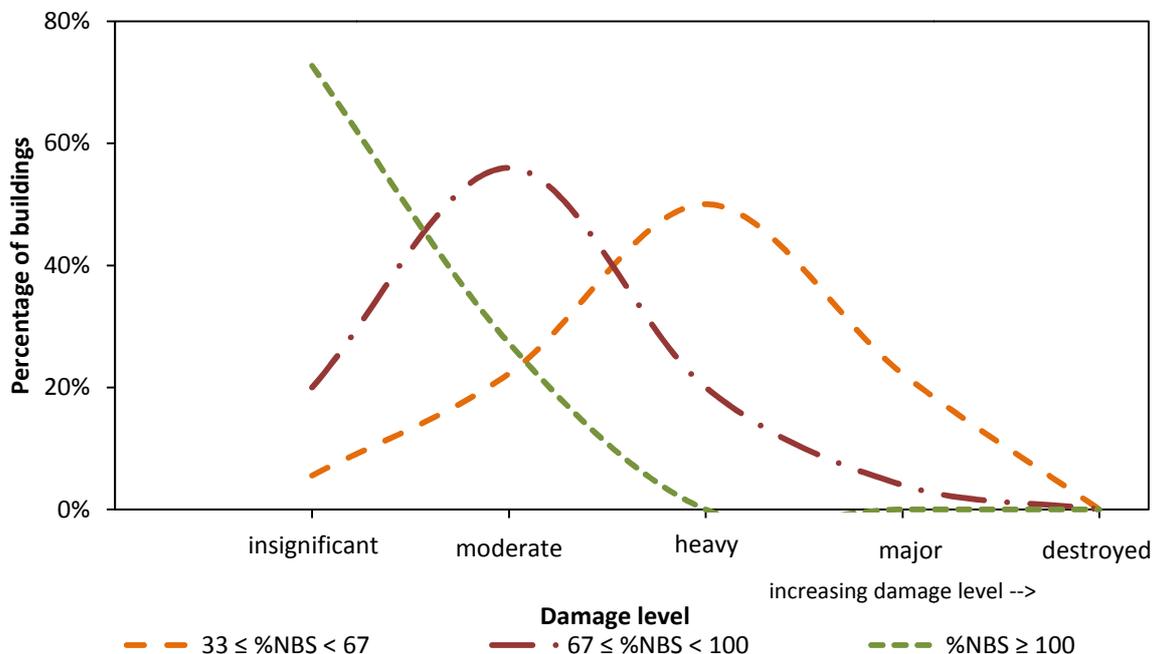
As can be expected URM buildings which had been seismically retrofitted performed better than those which had not. The damage levels for the URM buildings in the Christchurch CBD were plotted against the level to which they had been seismically enhanced (%NBS), shown in Figure 3.3, and clearly shows the buildings which were seismically retrofit to higher levels of %NBS sustained less damage than those strengthened to lower levels. Preliminary findings on the performance of seismic retrofits are reported by Ingham and Griffith (2011c), and work in this area continues.

Figure 3.3. Level of damage sustained by URM buildings that had received different levels of seismic retrofitting
