# Case Studies of Geotechnical Damage by the 2011 off the Pacific Coast of Tohoku Earthquake and Tsunami in Japan

**H. Hazarika & H. Okada**

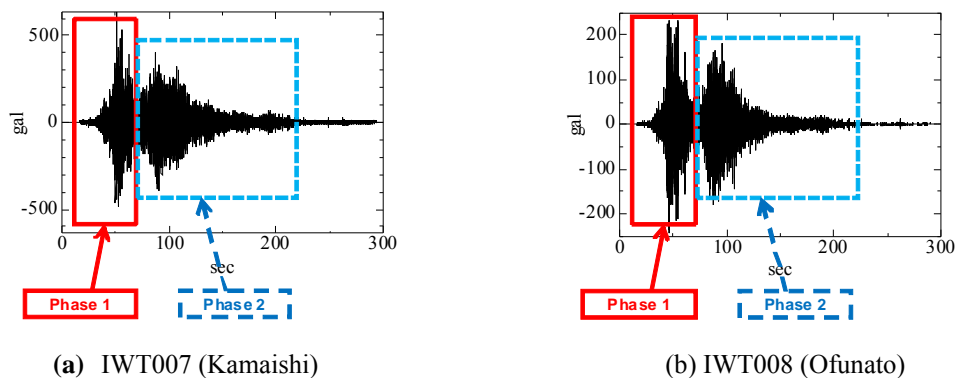
**Figure 4.** Acceleration records of the main shock recorded at K-NET

Figure 4(a) shows the acceleration records of the main shock recorded at K-NET IWT007 station (at Kamaishi), which recorded maximum acceleration 741.6 Gal. Fig. 4(b) shows the acceleration records of the main shock recorded at K-NET IWT008 station (at Ofunato), which recorded maximum acceleration 387.0 Gal. In both the acceleration records, continuation time was over 220 seconds. Such long continuation time, which is the characteristics of the earthquake this time, was one of the reasons for the damage to more than 2000 river dikes and coastal dikes in the Tohoku region.

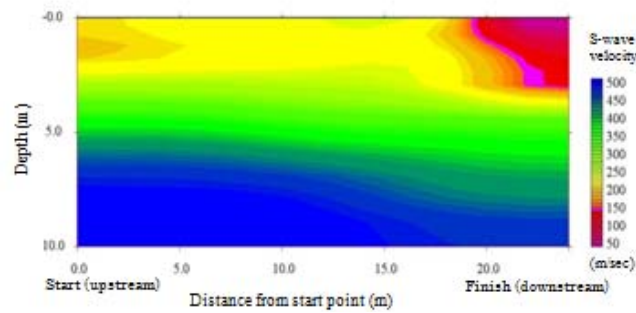
**Figure 7.** Distribution of S-wave velocity (River levee in Yoshihama area)

Figure 7 shows the S-wave velocity distribution analyzed from the surface wave exploration data of the ground near the embankment. The S-wave velocity ranges from 200 to 250 m/s near the surface, and the converted N-value was about 20 (Imai & Tonouchi, 1982), which implies that the surface soil is very dense. Near the end of the measured zone, the S-wave velocity was found to be low. Based on

the observations of the topography and the deposited sand due to tsunami, it can be said that the lower velocity was due to the reclaimed soils of restoration work.

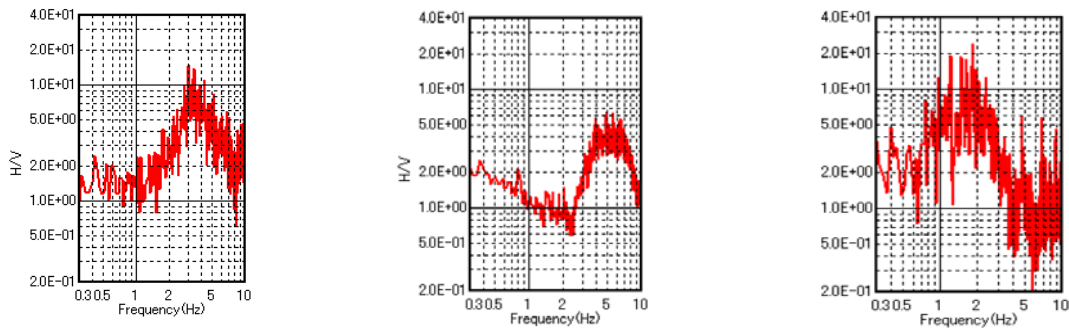
**Figure 8.** Micro tremor observation (River levee in Yoshihama area)

Figures 8(a)~(c) show the results of the micro tremor measurements. Measurements were made at the top as well as at the bottom of the embankment. On the surface of levee body, the predominant frequency of the soil deposits is 3.1 Hz (Fig. 8a). On the bottom of the levee body, the predominant frequency of soil deposits is between 4.0 to 6.0 Hz (Fig. 8b). Spectral ratio between the top and the bottom of the sloping side was found to be 2 Hz (Fig. 8c). As seen from Fig. 7, the shear wave velocity is approximately 200 m/sec within 5 m from the surface layer. The predominant frequency of the site is 10 Hz. At the lower stream, the shear wave velocity of the surface wave within 5 m from the surface is blow 100 m/sec. Thus, the result of the micro tremor measurements and the surface wave exploration shows a good agreement.

(a) H/V-ratio at the surface

(b) H/V-ratio at the bottom

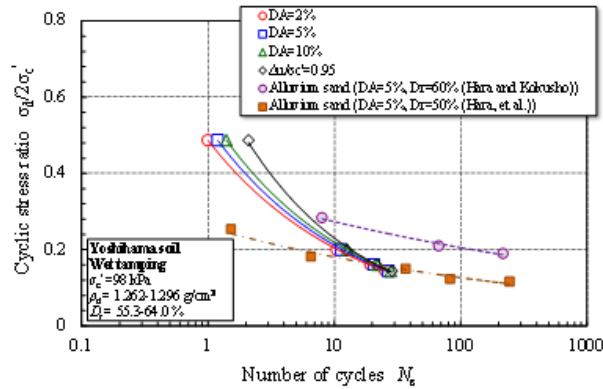
**Figure 9.** Cyclic triaxial test results

Figure 9 shows the relation between the cyclic stress ratio  $\sigma_d/2\sigma'_c$  and the number of cycles  $N_c$  from the undrained cyclic triaxial test when the double amplitude of the axial strain (DA) reached 2%, 5%, and 10% at the excess pore water pressure ratio of 0.95. It can be seen that the liquefaction strength has changed significantly with the increase in the number of cycles. Fig. 9 also shows liquefaction strength curves for various other alluvial sands and decomposed granite soil without fines (Hara et al., 2004). The liquefaction strength,  $R_{L20}$  of Yoshihama soil is found to be low (0.18) at  $N_c = 20$ . Comparing the  $R_{L20}$  values, one sees that Yoshihama soil has a lower strength than alluvial sand having the same relative density. The internal friction angle of Yoshihama soils was found to be 36.6 degree, which is close to value proposed by Nishida and Aoyama (1984) for undisturbed soils.

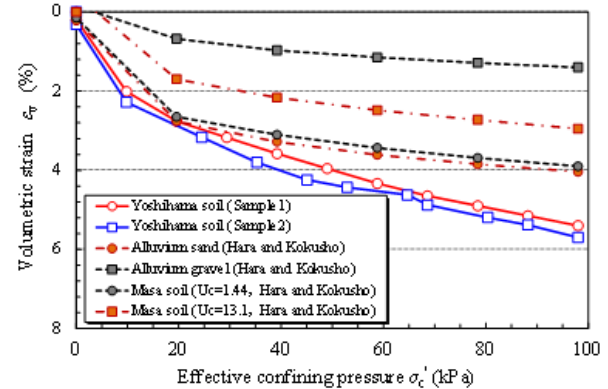
**Figure 10.** Consolidation test results

Figure 10 shows volumetric strain  $\varepsilon_v$  versus effective confining pressure  $\sigma'_c$  relationships obtained from the consolidation tests carried out after the undrained cyclic triaxial tests. The volumetric strain was found immediately after removing the load when DA reached 10%, based on the amount of drained water in a burette when specimens were returned to the drained state at the point of completion of the initial consolidation. Figure 10 also shows the same relation at  $D_r = 50\%$  for alluvial sand, alluvial gravel, and decomposed granite soil without fines. The change in volume for the Yoshihama soil after liquefaction was greater than for the alluvial sand and gravel containing hard grains or decomposed granite soil containing soft grains.

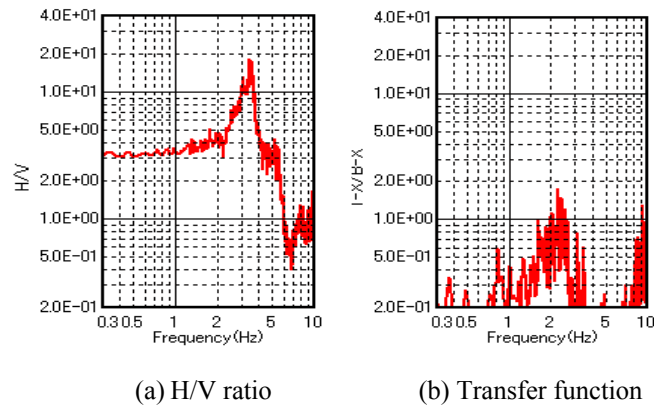
**Figure 14.** Micro tremor observations in Okirai

Figure 14 shows the results of the micro tremor measurements made at the top as well as at the bottom of the embankment. At location No. 2, the predominant frequency of H/V ratio of the soil deposits is 3.1 Hz (Fig. 14a). Spectral ratio between the top and the bottom of the sloping side was found to be 2.1 Hz (shown in Fig. 14b). The shear wave velocity from Fig. 13 was found to be approximately 200 m/sec beyond 10 m depth. The predominant frequency of site is 3.8 Hz. Therefore, it can be said that the result of the micro tremor measurements and the surface wave exploration is in good agreement. Laboratory test was conducted for soils samples that were collected at the sites. The in-situ density of the backfill soil was measured using the core-cut method (JGS1613-2003). The values of in-situ wet density  $\rho_t$  at the two locations (No.1 and No.2) are almost the same (a little more than 1.5 g/cm<sup>3</sup>). From the laboratory testing the void ratio of the soil was found to be less than 1.1. The grain size distribution showed that the soils were well-grained. It can also be said that the soils are well compacted. On the other hand, it is found that the filled soils inside the tires are found to be of higher

density, and thus can be said that they were compacted better. The angle of internal friction of the sample soil (collected within 30 cm from the surface) of the backfill ground is  $45.7^\circ$ , while it is  $48.2^\circ$  for the soil within the tires. Therefore, it can be said that near the surface both soils have high value of internal friction, because the wet density  $\rho_t$  is quite high.
