Repair and Retrofit of a 17th Century Library Structure in Istanbul

Sesigur, H. & Cili, F.

Istanbul Technical University, Turkey

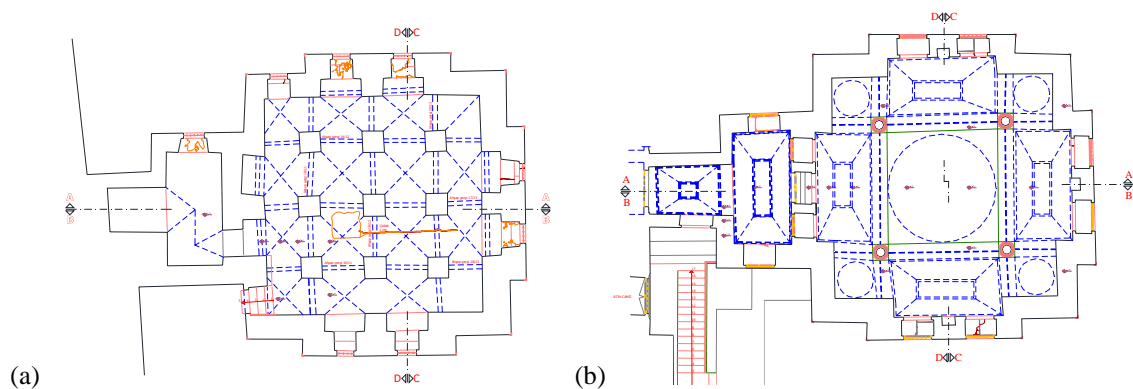
Figure 2.1. Plans of the building a) Basement Plan b) Ground Floor Plan

The Library Structure has a symmetrical cross shaped plan with dimensions of 24.54mx16.90m, Fig.2.1. It has two stories and the story heights are 3.60m and 7.60~11.00m for basement and ground floor respectively. The roof system consists of four vaults, four hemispherical, small diameter domes with a diameter of 2.00m and a main (central) dome with a diameter of 5.00m. The thickness of the main dome is 35cm at the top and 35cm at the support level. At the basement floor vertical load bearing members at the inner section of the building are aligned to a regular grid system, which consists of 3 gridlines parallel to the outer walls facing east and west and 3 gridlines which are parallel to the outer walls facing south and north. Grid spacing for both directions are of 2.50~2.60m. The buttresses are rectangular shaped elements with a 1.00m x 1.00m dimensions and they are connected to each other by timber ties having 10cm x 12cm cross sectional dimensions. At the ground floor, vaults and domes are supported by arches which are restrained by pillars inside the structure. The main arches have 5.20m span and 2.55m height while the pillars having 40cm diameter of circular cross sectional dimensions. The perimeter wall thicknesses vary from 80cm to 120cm. Material used in the masonry walls consists of shallow solid bricks, equal thickness crushed tiles and lime mortar for joints.

Within the scope of the restoration of the Library Building, detailed structural and architectural site investigations were performed. During these investigations following structural issues was encountered: At the ground floor, the cracks having up to 2cm wide were observed on the cross vaults, while at the roof level, up to 4cm wide were observed on the vaults. The observed crack patterns are shown in Fig. 2.2. Major structural problems of the Library Building originate from the tensile stresses (i.e. the masonry material in the system has low tensile strength) which occurred at different points of the building and are mostly concentrated at the vaults, domes and walls, which might be produced by ground settlements and earthquake forces.

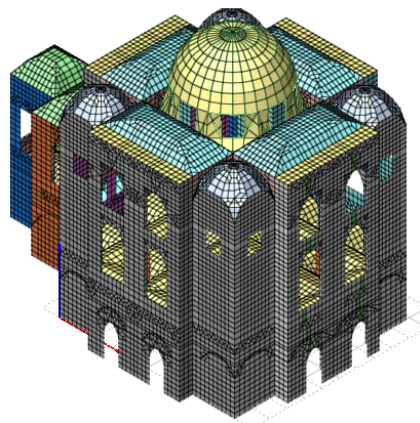
Figure 2.3. FEM model implemented in DIANA™, TNO, Delft

Besides the 2D rectangular curved shell quadratic elements (CQ40) it was also used triangular elements (CT30S). Tie-beams were included in the model by using Class-II fully numerically integrated beam elements, implementing an elastic-perfectly plastic constitutive law. The model comprises 19352 elements with 19107 nodes, resulting approximately 57000 DOF. A non linear behaviour was adopted for all elements, with the exception of the vaults' infill, that was assumed linear elastic throughout the analyses, however with a negligible stiffness compared to those of the structural materials.
