NEES/E-Defense Tests: Seismic Performance of Ceiling / Sprinkler Piping Nonstructural Systems in Base Isolated and Fixed Base Building

SUMMARY:

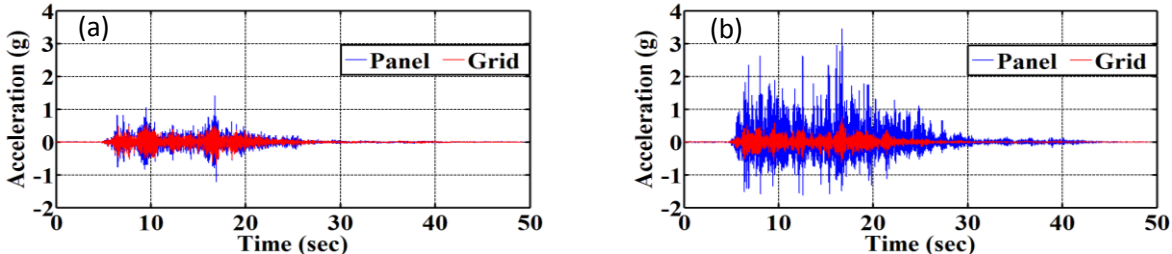
The accelerations in all three directions at the deck level, which represent the input excitation to the ceiling system, were slightly higher at the 6th deck than the 5th deck. However, the input acceleration alone does not explain the difference in damage; observed accelerations in each ceiling suggest that the compression posts used in the lateral bracing increased the damage to the ceiling system in this experiment. Fig. 10 shows the vertical acceleration of a ceiling panel and ceiling grid measured for a moderate excitation (3D-Superstition Hills Westmorland/TPB system) executed prior to the occurrence of ceiling damage. In the unbraced ceiling, little amplification of the panel acceleration relative to the grid was observed (Fig. 10(a)), which suggests that these two components moved together. However, in the braced system, the acceleration of the ceiling panel is significantly amplified relative to the compression post attachment location (Fig.10(b)), which suggests that the panel pounded on the grid system.

Figure 10. Vertical acceleration in panel versus grid in (a) 4th floor (unbraced) and (b) 5th floor (braced) ceiling due to 3D-Superstition Hills – Westmorland (TPB system)

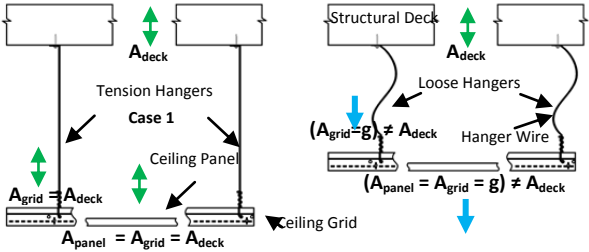
labeled A_{deck} , A_{grid} and A_{panel} , respectively. Fig. 11 depicts the unbraced ceiling, which is supported only by hanger wires. When the hanger wires are in tension (case 1), the accelerations of the deck, grid and panel are the same. However, when the hanger wires are loose (case 2), which as an example can be initiated by downward deck acceleration of more than 1g while the panels and grid system are limited to a maximum of 1g downward acceleration, the deck acceleration will differ from that of the panels and grid system. As the panel and grid system have almost the same acceleration, the panels will remain in place between the grid members and the probability of dislodging panels is low. Fig. 12 depicts the braced ceiling with compression posts at regular intervals. By constraint of the compression posts, the entire system (deck, grid, and panels) will generally move together with equal accelerations, as depicted in case 1. However, during downward deck acceleration of more than 1g, the grid system will move with the deck (assuming the compression posts are rigid) at the compression post locations while the panels are limited to 1g downward acceleration. As a result, the deck and grid accelerations will differ from the panel accelerations, causing a gap to form between the ceiling grid and panels. Once the gap forms, the ceiling panels are no longer constrained by the horizontal forces of the grid system, and hence the panels will “pop out” of the grid. Furthermore, the ceiling panels will impact the grid system when they fall, weakening the grid members.

Figure 11. Vertical dynamics of unbraced ceiling

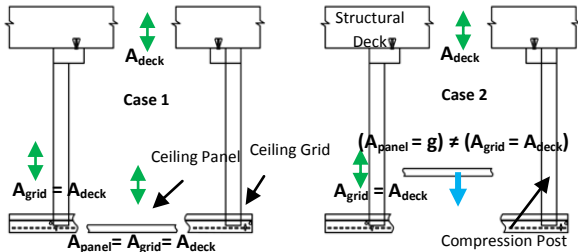
Figure 12. Vertical dynamics of braced Ceiling

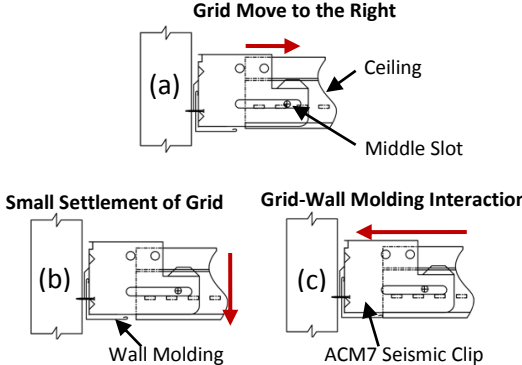
Fig. 13 shows minor damage observed at the unattached joints between grid members and wall molding. The mechanism is interpreted as follows: when the grid member moved away from the wall, the grid member lost contact with the wall molding (Fig. 14(a)). Since the middle slot is large relative to the screw dimensions, the grid member may settle slightly (Fig. 14(b)). As the settled grid member moved back toward the wall, it hit the wall molding to cause the observed damage (Fig. 14(c)). Note that ASTM E580/E580M-11ae1 (ASTM 2011) permits the use of either 22-mm (7/8-in.) or 50-mm (2-in.) wall molding to support seismic clips, and therefore, by installing the grid members with 19mm (3/4-in.) clearance from the wall, only 3.2mm (1/8-in.) seat length will be available from the edge of wall angle.

Figure 14. Grid - wall molding interaction mechanism

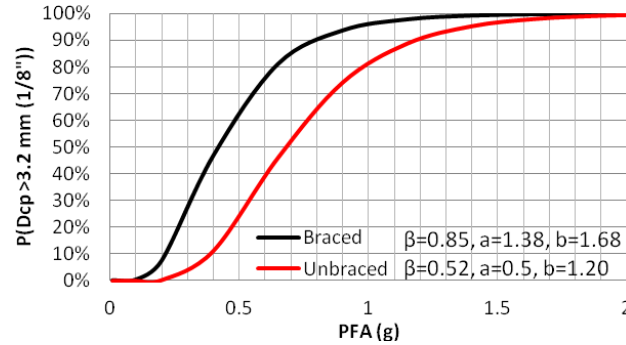
Based on the data from the experiment, fragility curves were developed to represent the statistical likelihood of occurrence of the ceiling perimeter damage shown in Fig. 13. These fragility curves are

shown in Fig. 15, and represent the probability that the ceiling movement relative to the partition walls on the unattached side (D_{cp}) exceeds 3.2 mm (1/8 in) -which would likely cause unseating- as a function of peak floor acceleration (PFA). The plots in Fig. 15 are represented by the following lognormal cumulative distribution function (Nielson and DesRoches, 2007):

Figure 15. Probability of grid-wall angle interaction

Fig. 15 shows that at PFA of 1(g) the probability of unseating was more than 80% in all cases. Unseating could perhaps be avoided by increasing the seat length of the 22 mm (7/8 in) wall molding.
