Seismic Retrofitting Journey of Industrial Buildings

This paper describes the collaborative project team set up by P&G and the journey of this team to implement seismic retrofitting on industrial buildings in Northern India. The journey starts at the point where seismic deficiencies were uncovered in existing facilities. P&G established and implemented a plan to create the project team to resolve the matter.

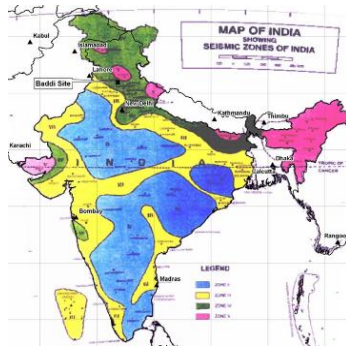
Figure 4. Indian Seismic hazard map in accordance with IS1893 (Part1): 2002 showing Baddi to be in zone IV.

According to the Indian seismic code, IS 1893, Baddi has a seismic zone factor of IV (i.e. 0.24g) as shown in Figure 4.

IS 1893 (Part1): 2002 does not include a provision for near-source factors which are clearly relevant in this instance.

7. The current Indian seismic hazard map in IS 1893(Part1):2002 needs to be used with caution and maybe un-conservative in a number of locations such as in Baddi.

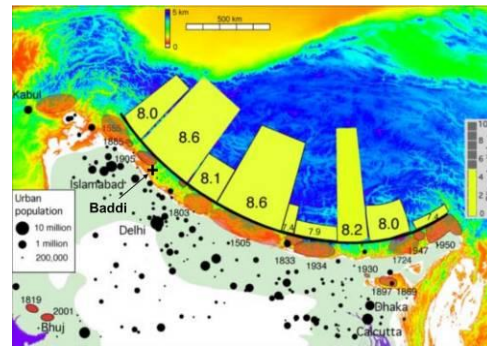
Figure 5. Potential earthquake magnitudes in northern India according to Bilham.

However the desk study quickly revealed that Baddi is in a very high seismic region as shown in Figure 5. Closer examination of the project location revealed that the site is located in a fault zone and surrounded by several active faults, at least one of which is highly active (slip rate > 5 mm/yr) and capable of generating large-magnitude ($M_w > 7.0$) earthquakes (Source Type A according to UBC 1997) as shown in Figure 6.

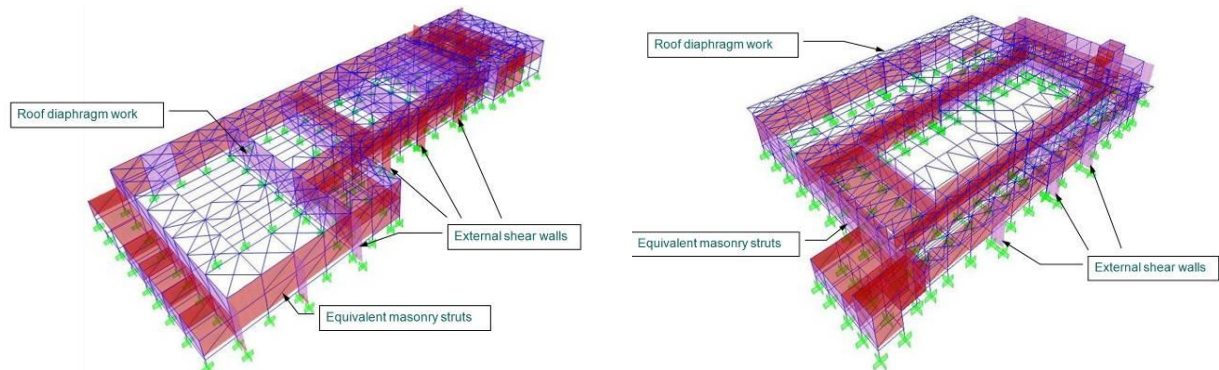
Figure 12. Final retrofit design analysis models for both facilities.

In the revaluation of the retrofit, the masonry stiffness and strength were evaluated by using guidance from FEMA 356, Al Chaar and Paulay & Priestley. Overall the number of required shear walls was able to be reduced. In close collaboration with the plants' operational management, the final locations of all the structural retrofitting items were agreed. As part of the design development process, P&G was also able to obtain a concession from their operational department to close the factory for a eight week period during which all internal foundation and shear wall construction work was to be undertaken. This is an important point as it recognises that in order to implement seismic retrofitting everybody has a contribution to make towards the necessary works.

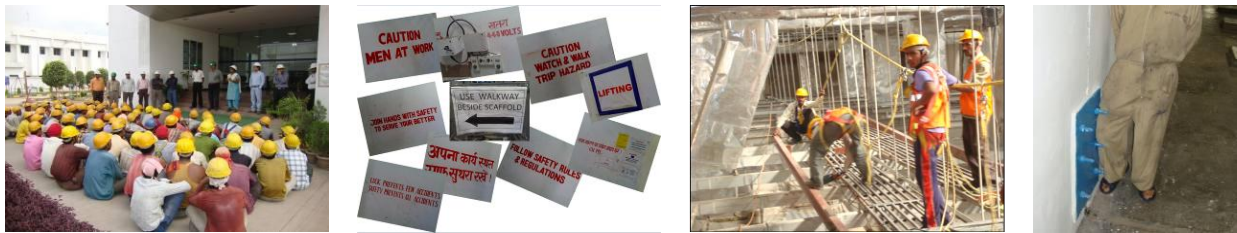
Figure 17. Tool box meetings, multi lingual safety signs, clip on when working at height and hazard identification

1. Enforcement of a clear responsibility structure
2. Review of the contractors health and safety standards and then enhancing them throughout the project:
 - Training system
 - Introducing a dedicated safety team.
 - Permit system.
 - Behaviour observation system.
 - Inspection system.
 - Developing project specific safety plan and methodology
 - Introducing safe working rules for working at height or hot working.

- Incident reporting and follow up system.
 - Clear sign posting of dangers and risks.
 - Daily coordination with the operations team
 - Having an agreed emergency management system in place
 - Weekly and monthly safety meetings
 - Results tracking and reporting system
3. Documentation & Record keeping so that all were aware of the
 4. Reward system to motivate the workers for safe performance.
 5. Safety was celebrated at all possible opportunities and senior leaderships attendance at these events.
 6. Education and raising awareness by having the workforce analyze incidents and near misses and present in team settings with recommendations to improve safety continuously.
