DAMAGE DUE TO TSUNAMI AND TSUNAMI RESISTANCE PERFORMANCE OF WOOD HOUSES DURING THE GREAT TOHOKU EARTHQUAKE

SUMMARY:

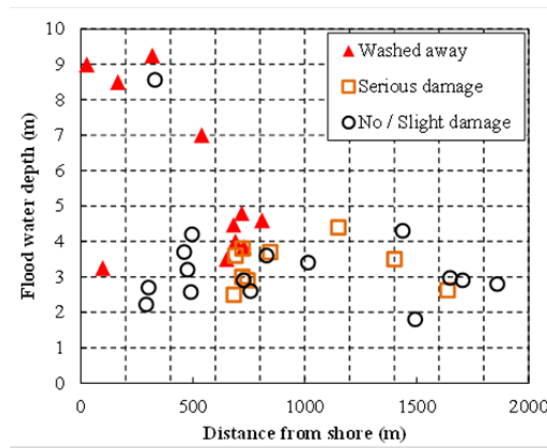
Figure 3.3. The distance from shore and the flood water depth of the houses investigated.

To study the coefficient, assumed as 3 in the previous paragraph, of flood water depth, the relationships between the tsunami wave force and the lateral resistance of timber buildings were discussed. The structural details and the flood water depth of about 50 buildings which were chosen as objects of study were grasped and measured. All the buildings chosen were detached residential buildings including 1-story or 2-story and less than about 1km from the shore. Many of studied house were Japanese conventional post and beam construction, and some of them were light frame construction. The investigated houses were various in the degree of damage, as shown in Table 3.1. The distance from shore and the flood water depth of the houses to study were shown in Figure 3.3.

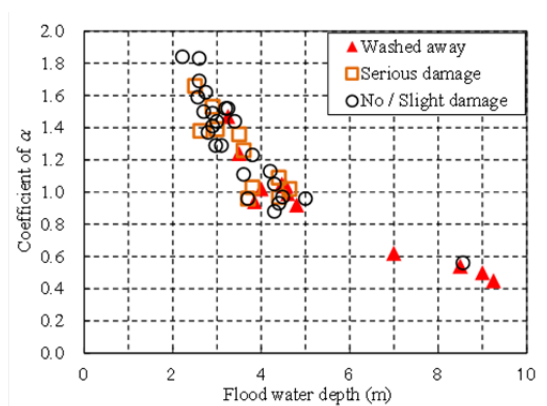
Figure 3.4. The distance from shore and the flood water depth of the houses investigated.

The relationship between the flood water depth and the coefficient α were shown in Figure 3.4. The deeper the flood water is, the smaller the coefficient α is. It is clarified that the house under the much flood water depth was acted by the relatively small wave force. And, the coefficients α were not over 2.0, and most of them were in the range from 1.0 to 2.0. On the other hand, the relationship between the distance from the shore and the coefficient α were shown in Figure 3.5. The both of them were not in significant correlations. However, these are the results that studied only lateral shear strength against the tsunami wave force. To resist the tsunami, wood houses must have performances of the sliding and the rocking of whole house, the floating, the shear force to the anchor bolts, the members resisting to the water pressure. Therefore, these studies are not complete.
