SOIL MECHANICS AND FOUNDATION ENGINEERING
ASPECTS OF THE ALASKAN EARTHQUAKE
OF MARCH 27, 1964

by Ronald F. Scott¹

SUMMARY

This report begins by briefly summarizing the geology and soil profiles of the Anchorage area. The most important effects of the earthquake with respect to soil engineering are then qualitatively described and illustrated and a brief discussion of the stability of slopes in the region of interest is presented.

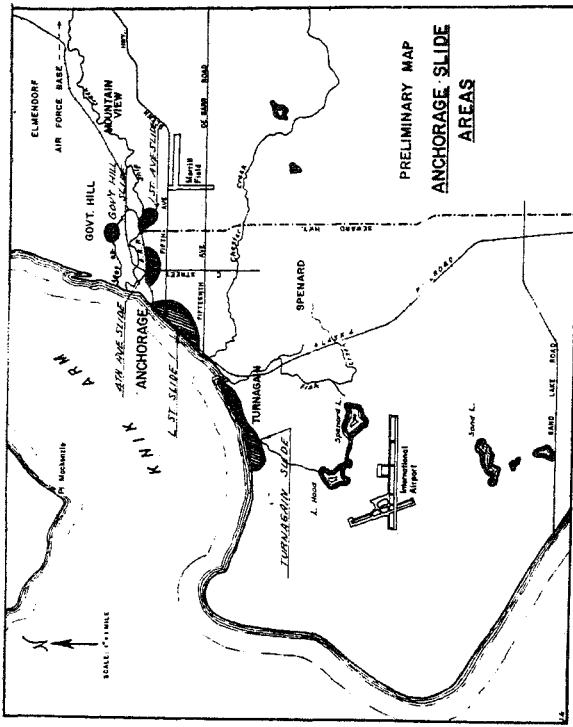
FIG. 2

The principal ground movements in the city are located on Fig. 2 and are illustrated by photographs discussed below. The soil movements appear to have been of three types, by spreading, lateral displacement, and by rotation, the failure mode in each case being a function of unknown ground motions during the earthquake, relatively poorly defined (at present) soil profiles and properties, and unknown static porewater pressures in soil layers prior to the earthquake.

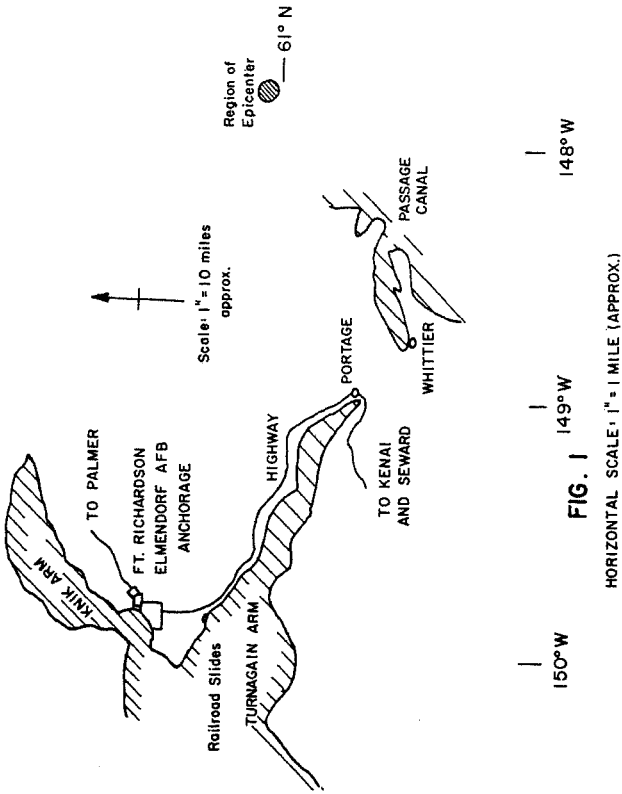
FIG. 1

At no location in Figs. 1 and 2 was there observed to be any sign of damage to a structure, with the possible exception of an oil tank at Whittier, due to local small-scale footing or foundation failure. All the structures affected by soil movements were in areas of large-scale ground movements due to landslides and slope failures.

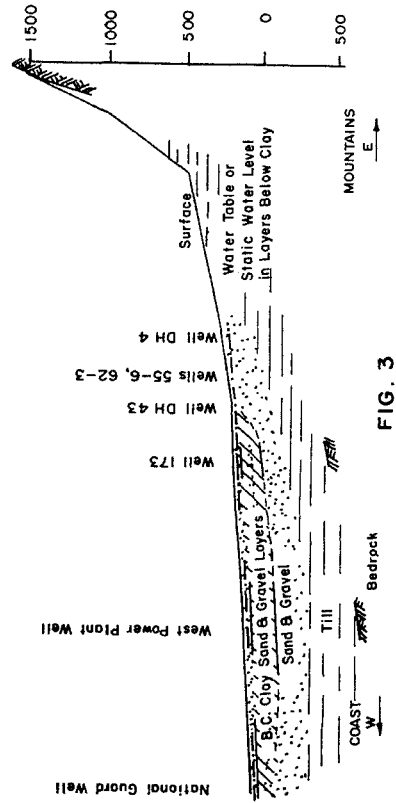
FIG. 3

- Fig. 1 Map of Anchorage, Portage and Whittier Region.
- Fig. 2 Map of Anchorage Showing Soil Slide Areas (From Ref. 4).
- Fig. 3 Approximate Cross-Sectional Soil Profile Showing Water Table, Anchorage Vicinity.

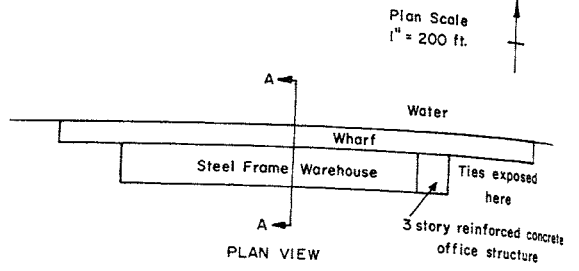
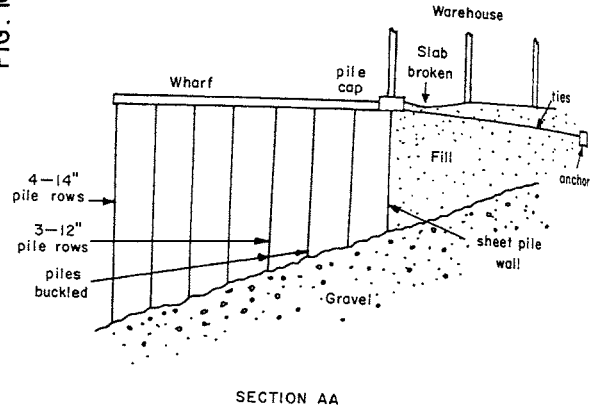
FIG. 12

A cross section through the wharf at Whittier is shown in Fig. 12, and Fig. 13 shows typical damage to the floor slab of the warehouse behind the wharf. It appears that the fill on which the warehouse floor slab rested underwent some compaction during the earthquake and settled away from the floor, which broke for lack of support. It is also possible that the ground shaking induced oscillations of the wharf structure and sheet-pile wall to and from the fill, assisting in its compaction and imposing lateral stresses on the unsupported floor slab, which, deflecting downwards, buckled as shown in Fig. 13. Movements of the latter kind would seem to be unlikely if the tie-rods and earth anchors to which they were attached were adequately placed and were sound before the earthquake. Since the tie-rods apparently passed unprotected through the fill below the warehouse, it is possible that they had been damaged before the earthquake and did not contribute full support during it.

- Fig. 10 Damage to Portage Highway (frozen to depth of several feet).
- Fig. 11 Collapsed Bridge and Temporary Bailey Bridge on Portage Highway.
- Fig. 12 Plan and Cross Section of Whittier Wharf.
