## ENGINEERING ASPECTS OF THE EARTHQUAKES

### IN THE MAIPO VALLEY, CHILE, IN 1958

Rodrigo Flores (1); Santiago Arias (2); Victor Jenschke (3); Luis A. Rosenberg (4).

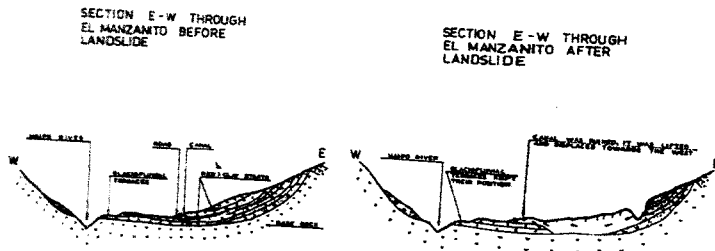
Fig. 3.- Section E-W through El Manzanito before and after landslide.

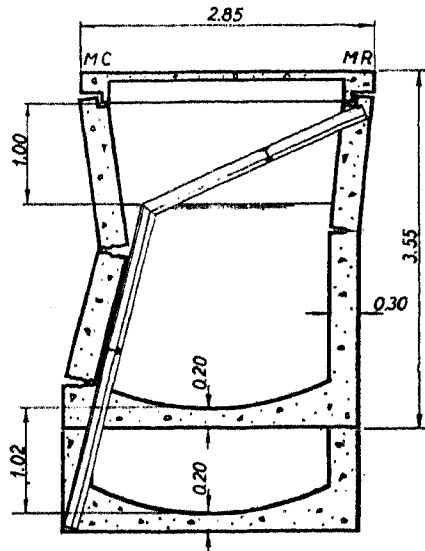
N° 1 Tunnel. This 300 mts. long tunnel traverses the Porphyritic formation through what appears to be a fault zone. The poor quality of the ground dictated the use of a lining in the form of an arched concrete floor, with vertical walls of concrete blocks supporting a roof structure formed by reinforced concrete T beams. Most of the damage consisted of failure of the concrete blocks under squeezing and consequent flexural cracks in the walls. (Fig. 8). The roof structure resisted well the vertical stresses which caused the T beams to develop their ultimate strength, with flowing in the reinforcing bars in many places. The work of repair was complicated by the fact that the change in sections downstream required lowering the tunnel to a depth that in some parts amounted to 1,4 m.

Fig. 9.- Tunnel 1. Maipo Canal - Typical section.

After weighing diverse solutions among which we can cite: reconstruction of both walls in reinforced concrete using a double system of stiffening steel frames; transformation of the original rectangular section into a curved shape inscribed in the distorted section, etc., it was decided to reinforce the complete tunnel by means of a rigid steel frame formed by 30 Km. of Decauville rails spaced about 60 cm. apart and filled with concrete in the gaps between these steel frames and the original tunnel section (Fig. 9). By this means a strong rigid frame was obtained capable of resisting both the horizontal pressure of the cracked hillside and the vertical forces acting on the present system of beams. The reactions of the steel frame are transferred in the lower end through its anchor to the new tunnel floor and in the upper end to the riverside wall which suffered less damage.

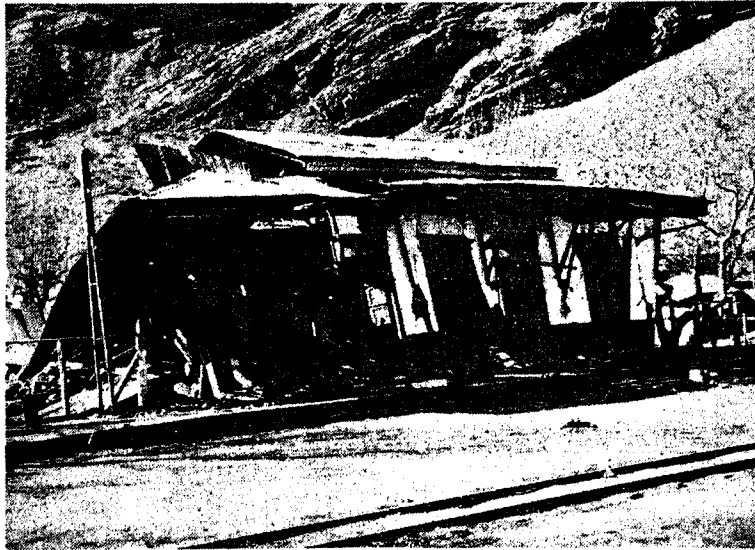
- 3.361.- Stone masonry houses, mud mortar. Total collapse.
- 3.362.- Houses with gypsum block walls. Destruction of walls and collapse in most cases.
- 3.363.- Houses with walls of timber frame construction, filled with gypsum mortar (Railroad station at El Volcan, Fig. 17). The gypsum filling failed in most cases.
- 3.364.- Houses with walls of timber frame construction filled with mud bricks. The filling was destroyed in most cases.
- .365.- Houses with mud brick walls. Many walls collapsed and the remainder were shattered and out of plumb.
- 3.366.- Houses with rammed earth walls. Failures in corners and walls out of plumb,
- 3.367.- Houses with walls of timber frame construction filled with concrete. Various damage ranging from cracks in plaster to collapse of fill.

Fig.17.- Railroad station at El Volcan.
