FOUNDATION FAILURES DURING THE COATZACOALCOS (MEXICO)
EARTHQUAKE OF 26 AUGUST 1959

Roger Diaz de Cossio[†]

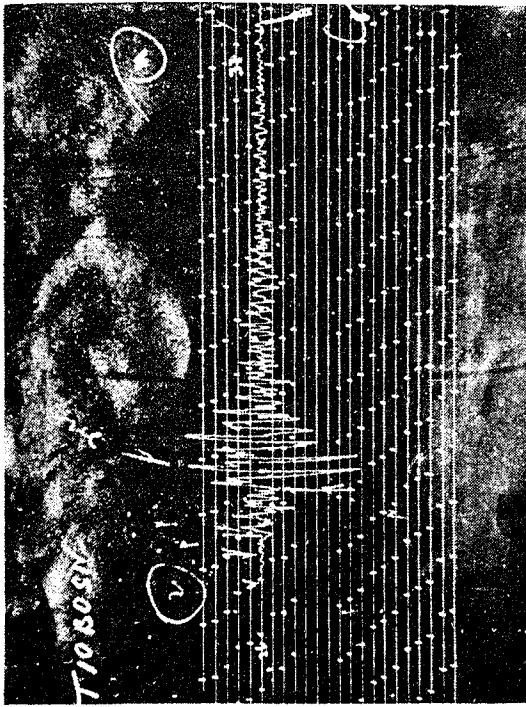
FIG. 2. SEISMOGRAM FROM THE TACUBAYA STATION (N-S COMPONENT)

Typical seismographs from the Tacubaya Station (520 Km from the epicenter), from a 10 Kg apparatus, are shown in Figs. 2 and 3. Relatively large initial vibrations can be observed. This probably accounts for the low death rate, as the population was awakened and had time to vacate their homes before the maximum shocks arrived.

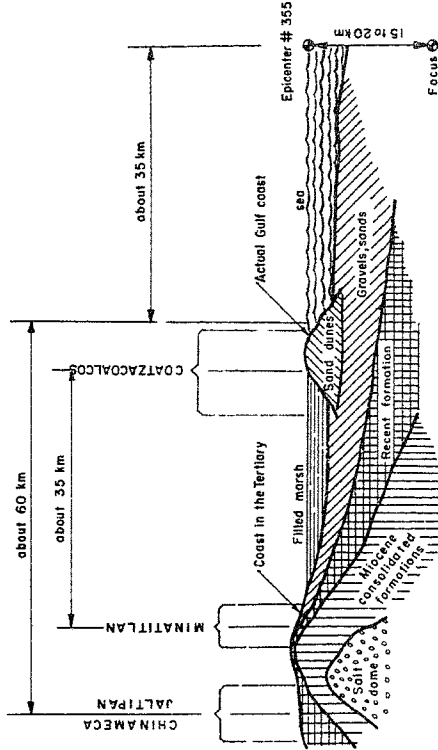
FIG. 4. GEOLOGICAL SKETCH OF ZONE

An approximate geological sketch of the zone where most of the damage occurred is shown in Fig. 4. The crust beneath Jáltipan and vicinity contains salt domes - salt that has been squeezed out to the surface by internal pressures. The domes are surrounded by some consolidated Miocene formations.

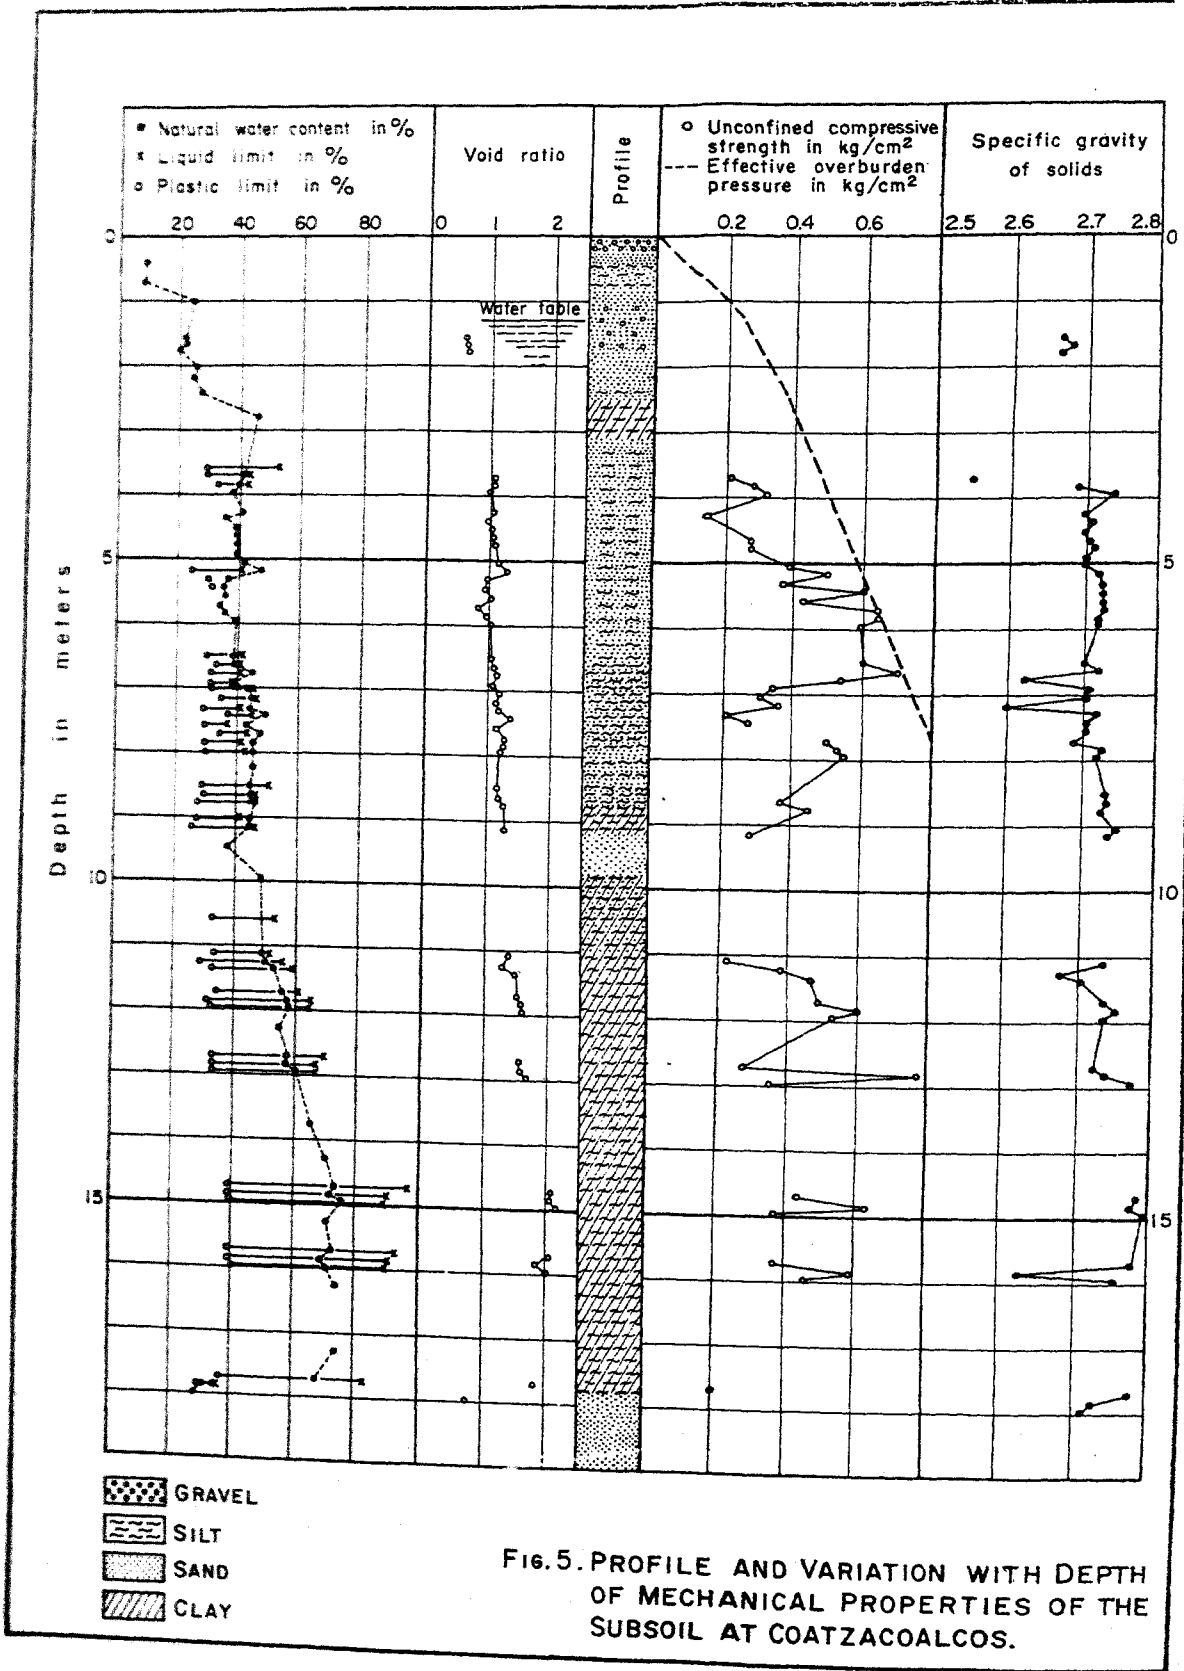
FIG.5. PROFILE AND VARIATION WITH DEPTH OF MECHANICAL PROPERTIES OF THE SUBSOIL AT COATZACOALCOS.

Undisturbed samples were obtained by means of continuous borings from the surface to 18 m depth. The results of standard laboratory tests are shown in the logs of Fig. 5.

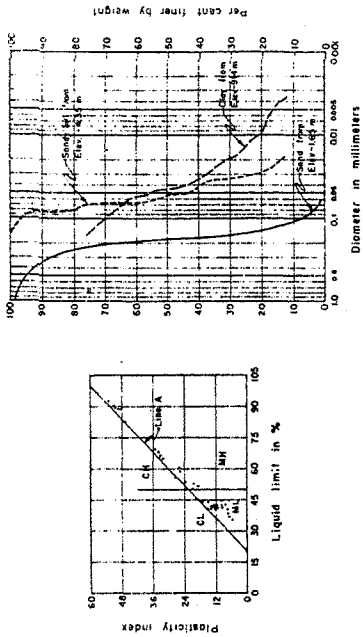
FIG. 6. PLASTICITY CHART AND GRAIN-SIZE DISTRIBUTION OF SOILS FROM COATZACOALCOS.

The plasticity chart and granulometric curves of the soils sampled are shown in Fig. 6. The sandy silt group is clearly defined in the plasticity chart. Its uniform grain size is shown in the curves. It is known that in a loose state, soils with these characteristics have a tendency to liquefaction when they are under actions that disturb their unstable structural equilibrium. Based on these facts, it was concluded that the sharp and large movements of the structures along the left margin of the Coatzacoalcos River (described in more detail in the following sections) were due to partial liquefaction of the layers of uniform sandy silt.

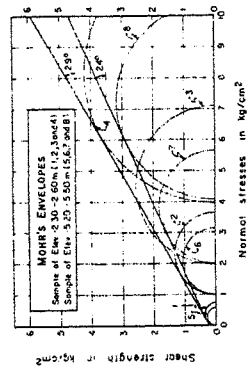
FIG. 7. MECHANICAL PROPERTIES OF THE JALTIPAN SOILS.

The results of tests made on two specimens at depths of 2.5 and 5.5 m are shown in Fig. 7. The natural water content of these materials is about 13 percent, with liquid limit of about 19 percent, plastic limit of 15 percent, and degree of saturation varying from 47 to 76 percent. The average unconfined compressive strength is 0.6 Kg/cm². Several triaxial tests were made without varying the

natural water content of the soil. The corresponding failure envelopes are also shown in Fig. 7. It is seen that the angle of internal friction varies between 24 and 29 degrees, with a cohesion of 0.2 Kg/cm^2 . Using these values, and a mean unit weight of 1.90 Ton/m^3 , and applying the Terzaghi formulas,⁴ it was estimated that the allowable bearing capacity of the soil was of 12 Ton/m^2 , with a factor of safety of 3.0 for long footings at least 1 m wide, and founded at a depth of at least 1 meter. The usual type of building in this town has probably bearing pressures much smaller than the above estimate. This fact is consistent with the behavior of buildings in the region during the earthquake, in that no foundation failures were observed in Jáltipan and vicinity.
