BEHAVIOUR OF A STEEL PLANT UNDER MAJOR EARTHQUAKES

S Y N O P S I S

This paper refers to the effects of the earthquakes of May 21st and 22nd, 1960, on the installations and facilities of an integrated Steel Plant owned and operated by Compañía de Acero del Pacífico, CAP, at Huachipato, San Vicente Bay, 10 miles West of Concepción, Chile.

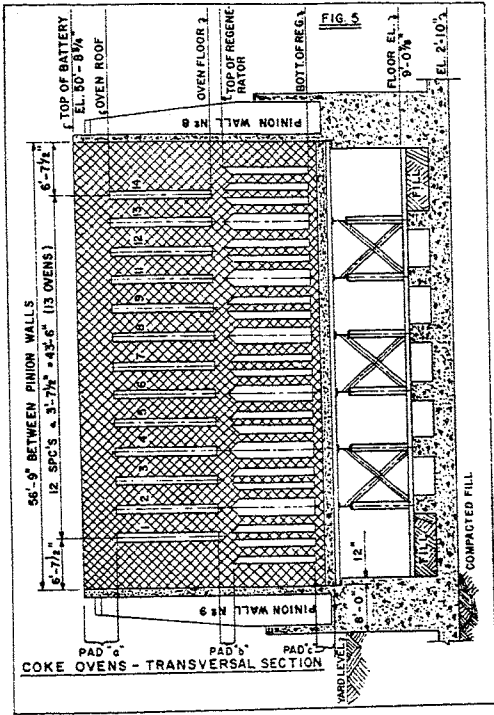
Fig. 5 Coke Ovens - Transversal Section

To assure the lateral stability of the whole system of vertical walls, it was assumed that lateral forces could be carried to the pinion walls by the three pads marked a, b and c (See Fig. 5); however, pad a and b are refractory brick masonry and have 1/2" expansion joints at each oven chamber. This lack of continuity may disappear when the coke battery is hot

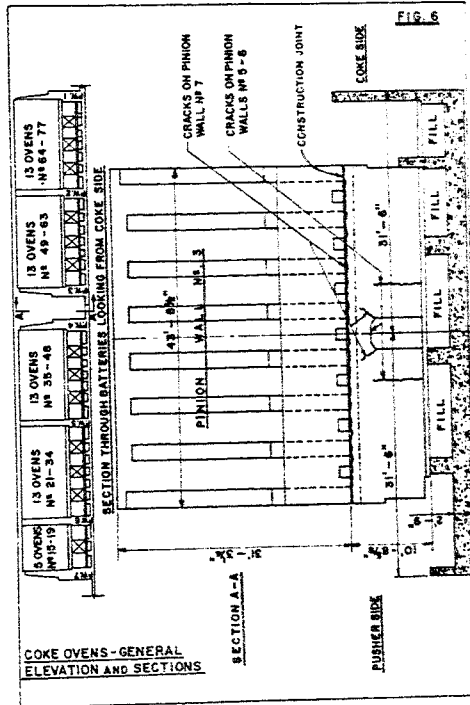
Fig. 6 Coke Ovens - General Elevation and Sections

There was only one obvious answer to the stability requirements: reduction of the number of ovens between pinion walls. To fix an order of magnitude for this number of ovens, it was necessary to resort to past history on oven failures. A maximum deflection at the top of the brick wall of 5" was reported as having been found in non-damaged walls. Expansion joints of 1/2" could be considered completely open in a cold oven and probably half closed in a new hot oven. A range of 10 to 20 ovens between each pair of pinion walls would therefore appear as a reasonable number that would at least confine the damage to a small number of units. To ensure uniform heating of the batteries and also to facilitate scheduling of the pushing sequence of the ovens, it is usually recommended that the number of ovens be a multiple of 4 plus 1. This reduced the alternatives to 13 or 17 ovens per battery. The first, 13 ovens per battery, was finally chosen as the maximum number of ovens that should be included between pinion walls. The required 57 ovens were therefore built as 4 batteries of 13 ovens plus one battery of 5 ovens (See Fig. 6).

Behaviour of the coke oven batteries under the two major earthquakes of May 21st and 22nd was highly satisfactory. Without considering minor damages to steel parts not related with the general structure of the ovens, such as breakage of a steam pipe, displacing of the two gas collecting mains alongside the top of the ovens, etc., the only real damage experienced was the appearance of cracks shown in Fig. 6. These cracks appeared on two pinion walls and are located around the doors. While no exact explanation has been yet developed, there are reasons to believe that they are due to careless detailing of the reinforcing concrete bars around the door openings.

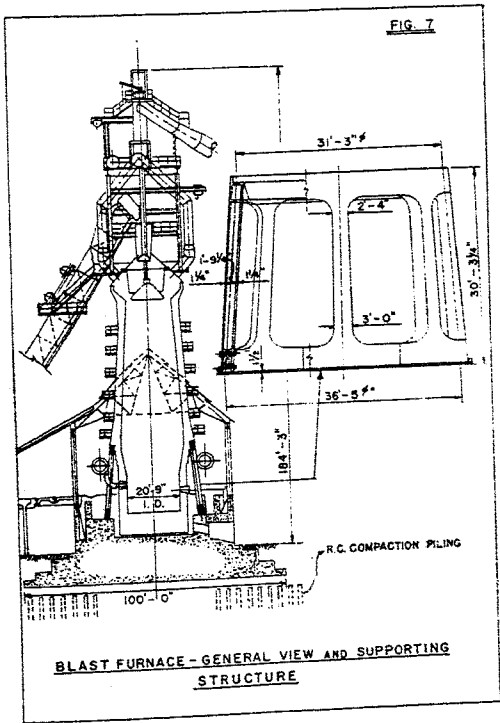
Fig. 7 Blast Furnace - General View and Supporting Structure

The Blast Furnace is the heart of a steel plant, It is a very tall, heavy and expensive structure supported by columns (See Fig.7). It is therefore a unit where seismic forces can produce damages of such magnitude that the very life of a steel plant may be impaired.

An entirely new structure has to be developed in close cooperation with our Blast Furnace Consulting Engineers, H.A.Brassert and Co. This structure as shown in Fig. 7 is a monolithic welded unit where the bottom

If the energy method developed by Lord Rayleigh is applied to the Blast Furnace structure shown in Fig. 7 a natural period of vibration of 0.6 seconds is obtained. A seismic coefficient of 17 % was applied to the design of the structure and the foundations.
