A REPORT ON THE BUYIN EARTHQUAKE (IRAN) OF SEPT. 1, 196.

S. Omote*, K. Nakagawa*, H. Kobayashi**
S. Kawabata***, E. Nakacka****

SYNOPSIS

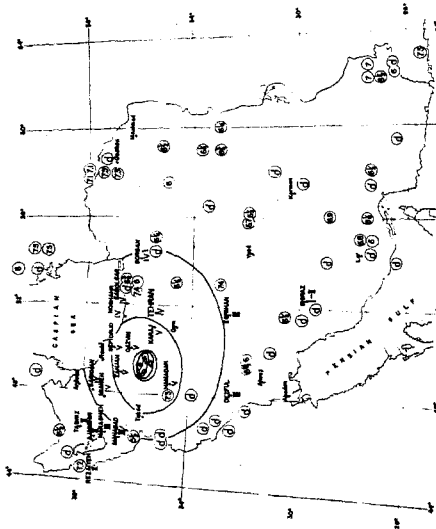
Fig. 1
Seismicity map of Iran and isoseismal lines of the Buyin Earthquake

to observe the seismic intensity at as many villages as possible. Results of observed intensity in the Modified Mercalli Scale are shown in the map in Fig. 1.

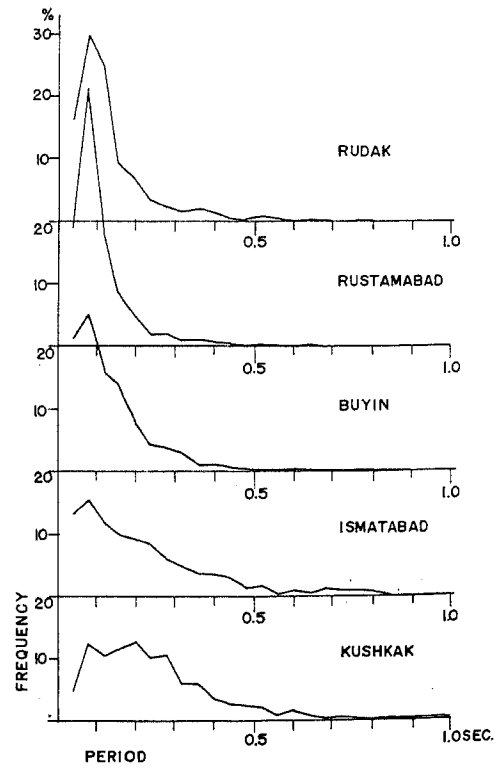
FIG. 7

2. Another example of frequency-period curves analyzed from the records of microtremometer is shown in Fig. 7. Three curves observed at Rudak, Rustamabad and Buyin show clear peak of predominant period again at about 0.1 sec., whereas those of Ismatabad and Kushkak where damage was quite slight show a flat shape and no clear predominant period.
