THE ACAPULCO, MEXICO, EARTHQUAKES OF MAY 11 AND 19, 1962

By Reuben W. Binder⁽¹⁾

ABSTRACT

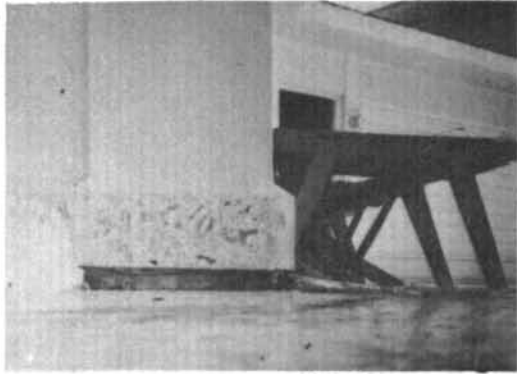
FLOOR SETTLEMENT
FIGURE 4

As an example of the evidence of displaced soils and of settlement, Fig. 4 shows a site where a displacement of approximately 3" took place. By noting the displacement of soils, it can be concluded that little or no compaction was used in placing the fill material at several sites and that this probably was the cause of some extreme damage.
