A STUDY ON HEALTH MONITORING TO STRUCTURAL DAMAGE FOR TWO STORIES MODEL BY USING VIBRATION TEST

SUMMARY

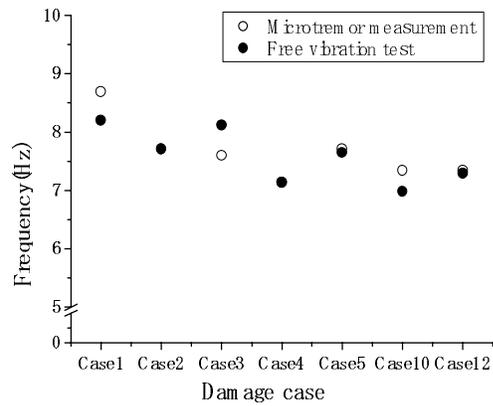
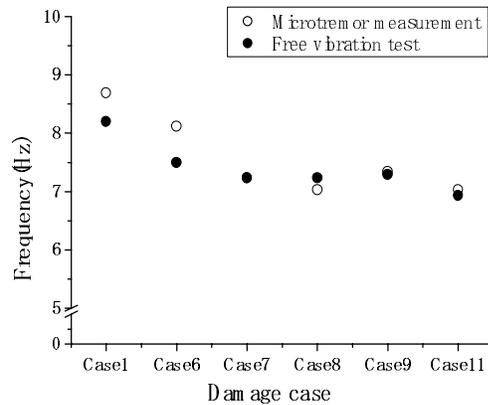
Fig.4 Relationship between damage cases and natural frequency

(a) Damage cases at the first floor.

(b) Damage case at the second floor.

The natural frequency in the lateral direction was estimated using the microtremor measurements and vibration tests. The data was analyzed in the frequency domain by using FFT analyses. The results of the testing are summarized in Fig.4. This figure shows the first order natural frequencies of undamaged and damaged steel frame. The natural frequencies of microtremor measurements of the structure are same as those obtained by the free vibration test. The results of natural frequency for all damage cases in the free vibration test and microtremor measurement were shown in Fig.4. The figures 4(a) and (b) were categorized by the results at the first floor and the second floor. The values of natural frequency in the free vibration test and microtremor measurement were similar. The values of natural frequencies of damage cases decrease for that of undamaged case. As mentioned above, it is possible to have an estimation of the sensitivity in the model and member properties. As a result, damage evaluation of the whole model from natural frequency is possible. However, it turns out that damage evaluation of model details is difficult.

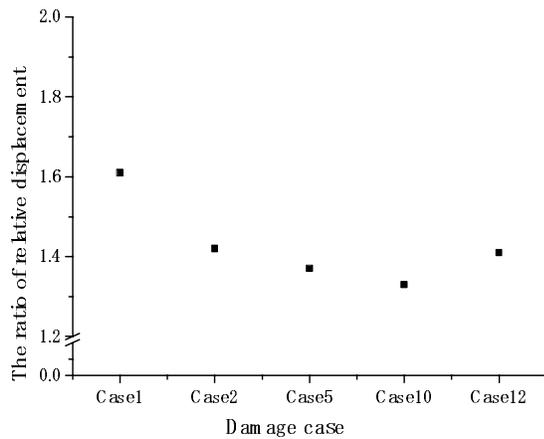
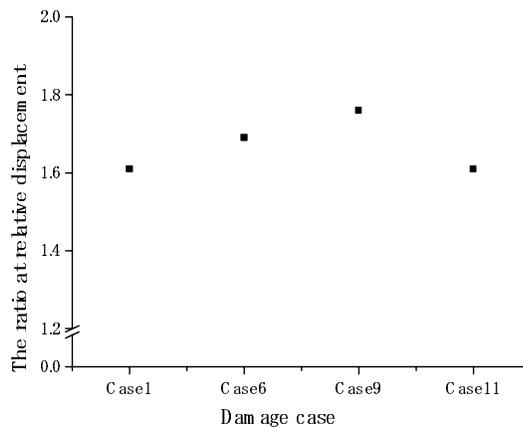
Fig.5 Relationship between damage cases and the ratio relative displacement

(a) Damage case at the first floor.

(b) Damage case at the second floor.

in the first and second floors was defined as the index to detect the damaged floor. Figure 5 shows the comparison between these values with damage cases. In case of the first floor, the ratios become low according to the fracture scale of the frame (Case II, V, X). In the second floor same as the first floor, the ratio also increases according to the fracture scale of the frame (Case VI, IX). However, in the damage cases by disconnecting the beam-column connection in the second floor in case XI and the base-column connection in case XII, we cannot find damage detection by using the presented ratio. Because, it is difficult to evaluate the change of dynamic behavior by disconnecting the connection.
