THE EARTHQUAKE RESISTANCE OF TRADITIONAL TIMBER AND MASONRY DWELLINGS IN TURKEY

Polat GÜLKAN¹ and Randolph LANGENBACH²

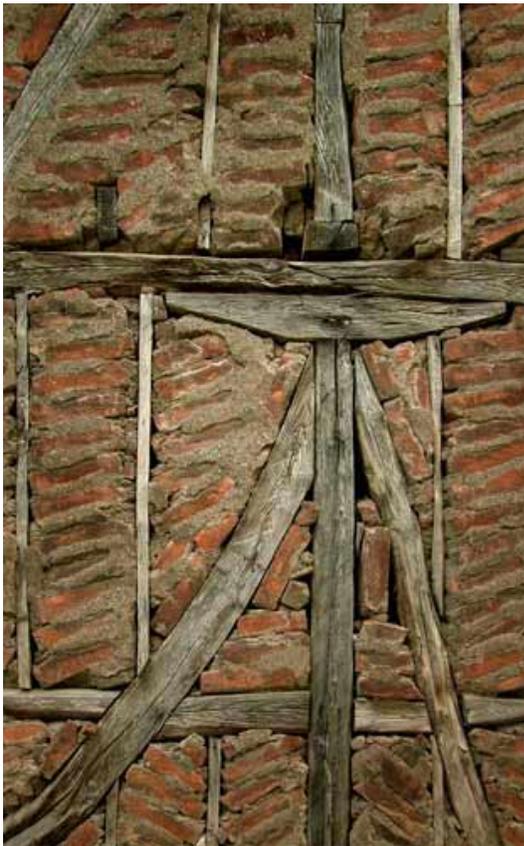
Figure 1: *Hımsı*, traditional Turkish construction.

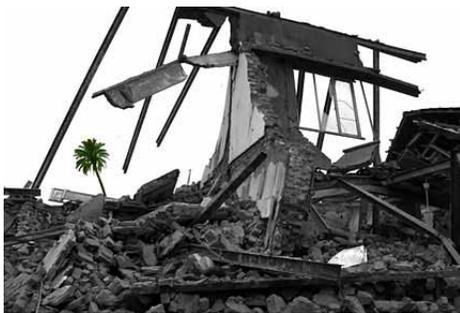
Figure 2: Bam, Iran, after the January 26, 2003 earthquake showing a collapsed residence. The steel beams illustrate that this was recent construction using modern, as well as traditional, materials. The steel beams supported masonry jack arches, but because of inadequate ties and poor connections, the beams separated, dropping the heavy masonry onto the occupants. (Photo by Ahmad Nateghi, Kargah.com)

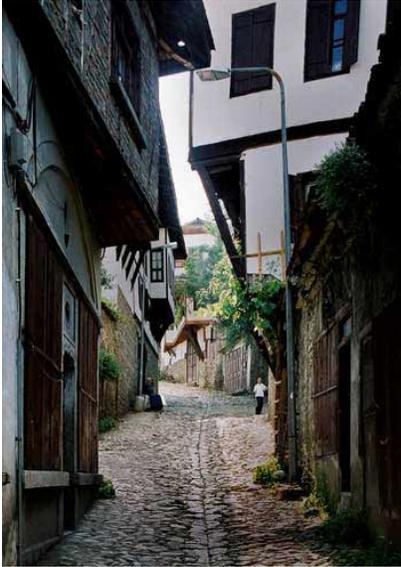
Figure 3: LEFT: Street of houses with overhanging jetties of *humuş* construction in Safranbolu.

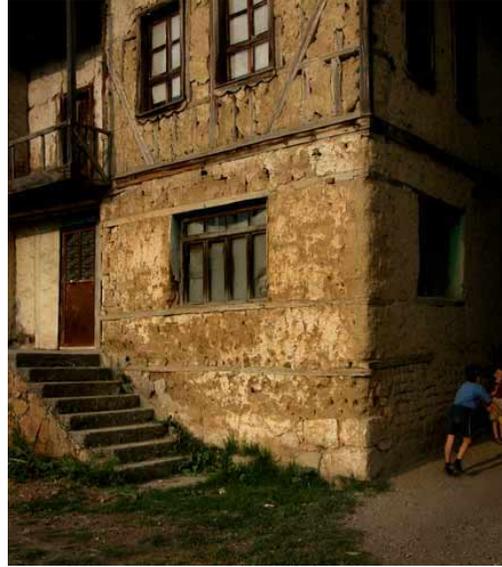
Figure 4: RIGHT: Early 20th century dwelling in Bayirköy with *hatils* in the masonry bearing ground floor walls, and *humuş* construction above.

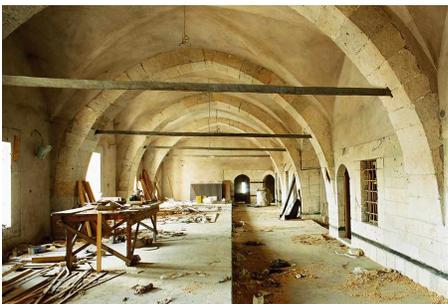
Figure 5: LEFT: Interior of Ancient Caravansary in Safranbolu with *hatil* visible along right wall.

Some of the more prestigious monuments of dressed stone construction nevertheless were constructed with *hatils*, as in the caravansary of Safranbolu (Figure 5 & 6). Over the past two centuries, many of the more common houses throughout the northern part of Anatolia have been constructed entirely in *humuş*, usually with brick infilling. Examples of this later type of *humuş* construction can be found in the areas affected by the 1999 Kocaeli and Düzce earthquakes, which thus provided a unique opportunity to examine their performance in earthquakes that were severe enough to cause widespread collapses of modern buildings.

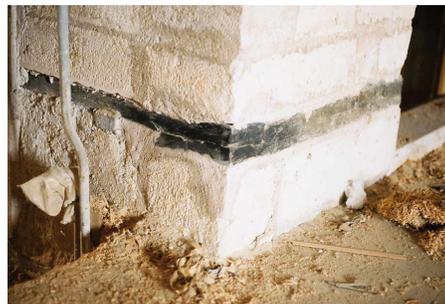
Figure 6: RIGHT: Detail of *hatil* in same building.

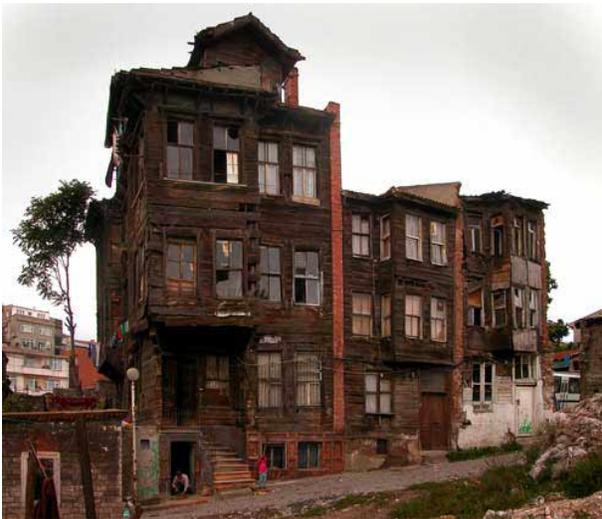
Figure 7: LEFT: Ruinous, but still occupied, timber houses in Fatih section of Istanbul in 2003.

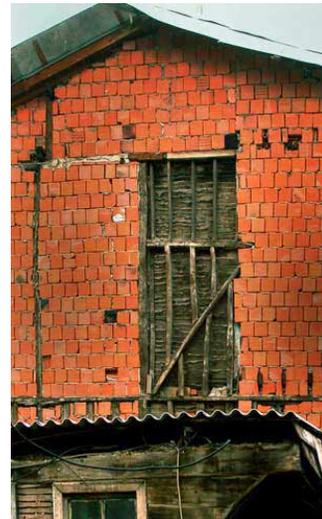
Figure 8: RIGHT: Detail of a timber house in Istanbul where the timber studs remain in only one portion of the wall and the rest have been replaced with hollow clay block creating a condition dangerous for earthquakes.

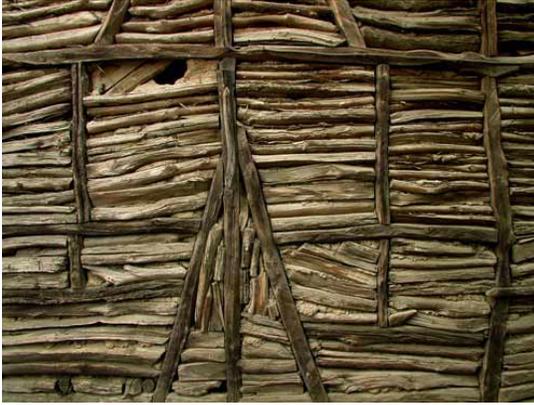
Figure 9: LEFT: Detail of *Bağdadi* wall, Golcuk.

Outside of Istanbul, such profligate use of timber was less prevalent, so its combination with masonry was more usual, but one type, known as *bağdadi*, was fairly common in areas where *humiş* was common as well. A sample for *Bağdadi* is shown in Figure 9, below. It is characterized by the use of short rough pieces of timber for the infilling instead of masonry. These were then usually plastered on the interior and exterior to form a solid wall. In using what must have largely been scrap wood that could not be used for structural elements, *bağdadi* houses were light weight, earthquake resistant, economical to build, and did not require industrialized saw mills for the preparation of the timbers. However, *Bağdadi* is subject to increased rot and insect attack. The masonry infill of *humiş* construction has generally been considered to be a more permanent and higher grade of infill material.

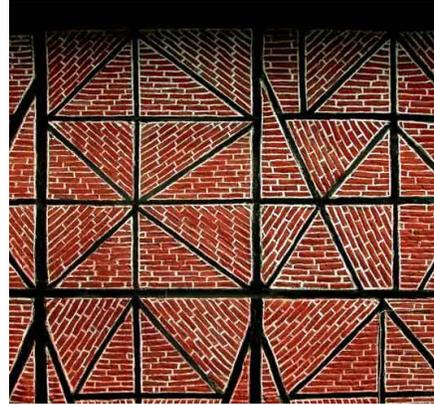
Figure 10: RIGHT: Detail of ornate variation of *himiş* construction near Duzce. Despite their locations, the 1999 earthquakes did not damage these buildings.

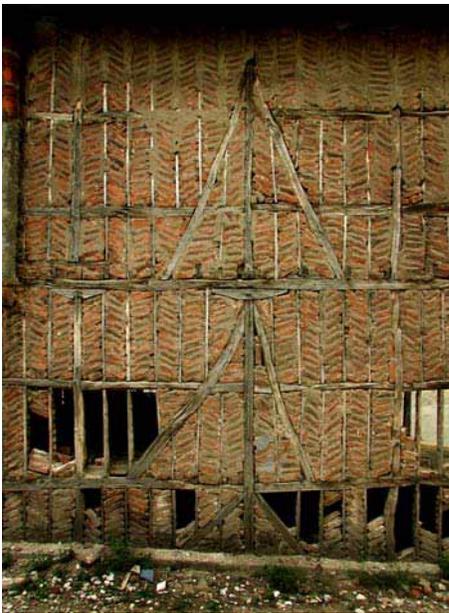
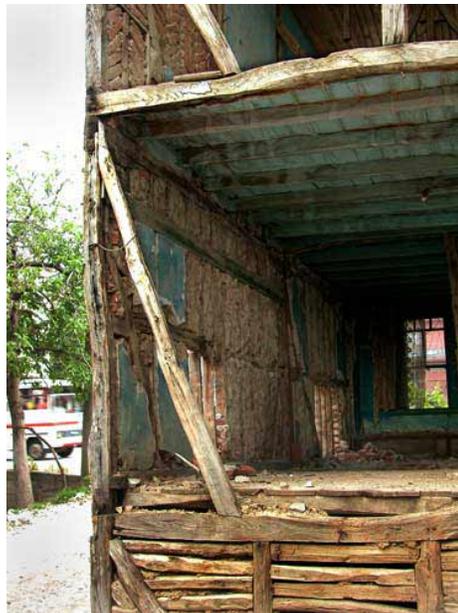
Figure 11 & 12: Partially demolished house in Golcuk showing the single brick wythe thickness of typical *himiş* wall. On the LEFT is the exterior and on the RIGHT is the interior face of the same wall.

This house was abandoned and partially demolished at the time of the earthquake. Despite its condition, the earthquake had little affect on it. It was photographed in 2003.

fragile sheet of thin masonry reinforced with small timbers only lightly nailed together, which would seem to be too heavy and vulnerable for safety in earthquakes (Figure 12).

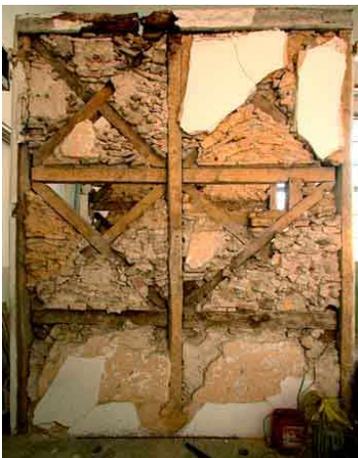
Figure 13 & 14: One story frame section removed from “gaiola” building tested for strength and stiffness in Portuguese National Lab by Córias e Silva recently. Fig.18 shows one of three walls after cyclical tests to a point just short of collapse, and Fig.19 shows hysteretic behavior of one of the walls. The loss of the plaster and the wide hysteresis loops show that the walls were able to dissipate energy over many cycles without losing their structural integrity. (Córias e Silva, 2002) [4]

The Pombalino system used on the interior of buildings consisted of timber frames with vertical and horizontal timbers of approximately 10 cm to 12 cm square, with internal braces, forming an “X” otherwise referred to in Italy and Portugal as the “Cross of St. Andrew” (Figure 13). The timbers for the cross are 9 cm by 11 cm in section. The frame was then “nogged”(i.e., filled with brick) in the triangular spaces formed by the crosses with a mixture of stone rubble, broken brick, and square pieces of Roman brick in different patterns in each panel. The interior walls were then covered with plaster, hiding the infill and the timber frame. The exterior facades of the Baixa buildings were reconstructed with load-bearing masonry walls of about 60 cm in thickness, some of which had a timber frame on the inside face. Langenbach [13]

The problem is not just an academic one. The evaluation of older structures after earthquakes can lead to broadly divergent views on the significance of the damage, and the reparability of the structures. This can have profound consequences for the owners and for the economic and social dislocation of the disaster as a whole. Dusi and Langenbach [6] It can also result in the unnecessary loss of buildings of historical and cultural value. This is a problem that can affect archaic and modern buildings alike. Earthquake damage has often been looked at with little understanding of what it represents in terms of loss of structural capacity. The standards applicable to reinforced concrete, where a small crack can indicate a significant weakness, are applied to archaic systems where even large cracks may not represent the same degree of degradation, e.g., a masonry building with cracks in the walls with fallen plaster, and a reinforced concrete building with only hairline cracks at the beam/column intersections do not correspond to the same level of degradation. It is the reinforced concrete building that may be closer to collapse than the masonry building. In the case of masonry, it is the friction of the moving and cracking materials that produces damping, thus helping to reduce the structure’s response to an earthquake. Disruption of plaster or stucco over a significant portion of a wall area can represent a beneficial performance. (Figures 13, 20, 22, 23)

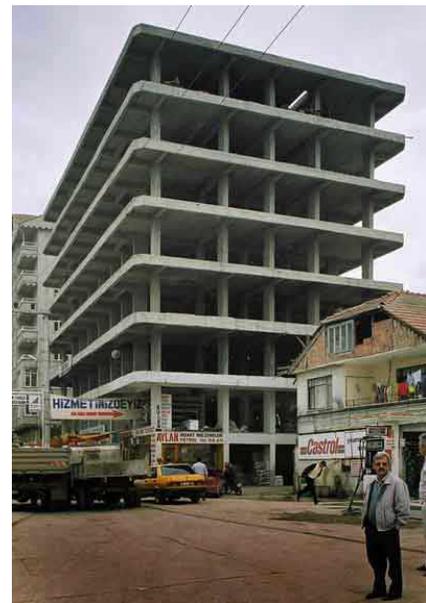
Figure 16: Eight-story reinforced concrete frame structure in G6lcük under construction at the time of the İzmit, Turkey earthquake in 1999, which collapsed many occupied buildings around it. From a street-level inspection, this building did not appear to be damaged. Undoubtedly, the absence of the masonry infill allowed the frame to deflect evenly, rather than causing a soft story at the base of the structure where it is most vulnerable. Had the building been finished at the time of the earthquake, the results may have been quite different.

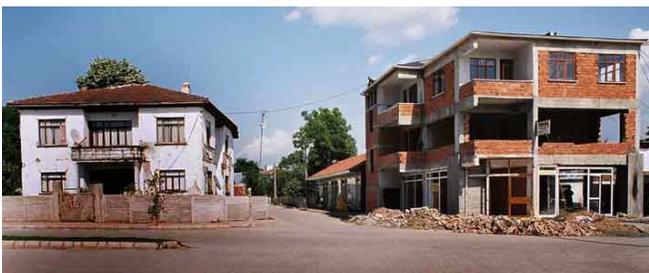
Figure 17: Three story RC building next to a 2½ story *himiş* house near Düzce showing the repair of severe damage to the RC building (notice the size of the ground floor columns). The *himiş* structure has lost only stucco on the side. Almost all of the hollow clay block on the RC building has been reconstructed after the earthquake. This shows that even low rise RC buildings sometimes suffered more damage than nearby traditional buildings.

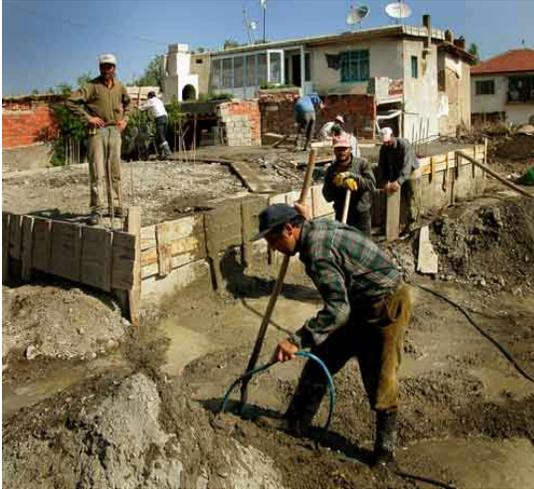
Figure 18: LEFT: House being reconstructed to replace one destroyed in Afyon earthquake. Concrete is being mixed on ground with garden hose and without slump test or measurements.

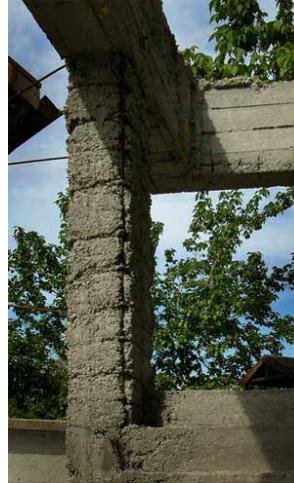
Figure 19: RIGHT: Concrete column in new mosque being constructed on site of building destroyed in Afyon Earthquake showing rock pockets leaving re-bar exposed. Vibrators are not used in most Turkish construction.

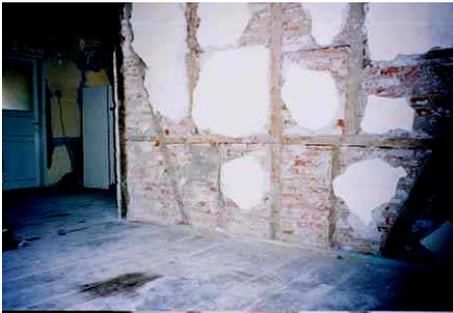
Figure 20: *Hımış* interior wall in house in Düzce earthquake damage district showing “working” of wall that caused loss of plaster.

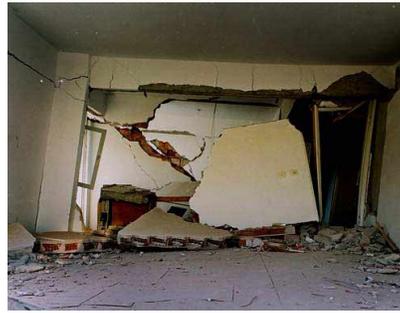
Figure 21: Collapse of a brittle interior hollow clay block wall illustrating typical failure pattern for such walls lacking subdivisions.

this fails to take into account the essential mechanism by which the traditional construction is able to resist earthquakes – flexibility and energy dissipation, rather than strength and stiffness. Its survival in the much larger and longer earthquake illustrates that the *hımış* is capable of maintaining stability over many cycles. To do this, however, the deflection of the structure and friction in the infill must begin at the onset of shaking. Thus the shedding of the plaster and stucco in both the large and small earthquakes was similar. By comparison, although only lightly damaged in this and other smaller earthquakes, the non-engineered concrete buildings often suffer from a rapid and sometimes catastrophic degradation of strength in larger earthquakes because they are inflexible and lack the reserve capacity that is found in the *hımış* construction. The brittle hollow tile block infill walls in the concrete frame buildings are initially stiff, and then, once cracked, tend to collapse (Figure 21). Langenbach [13]

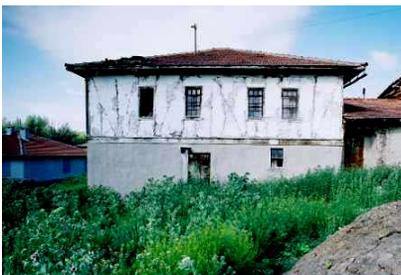
Figure 22: LEFT: House in Orta, Turkey one day after the 2000 Orta earthquake – showing plaster cracking that reveals the timber frame.

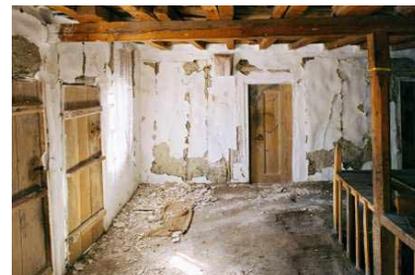
Figure 23: RIGHT: Interior of *hımış* house after the Orta earthquake showing the “working” of the masonry panels.

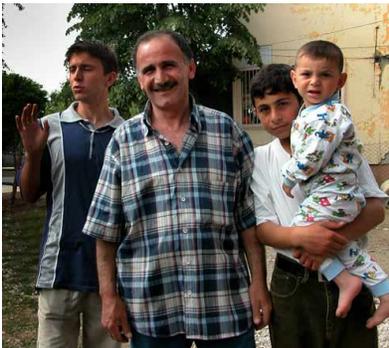
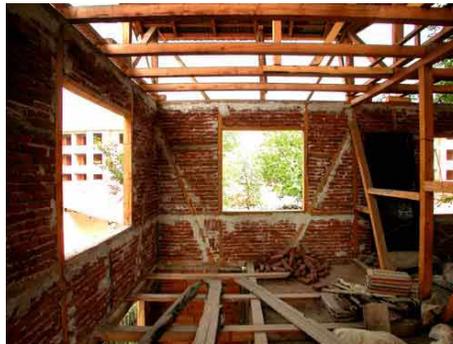
Figure 25 & 26: After witnessing the destruction of RC buildings around him in Duzce and seeing that his father's *hımiş* house survived undamaged, this resident of Düzce decided to stop building a new RC house and build a house for himself and his family with *hımiş* construction.

An interesting and timely exception to this was found near the center of Düzce, where reinforced concrete buildings had collapsed in both the August and the November 1999 earthquakes. The resident of the earthquake damaged city of Düzce in Figure 25 had begun to construct a home in concrete before the earthquake. After noticing that his father's *hımiş* house had survived both 1999 earthquakes without damage near collapsed and heavily damaged reinforced concrete structures, he switched to the traditional construction method, and continued to build his three story house with timber and brick. It was under construction when photographed in 2003 (Figure 26).
