## **IRREGULAR OLD STORIED MASONRY BUILDINGS. RISK EVALUATION AND STRENGTHENING SOLUTIONS**

### **SUMMARY**

In the first part of the paper, one presents the general aspects regarding the general features of old storied masonry buildings, having irregular conformations, especially. Afterwards, a short review of the analysis procedures used in the risk assessment of these “non-classic” structures marks their efficiency degree. Finally, it presents an analytical FEM study on a representative model. A very irregular quasi-dual structure was been supposed at two successive simplifications: a. the erase of its the major tower-story; b. the split (divide) of the initial building in two different independent structures. The comparisons between result data lead to the quantification of the idealization errors.

In the second part of the paper, there present two applications with irregular old buildings. First, historic data and structure information (conformation, supported earthquakes and damages) are given. Second, there present the used earthquake assessment analyses with their main conclusions and recommended strengthening interventions. The analyses tacked into account the findings o

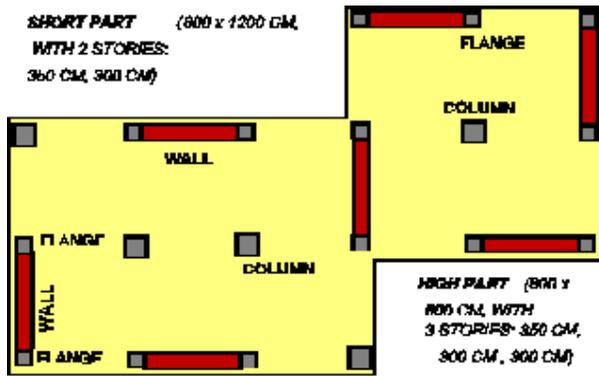
The author of this paper conceived a model structure represented in the Fig. 1. This building has the next features:

Figure 1. Floor plan of the "ALL" structure

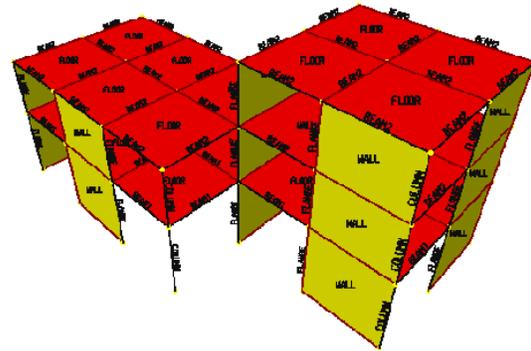
Figure 2. Idealization of the "ALL" structure

- Entire structure (without simplifications), named “ALL STRUCTURE” (ALL), Fig. 2
- Structure without the third level of the high zone, named “WITHOUT TOWER” (WT), Fig. 3
- The two parts decoupled in “SHORT PART” and “HIGH PART” (DEC), Fig. 4.

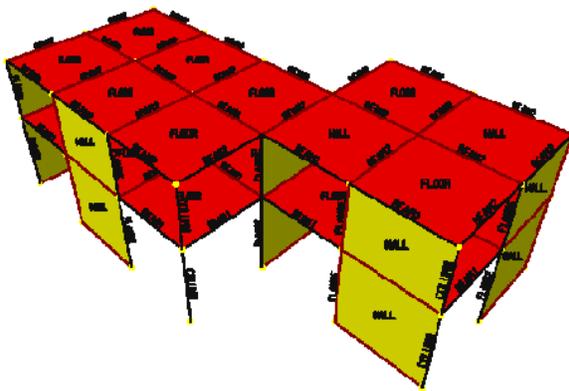
Figure 3. Idealization of the "WT" structure

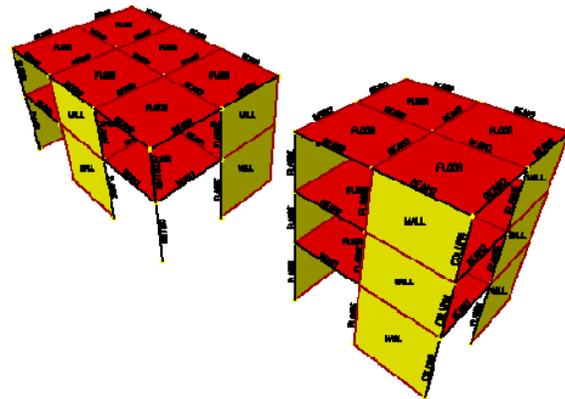
Figure 4. Idealization of the "DEC" structures

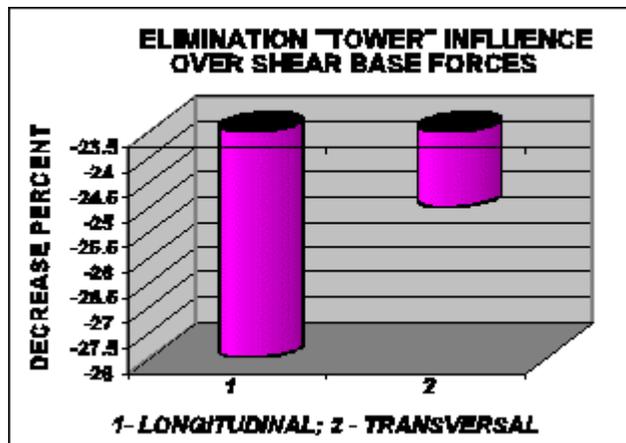
Figure 5. Base shear reduction by WT

The first effect was the major reduction of the earthquake base shear: with 25.4 % for transversal direction and with 28 % for longitudinal direction. This means the possibility of the neglecting of the very important parts of the total efforts in structural members, if one will cut the heavy tower in the analysis model.

The main processed result data regarding the elimination of the third partial level of the initial structure are presented in the Fig. 5 and 6.

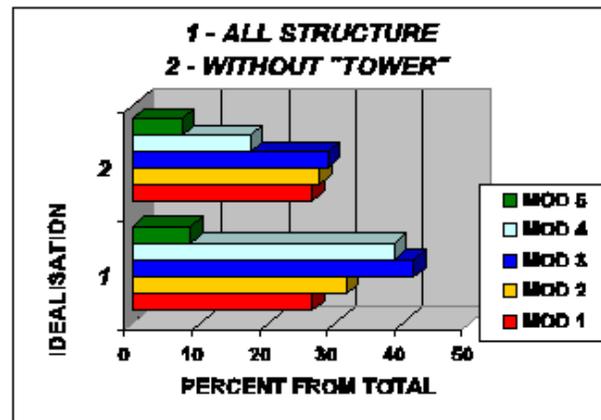
Figure 6. Modal participation factor changes by WT

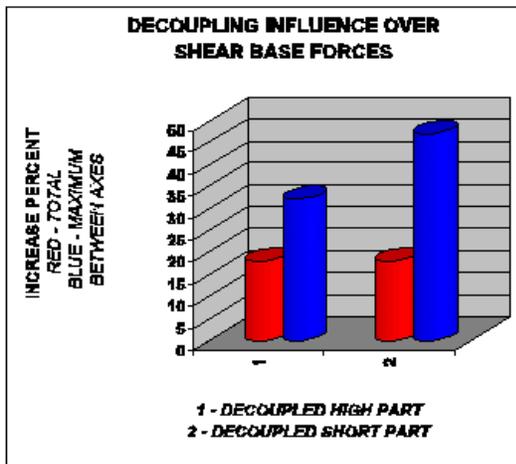
Figure 7. Base shear increases by DEC

The first major effect of the decoupling is the considerable increase of the earthquake base shear: till 200 % for HIGH PART substructure and until 300 % for SHORT PART substructure. The errors are too higher for the acceptance the decoupling simplification for irregular structures.

The main processed results regarding the total separation of the initial (ALL) structure into two independent ones (SHORT PART and HIGH PART) are given in the Fig. 7 and 8.

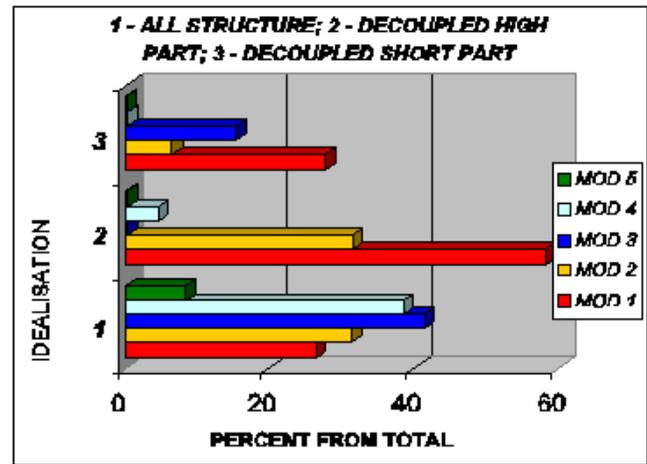
Figure 8. Modal participation factors changes by DEC

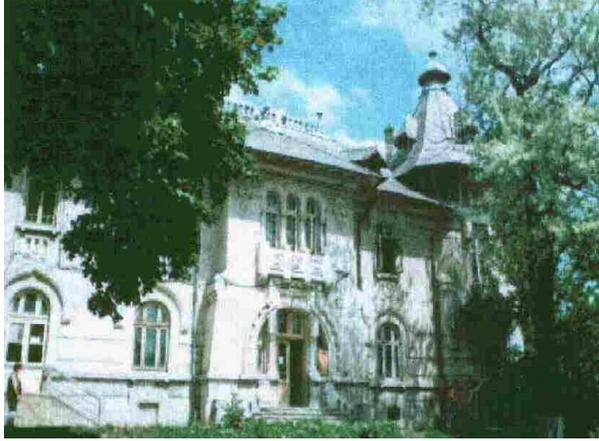
Figure 9. Old Custom House (OTH). Main façade

Old Custom House (OCH) represents one of the most representative buildings from Botosani city, Fig. 9 and 10. This object was been registered as an architectural and historic monument, having a regional importance. The railway station of the city, having similar architectural characteristics, was build simultaneously, in 1872 year. The both structures supported three major earthquakes (1940, 1977 and 1986) at least.

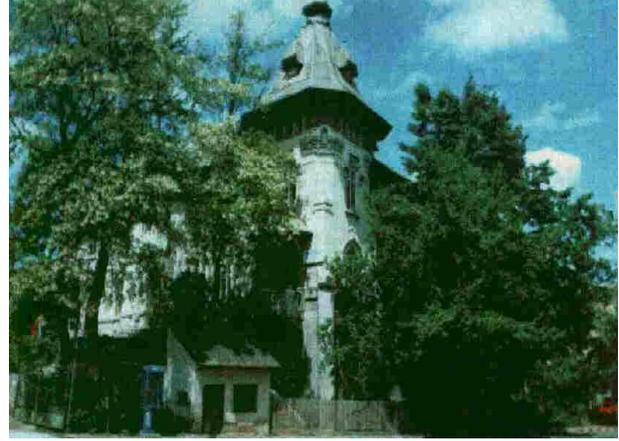
Figure 10. OTH. Staircase tower detail

The main deficiency of the structure is the non-verticality of many interior structural walls. Another disadvantage consists in the eccentric disposal of the high staircase “tower” (the 3<sup>rd</sup> story over the quota  $\pm 0.00$ ). This position favors the general torsion effect at earthquake actions.

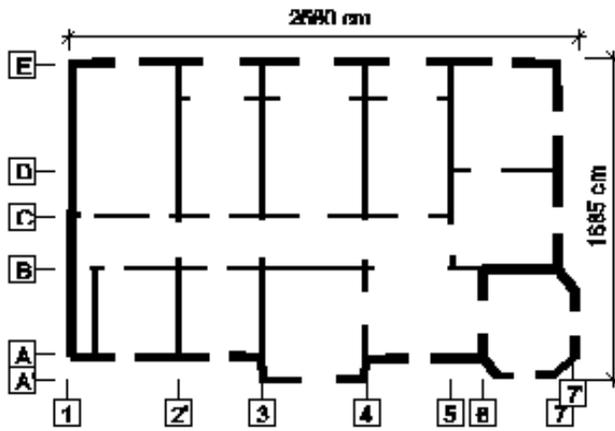
Figure 11. OTH. Ground floor plan

The main members of the OCH are the exterior massive masonry structural walls (50 cm thickness). The interior masonry walls have only 30 cm, but all vertical members include weak bricks (C50) and lime mortar (M10), Fig. 11 - 14. The floors include wood components (beams, planking and ceiling) and some iron beams (for “large” spans, especially).

The structure has two complete stories over the quota  $\pm 0.00$  (“1<sup>st</sup>” and “2<sup>nd</sup>”), two incomplete stories under this quota (“1<sup>st</sup> under” and “2<sup>nd</sup> under”) and one partial level over the second complete one (“3<sup>rd</sup>”). The last level means the “appendix” of the staircase. This very irregular configuration resulted from the very inclination of the location.

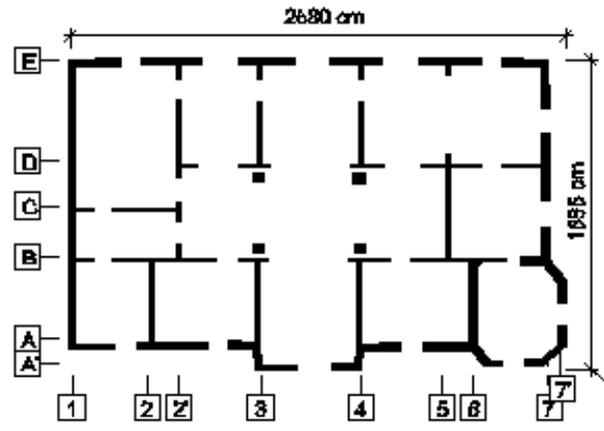
Figure 12. OTH. The 2<sup>nd</sup> main floor plan

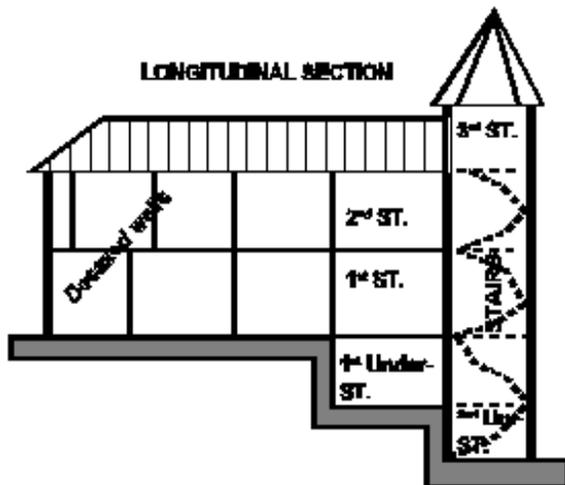
Figure 13. OTH. Longitudinal section

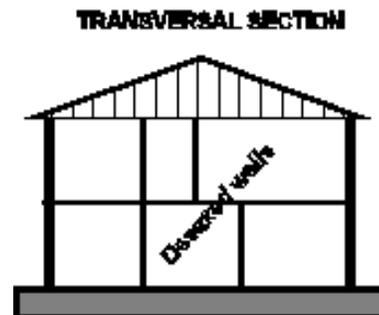
Figure 14. OTH. Transversal section

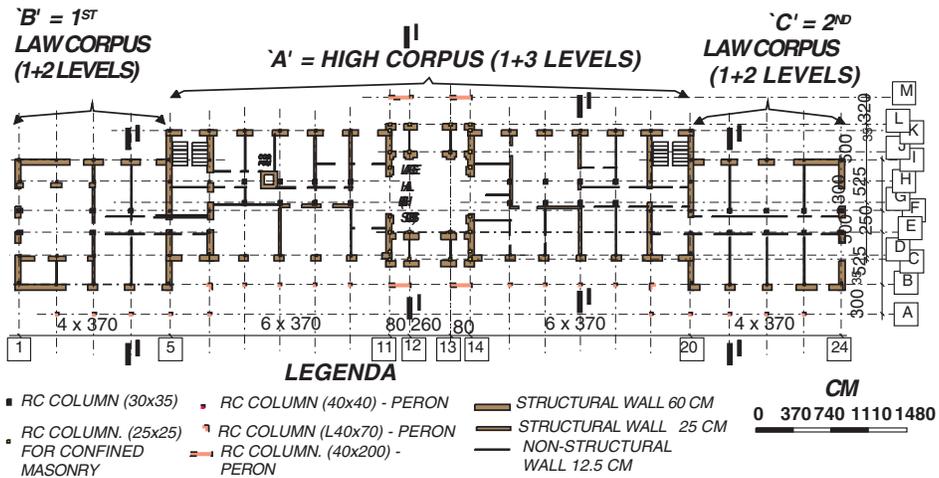
Figure 17. NIRS. Ground floor plan

NIRS has an approximate dual structure, Fig. 17 - 20. The vertical members are weak confined masonry walls and rare RC interior columns. Some of the transversal walls were been framed with cantilever truss RC systems. The horizontal members are the RC girders and plates. The RC walls and thick ground floor of infrastructure represent a true rigid foundation box.

Over the quota +/- 0.00, the central (A) corpus has three stories and the lateral corpuses (B and C) have only two stories. The floor of the quota +4.00 interrupts between axes 11 and 14, (in corpus A).

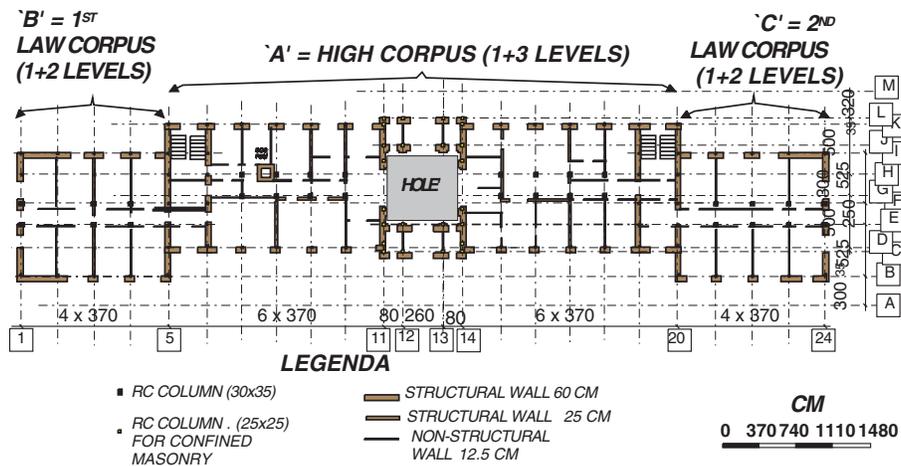
Figure 18. NIRS. The second floor plan

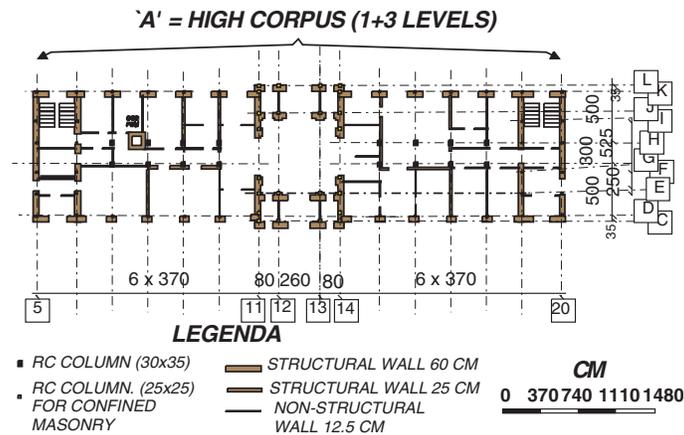
Figure 19. NIRS. The 3<sup>rd</sup> main floor plan

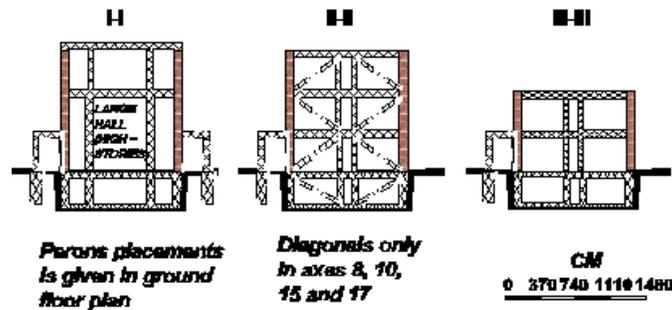
Figure 20. NIRS. Transversal sections

It can remark two major earthquake disadvantageous structural conformations. First: In horizontal plan, the general torsion is important, because of the different position of the torsion and weight centers. Second: In vertical longitudinal plan, the retreat of the corps A and C leads to the increase of the higher oscillation modes, especially for central corpus A.
