A COMPARATIVE EVALUATION OF PERFORMANCE-BASED SEISMIC ASSESSMENT PROCEDURES

SUMMARY

A building stock consisting of 130 medium-rise reinforced concrete buildings were damaged moderately during the recent earthquakes in Turkey. These buildings were rehabilitated by using simple, cost-effective methods where the newly added shear walls comprised the primary lateral load resisting system. In the presented study, different seismic performance evaluation procedures are tested first on the samples of damaged buildings for predicting their observed performances. Then the expected performances of the rehabilitated buildings are evaluated by employing these procedures. It has been found that the nonlinear static procedure is equally successful as the nonlinear dynamic procedure in predicting the observed performances of damaged buildings. The demand-to-capacity ratios obtained from linear spectral procedure are also good indicators of member performances predicted by the nonlinear static procedure. The predicted performance of the rehabilitated buildings evaluated under design excitations revealed that the simple rehabilitation methodology applied systematically should provide life safety

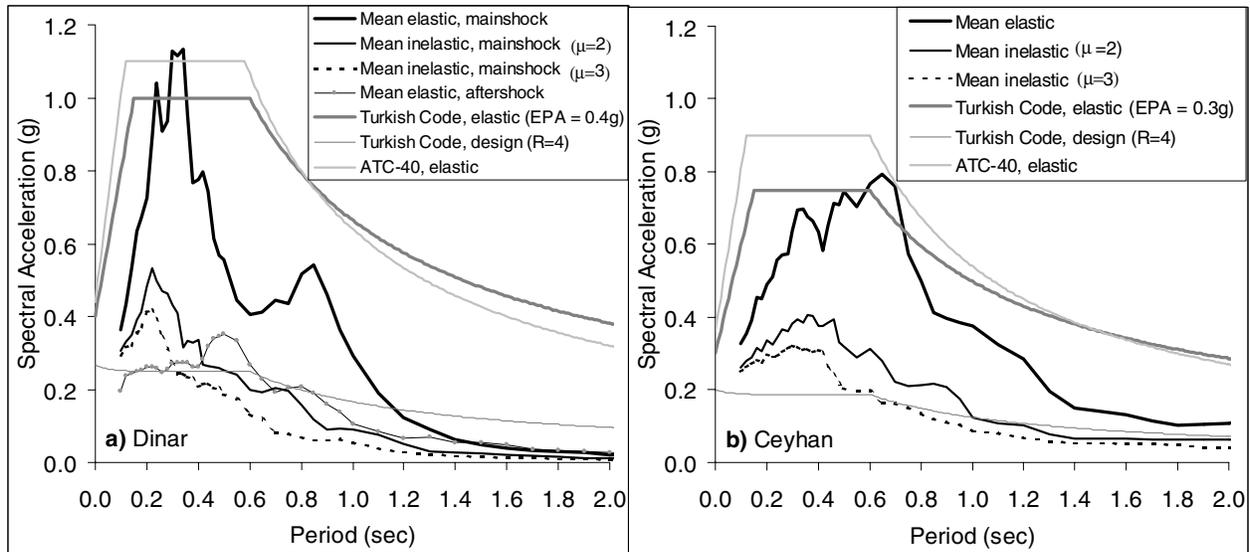
Figure 1. Acceleration response spectra of the Dinar and Ceyhan earthquake ground motions and the related code spectra

Three-dimensional models were employed in the linear dynamic procedure, where modal spectral analysis was carried out. The acceptance of component performances was based on the criteria for linear procedures (FEMA-356 [10]). In nonlinear static and dynamic procedures, two-dimensional models were prepared by using the Drain-2DX program (Prakash [11]). A displacement-controlled pushover analysis (Allahabadi [12]) was carried out in the nonlinear static procedure, and both the target displacement method and the capacity spectrum method were employed for calculating the global performance levels. Deformation-controlled actions were considered for acceptability of the component performances. Finally, nonlinear time history analyses were conducted for the damaged buildings under the Dinar and Ceyhan ground motions for comparing the maximum dynamic response displacements with the target displacements from nonlinear static procedure. All spectrum based performance evaluation procedures were applied to both the existing and rehabilitated states of the buildings for observing their seismic performances before and after rehabilitation. Ground excitations were expressed by the recorded ground motions and their spectra for the damaged states, and by the design spectra for the rehabilitated states of the buildings (Fig.1).

The performances of the rehabilitated sample buildings are calculated by the evaluation procedures discussed in the previous section. Linear elastic design spectra shown in Figure 1.a and 1.b describe seismic input for the four and eight story buildings, respectively. The performance evaluation results are presented comparatively in the following paragraphs.

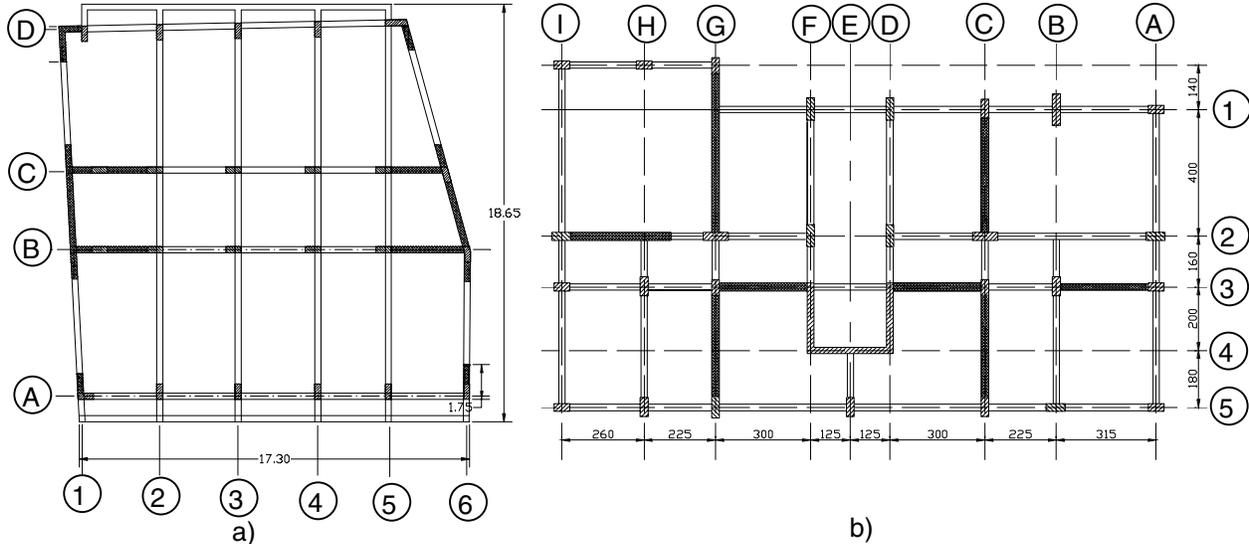
Figure 2. Rehabilitation scheme applied to the ground story plan of a) the four story building in Dinar, b) the eight story building in Ceyhan

The four-story building was moderately damaged after the Dinar earthquake. It was rehabilitated by adding new shear walls extending along the full building height indicated by darker shading in Figure 2a, on the ground story plan. Before seismic rehabilitation, the structural system of the building was a reinforced concrete frame with concrete slabs and individual footings connected by foundation tie beams in both directions. A typical floor area was 310 m²; the story heights were 3.80 m at the ground level and 3.50 m at the three layers above. The most common column size was 25 cm by 60 cm and all beam sizes were 25 cm by 70 cm. There were cantilevering floors of 1 meter above the ground level on the front and the backsides of the building (Figure 2a). The ground story had a smaller number of brick partition walls than the upper stories, which created a weakness.

During the 1 October 1995 Dinar earthquake, all of the 23 columns in the ground story were damaged with two where the damage was severe due to shear failures at both ends (columns 3B and 6C in Fig. 2a), three with moderate (1A, 2A and 5D) and 18 with light damage. Out of 37 beams at the first floor, two were severely (B12 and B45), three were moderately (B23, C12 and C45) and one was lightly damaged in combined shear and flexure modes. All of the nine brick partition walls were severely damaged at the ground story. Although the damage was concentrated at the ground level, masonry partition wall damages continued in the upper stories accompanied with lighter damages in the concrete members. Less damage in beams indicated stronger beams than columns at the connections. The concrete core specimens taken from the building revealed a mean concrete strength of 12 MPa. The spacing of transverse reinforcement in columns and beams was 20-25 cm.

In the seismic rehabilitation of the building, two U-shaped shear walls were added to the existing system and the corner columns were improved as shown in Figure 2a. The column 6C was severely damaged. Since it was to remain in one of the new shear walls, its concrete was completely removed and it was recast with the new wall. The other severely damaged column 3B was jacketed with a concrete cover in the ground story. The shear wall ratio in the rehabilitated building (shear wall area divided by the total floor area) was 0.0021 in the x-direction and 0.0032 in the y-direction.

The eight-story building experienced moderate damage during the June 25, 1998 Adana-Ceyhan earthquake. Damage was mostly observed in beams in the first five levels, and in the columns and the U shaped shearwall around the elevator shaft in the first level. The shearwalls with darker shading indicated on Figure 2b were added for seismic rehabilitation.

During the Adana-Ceyhan earthquake, four of the 24 columns at the first story were lightly damaged (1D, 3G, 3I and 5B in Fig. 2b), and the other 20 were undamaged. Two of the three existing concrete wall segments were lightly damaged and one was moderately damaged. Most of the 55 beams and 36 infill walls at the ground level were light to moderately damaged. Similar beam and infill-wall damage patterns were repeated from the first to fifth stories above the ground level.

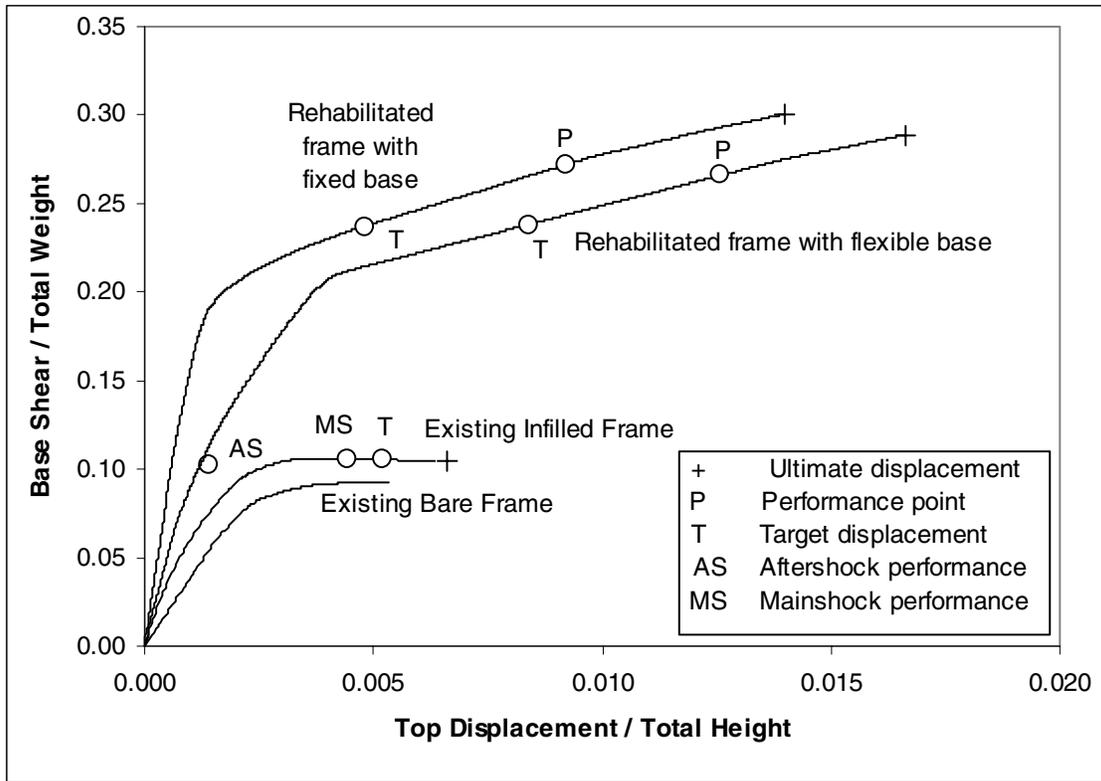
Figure 3. Normalized capacity curves of the four-story building obtained by pushover analysis

The results of the pushover analysis are presented in Figures 3 and 4 for the four and eight story buildings, respectively. The lower curves represent the existing buildings. It can be observed from Figure 3 that brick infills increased the lateral strength and initial stiffness of the four story bare frame by 20% and 70% respectively.

The effective vibration periods of the 2D models of the four and eight story buildings are calculated as 0.69 and 0.90 seconds respectively, with the corresponding spectral displacements of 5.25 and 8.5 cm. When these values and the first modal participating factors at the roof level are employed to calculate the target roof displacement, which is normalized with respect to the associated building height, target values of 0.0052 and 0.0049 are obtained for the two buildings. These values are marked on respective capacity curves in Figures 3 and 4.

Nonlinear time history analyses are conducted for the four and eight story buildings under the NS components of Dinar and Ceyhan ground motions respectively. The maximum values of roof displacement to building height ratios are obtained as 0.0044 for the four-story building under Dinar, and 0.0040 for the eight-story building under Ceyhan ground motions. It can be inferred from Figures 3 and 4 that these displacements are lower than the ultimate displacement capacities of both existing buildings. The maximum response ratios obtained from the nonlinear dynamic analyses are shown on the capacity curves of respective buildings in Figures 3 and 4 with the legend MS.

The results of the pushover analysis are shown in Figures 3 and 4 for the two buildings. Rehabilitation of the existing frames by adding shear walls increased their stiffness, strength and ultimate deformation

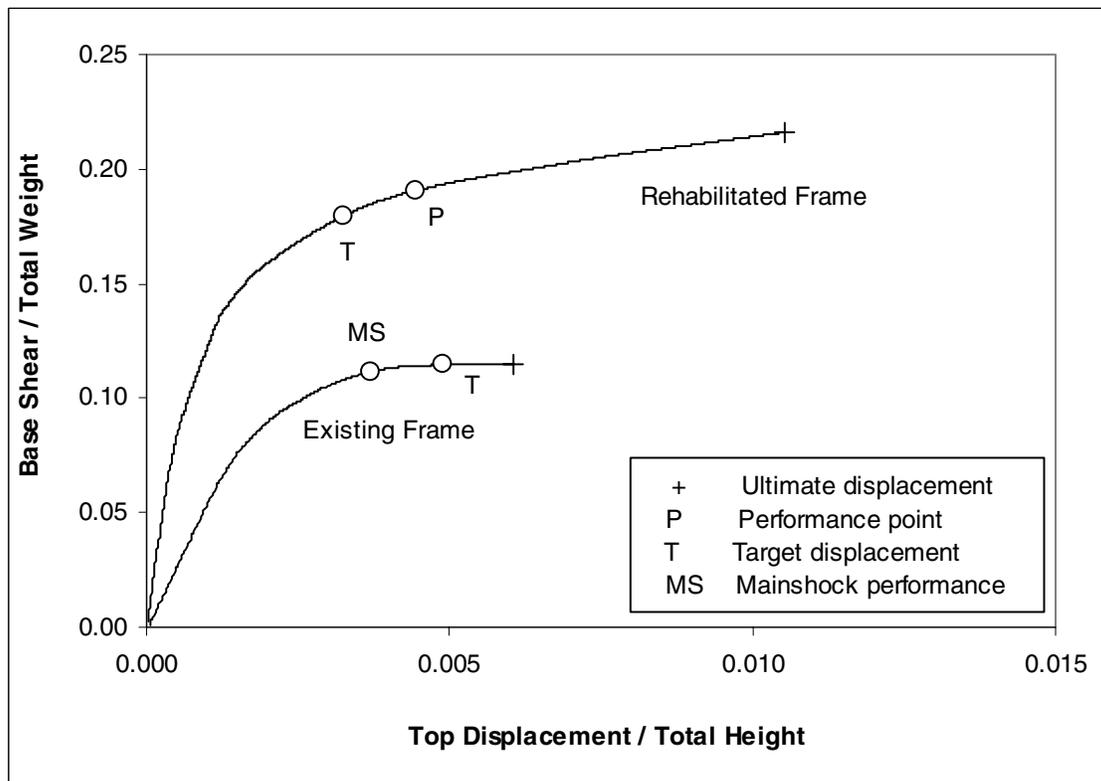
Figure 4. Normalized capacity curves of the eight-story building obtained by pushover analysis

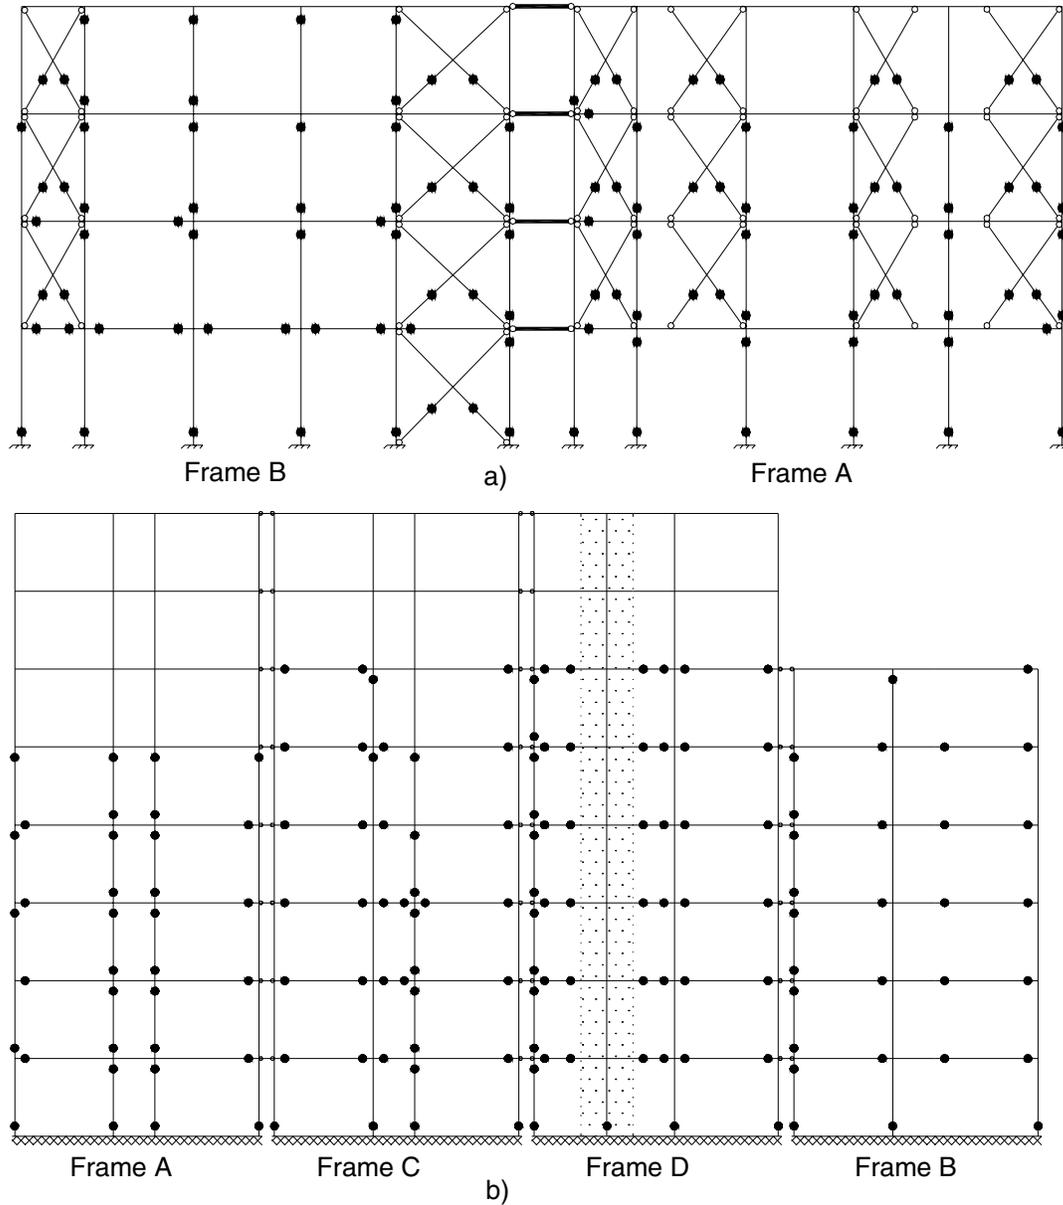
Figure 5. Plastic hinge mechanisms a) in the four-story existing building under Dinar ground motion, b) in the eight-story existing building under Ceyhan ground motion at target displacement

The target displacements obtained from the coefficient method and the maximum displacements obtained from the time history analysis are in reasonable agreement. The plastic hinge mechanisms at the respective target displacements of the four and eight story buildings are presented in Figure 5. The distribution of plastic regions generally conforms well to the observed damage distributions in these buildings.

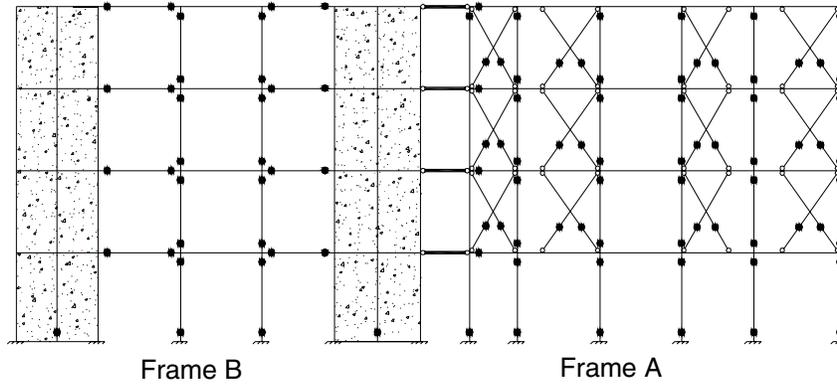
Figure 6. Plastic hinge mechanism in the four-story rehabilitated building at target displacement under design ground motion

The plastic hinge distribution at the target displacement of the four-story building is shown in Figure 6, and the corresponding plastic rotations of the first story members are given in Table VIII. All members in Figure 6 are numbered from left to right in Table VIII, and only the maximum of plastic rotations from both ends are given.

All beams, columns and walls displayed plastic rotations less than the acceptable values, including the coupling beam number 4 in frame C that is assigned a plastic rotation limit of 0.008. On the other hand the three shear walls that received 70 percent of the total base shear force at the target displacement performed at the immediate occupancy level.

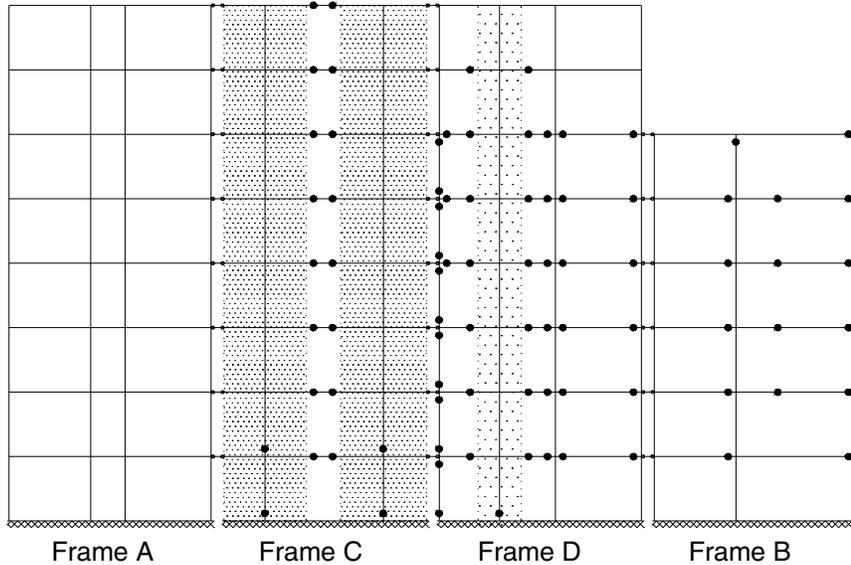
Figure 7. Plastic hinge mechanism in the eight-story rehabilitated building at target displacement under design ground motion
