BEHAVIOR OF PHC PILE FITTED WITH ASEISMIC SPLICE UNDER THE CYCLIC HORIZONTAL LOADING AND VARIABLE VERTICAL LOADS

Madan B KARKEE¹ And Yoshihiro SUGIMURA²

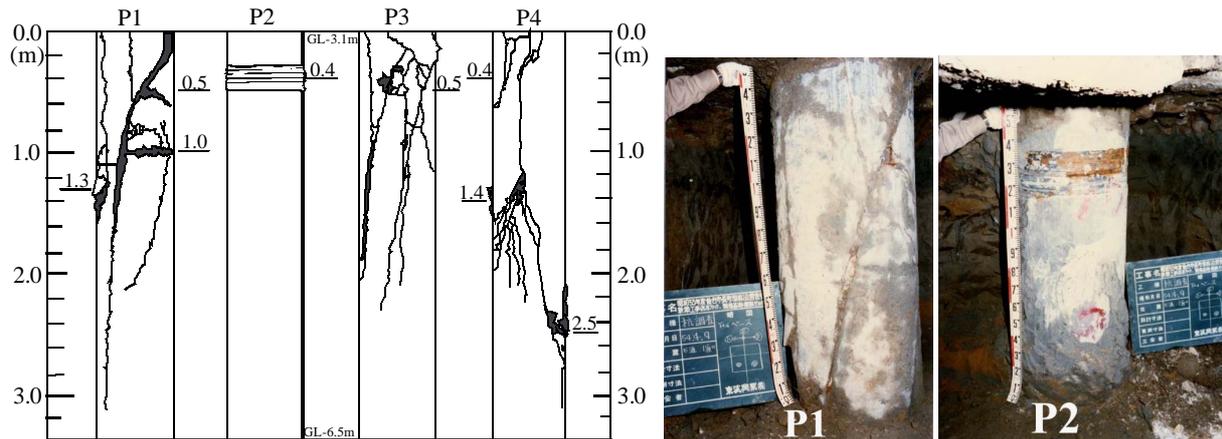
Figure 1: Difference in behavior between PHC piles with (P2) and without welded splice near the top

Investigations on a building with most of the column footings having 4 piles, affected by the 1978 Miyagiken-oki earthquake, is reported by Sugimura and Ohka [1981]. It was observed that one of the four piles in some of the footings remained undamaged while the remaining three had completely failed, apparently in bending shear mode. Closer examination revealed that, in each case the undamaged pile had been accidentally overdriven during installation, requiring a short pile segment to be added, resulting in a welded splice near the top. The sketch in Figure 1 clearly shows the distinct difference in behavior of the pile with a welded splice (P2) compared to the remaining three piles without the splice (P1, P3 & P4). The sketch shows the condition of all the four piles in the footing, based on the excavation and direct inspection carried out after the earthquake. The distinct difference in behavior can also be seen in the photographs of the top portion of piles P1 and P2 given in Figure 1. It appears that the existence of the welded joint enhanced the otherwise low ductility of the pile body, thus preventing the spliced pile from failure.

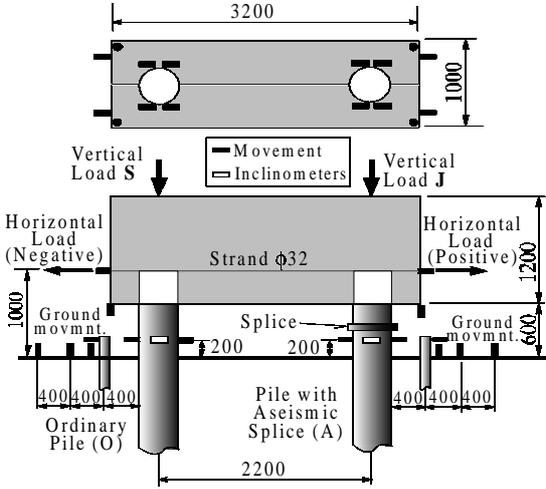
Figure 2: The outline of the loading test arrangement

The experimental setup for the load application is shown in Figure 2 and the soil profile of the test site together with the layout of the set of test piles is given in Figure 3. The test piles consist of $\phi 400$ mm PHC piles of type B (thickness $t=65$ mm, concrete strength $F_c=85$ MPa, Young's modulus of concrete $E=40,000$ MPa and with 12 $\phi 9.2$ mm prestress strands). The two piles, one with aseismic splice (designated as pile A) and the other ordinary pile without the splice (designated as pile O), are connected to a rigid base slab (3.2m long, 1.2m deep and 1.0m

wide) by embedding a length of piles equal to the diameter (0.4m). Thus the system tested consists of a single span structural unit as shown in Figure 2. The center to center spacing between the piles is 2.2m (5.5 times the pile diameter). Attempt was made to place the splice as close to the base slab as possible. However, due to steel band detailing the center of the splice was actually at 25cm below the bottom of the base slab. For a simple and direct comparison of the performance of the two piles, it was decided not to locate the splice below ground. The center of the splice was at a level of GL+0.35m as shown in Figure 2.

The horizontal load was applied through the $\phi 32$ mm strand embedded in the base slab at the level of GL+1.0m as shown in Figure 2. The load was applied by pulling the strand by hydraulic jacks suitably arranged on both sides of the base slab. Two hydraulic jacks located centrally above the two piles, designated as S and J in Figure 2, were used for application of the vertical load. The vertical and the horizontal jacks on both sides of the base slab were manually operated independently, thus making the load application system completely asynchronous.

Arrangement was made to measure the movement, inclination and strain at different locations and in different directions together with the measurement of applied cyclic horizontal load (positive and negative) and vertical load (S above pile O and J above pile A). The location of the movement sensors, inclinometers and strain gages utilized to measure and evaluate the behavior of the system being tested are also indicated in Figures 2 and 3.

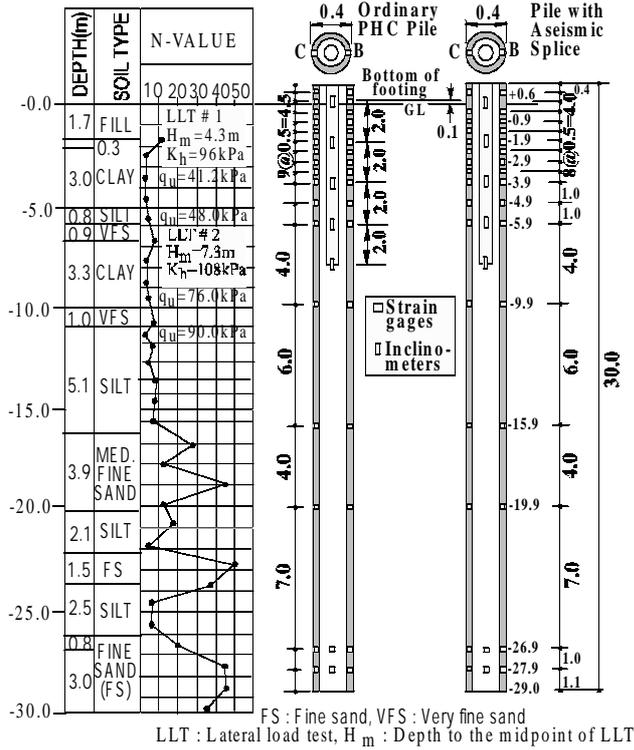
Figure 3: Profile of site condition and the test piles

Based on the results of site exploration and the soil tests, the ground condition of the test site consists of a fill material to a depth of about 1.7m, underlain by a mainly clayey soil layer to a depth of about GL-10m. As shown in Figure 3, the standard penetration test (SPT) N-value in the fairly soft clayey layer ranges from 2 to 4 and the undrained compressive strength q_u ranges from 40 to 90 kPa. The coefficient of horizontal subgrade reaction k_h in the clayey material, estimated from the lateral loading test (LLT), was found to be about 100kPa. It can also be noted in Figure 3 that the soil condition below about GL-10m consists of alternate bedding of silty and sandy material with a large variation in N-value ranging from less than 10 to more than 40. The soil close to the pile toe region is of sandy type with N-value of about 40.

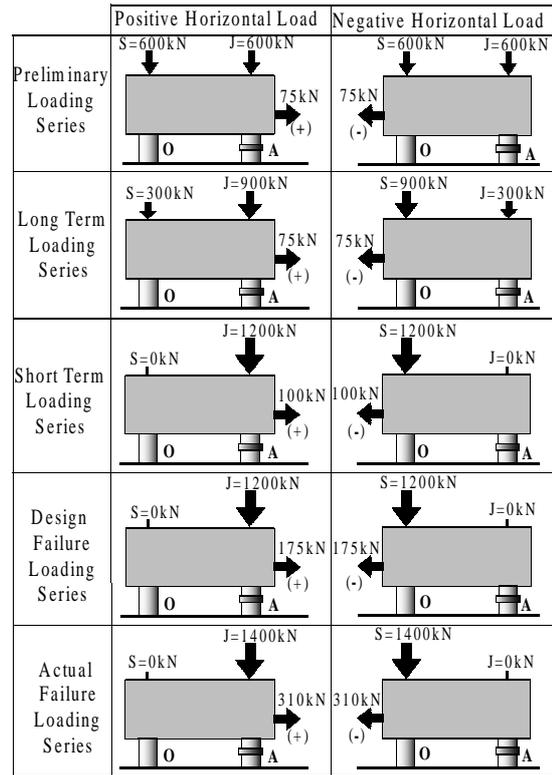
Figure 4: Loading scheme & the maximum loads

As mentioned above, a unique feature of the testing program consists of an attempt to represent the loading condition in piles during earthquakes by employing different combination of horizontal and vertical loading. The actual procedure followed is illustrated schematically in Figure 4. Different series of cyclic horizontal loading under different combination of vertical loads are depicted in Figure 4 together with the maximum values in each series. The preliminary series consists of applying the design vertical load (long term allowable bearing capacity) on both the piles. That is, the cyclic horizontal load was applied under equal vertical loads on each pile. The long term allowable vertical load R_a (also referred to as the design capacity) of the bored PHC pile for the ground condition shown in Figure 3 was estimated to be about 600kN (60t) from Equation 1 generally recommended for design practice in Japanese. The total vertical load capacity of 1200kN (120t) for the two piles forms the basis for the scheme of vertical load application depicted in Figure 4.

In Equation 1, \bar{N} is average N-value within the range $1B$ below and $4B$ above the pile toe (B is pile diameter), \bar{N}_s & L_s are the average N-value & thickness of sandy soil layer, \bar{q}_u & L_c are the average value of undrained compressive strength and thickness of clayey layer, and A_p & ψ are the cross-sectional area & perimeter of the pile of diameter B . The maximum horizontal load of 75kN in the preliminary series corresponds to long term bending strength of the pile material. It is the horizontal load required to produce a moment corresponding to the long term allowable bending strength of the pile material, and was obtained from the theory of beam on elastic foundation, following the Japanese design practice [Sugimura, 1988]. One cycle of horizontal load with a maximum of 75kN was applied during the preliminary series, while two cycles of the same were applied during the long term loading series, when the vertical load on individual piles was also varied, while keeping the total to 1200kN. As shown Figure 4, the vertical load was raised to $J=900$ kN and $S=300$ kN when loaded in the positive horizontal direction. It was reversed to $S=900$ kN and $J=300$ kN when loaded in the negative direction. In principle, the virgin horizontal load was always applied in the positive direction (Figures 2 and 4) so as to avoid severity on the ordinary pile.

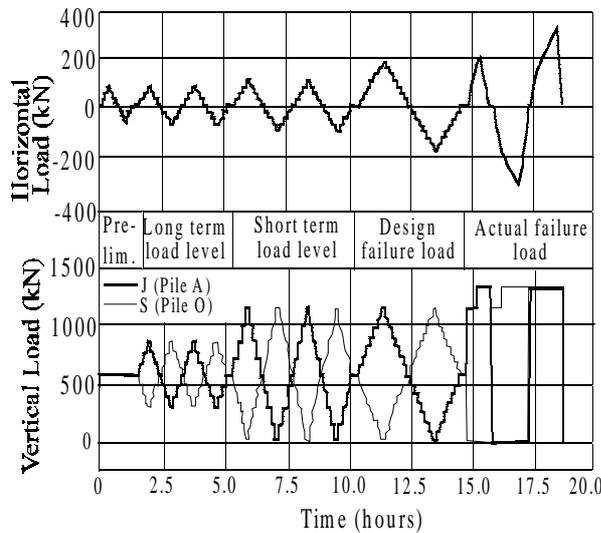
Figure 5: Steps and time schedule of loading scheme

limiting design situation. As the system of hydraulic jacks for load application are not synchronized, the sequence of loading involved first setting the vertical load and then applying the horizontal load manually at all the steps. The actual scheme of the horizontal and vertical loads is given in Figure 5.

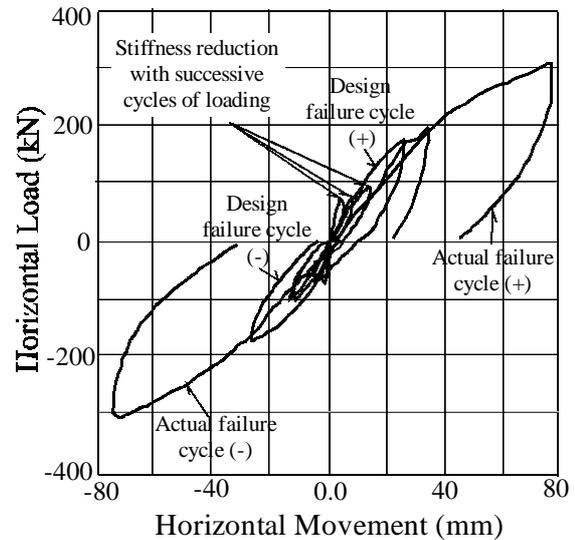
Figure 6: Horizontal movement of the footing

The cyclic horizontal load movement relation of the footing is shown in Figure 6. During the preliminary series, when equal vertical load ($S=J=600\text{kN}$) was applied, both the piles settled uniformly by about 3mm. Next, when the horizontal load was initially applied in the positive direction, the horizontal movement was 4.4mm, while it was only 2.5mm when the load was reversed next in the negative direction, indicating a clear imbalance in the movement. However, the movement was close to the linear range and there was no appreciable tilting in the footing. As noted above, the long term loading series differs from the preliminary series only in that the vertical load is varied, for example $J=900\text{kN}$ and $S=300\text{kN}$ when loaded in positive direction. Because of the unequal vertical load, the horizontal movement increased by about twofold to 8.5mm in the positive direction and to 5.2mm in the negative direction. The inclination of the footing was found to be appreciable at this stage.

In short term loading series, although the horizontal movement became comparatively large (positive direction 14.3mm, negative direction 12.8mm), practically linear behavior seemed to be still maintained. However, the lateral stiffness of the system declined with successive cycles. The inclination of the footing was slightly larger when loaded in the negative direction, and it followed to a smaller value in the positive direction. The movement of the footing became clearly nonlinear during the design failure series of loading. Also the horizontal movement in the negative direction became slightly larger (26.6mm) than that in the positive direction (25.4mm). This reversal in horizontal movement may be attributed to the lopsided inclination of the footing in the negative

direction during the long term loading series, which became even worse in the design failure stage. During the actual failure series, the horizontal movement was already quite large under the large vertical load difference of 1200kN and 0kN alone, even before the horizontal load was applied. When the maximum horizontal load of 310kN was reached, the horizontal movement increased to 71.4mm in the negative direction and 76.3mm in the positive direction. However, the inclination of the footing increased rapidly during negative horizontal loading and did not recover when the horizontal load was reversed to the positive direction. Consequently, the inclination in the positive direction at the maximum horizontal load of 310kN was even smaller than that at the maximum horizontal load in the short term series, resulting in the overall residual inclination in the negative direction.

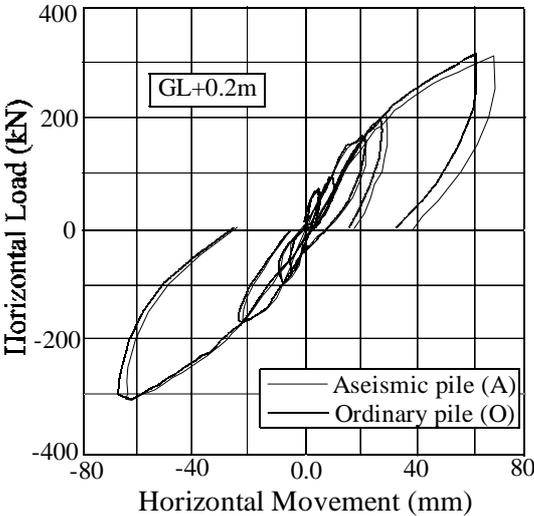
Figure 7: Horizontal movement of piles close to top

Figure 7 shows the horizontal movement of the pile near the top (at GL+0.2m). Although the movement is slightly larger in the positive horizontal load direction, towards which the virgin load was initially applied, there is practically no difference in the load movement behavior between the two piles up to the long term series. As may be noted in Figure 7, the difference between piles A and O tends to be noticeable from short term series. The movement in pile A is slightly larger than that in the pile O when loaded in the positive direction, while reverse is true when loaded in the negative direction. As it is, the two piles are connected to a rigid footing at the top, and it is no surprise that the piles A and O show similar horizontal load movement behavior close to the top.

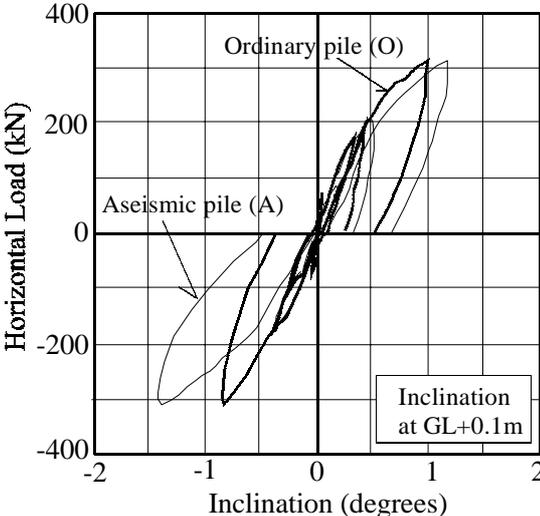
Figure 8: Inclination of piles close to the top

Figure 8 shows the inclination of the piles close to the top (GL+0.1m), where it is seen that the inclination of pile A is larger than that of the pile O irrespective of the loading level and the direction of horizontal load. It may also be noted in Figure 8 that the inclination in the negative direction in pile O shows the tendency to peak during the actual failure series, while it is still increasing in pile A in either direction. The peaking of inclination in pile O when loaded in the negative direction may be attributed to the increased restraint to rotation due to the very large vertical load. Owing to the presence of aseismic splice, application of similar vertical load does not seem to result in any appreciable increase in restraint against rotation in case of pile A.

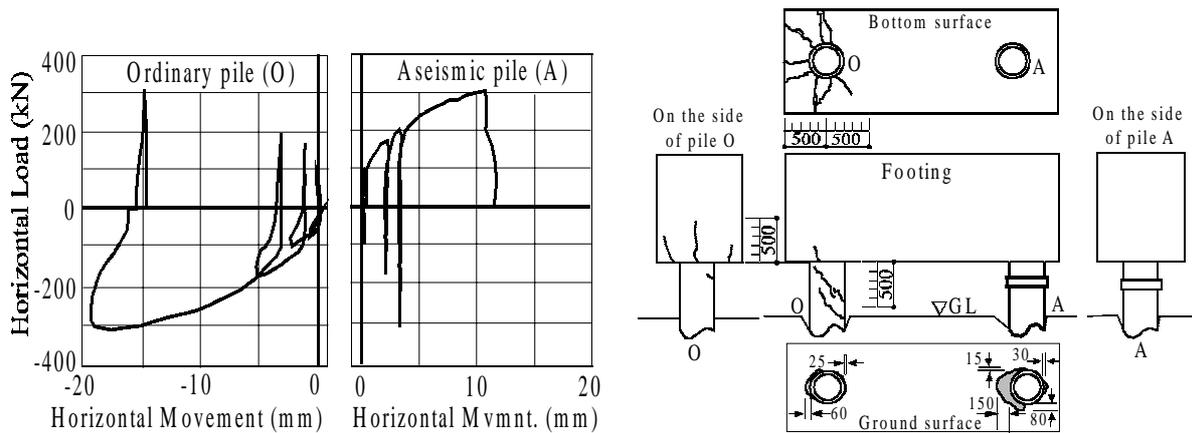
Figure 9: Horizontal ground movement adjacent to piles

Figure 9 shows the horizontal movement of the ground adjacent to pile O and pile A under the action of the cyclic horizontal loading. The horizontal movement adjacent to pile A occurs only when loaded in the positive direction and that on the side of pile O occurs only when loaded in the negative direction. Figure 9 also shows that most of the horizontal ground movement occurred after the short term loading series, and the movement on the side of pile O is much larger than that on the side of the pile A, particularly at the failure loading cycle. The later is most likely due to the increased restraint against rotation in case of pile O as mentioned above. In this sense, the horizontal movement of adjacent ground in Figure 9 seems to relate with the inclination of the pile top shown in Figure 8. As noted above, the inclination of pile A is larger than that of pile O, whichever way the load is applied, indicating easing of the restraint against rotation by the splice in pile A. Vertical movement of adjacent ground, due to swelling of the ground as it is pushed horizontally, was also observed. Although conspicuous close to the piles, the vertical movement due to swelling was found to decline rapidly with distance.
