A Dynamic Centrifuge Model Test for the Seismic Strengthening of Existing Embankments by the Reinforcement Bar Inserting Method

H. Hashimoto¹ S. Nishimoto² H. Hayashi³ and K. Kawakami⁴

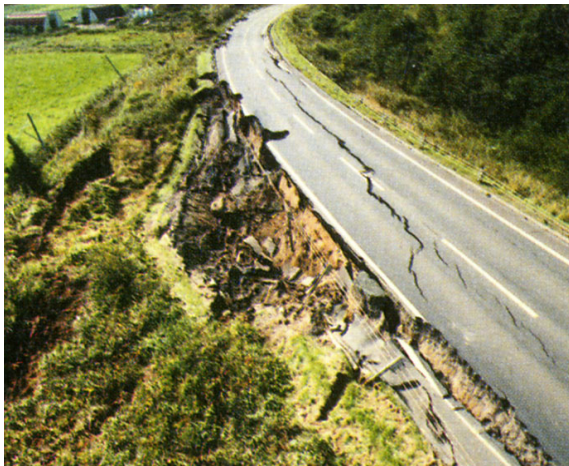
Figure1 National highway embankment damage in the HOKKAIDO TOUHOU-OKI Earthquake

In recent years there have been many major earthquakes in the country. The embankment damage of the Mid Niigata Prefecture Earthquake is still fresh in our minds. There have been 4 major earthquakes in the eastern region of Hokkaido in the past ten-odd years, and the destruction of national highway embankments has affected society seriously. In particular, after the Kushiro-Oki Earthquake in 1993, some areas had to spend up to 44 days to restore damaged embankments (Figure 1).

Figure 1 shows the road embankment heavily destructed in the Hokkaido Touhou-Oki Earthquake, and this is also a damage pattern II example.

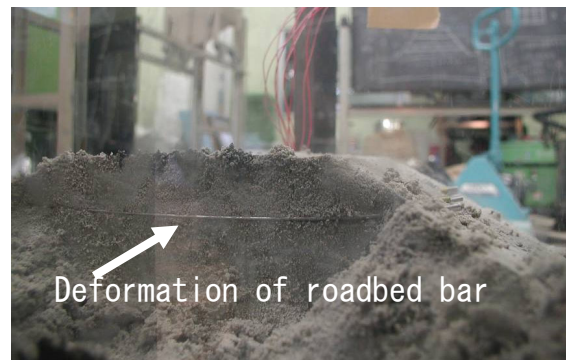
Figure 6 Case4 After Vibration Experiment (cross-section)

Due to the ground motion of the third vibration (set acceleration: 500 gal), the embankment itself tended to sink directly down. It can be thought as a reason that longer oblique bars and bearing pressure plates mitigated deformation of the entire embankment, and the bars under the roadbed and bearing pressure plates further mitigated the deformation due to sinking. We conjecture that the roadbed bars in Case 5 concaved more in comparison to Case 4 for this reason (Figures 6 and 8).

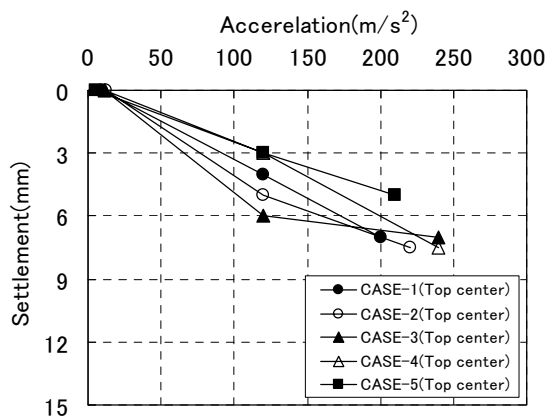
Figure 9 Vertical Displacement Comparison (top center)

For Case 5, as in Case 4, reinforcing bars were cast in the embankment slope and under the roadbed, and bearing pressure plates were set at the head of the reinforcing bars. The length of the oblique bars was 8 cm (real-size conversion: 4 m), which was 3 cm (real-size conversion: 1.5 m) longer than in Case 4. In this condition, after the third vibration (set acceleration: 500 gal) cracks occurred in the top center of the embankment. However, the cracks were much reduced compared to Cases 1 to 4. Furthermore, there were no cracks at the slope top. Also, the sinking was only 5 mm at the top center of the embankment (real-size conversion: 25 cm) and 4 mm at the slope top (real-size conversion: 20 cm). The sinking was mitigated compared to Cases 1 to 4 (Figures 9 and 10).

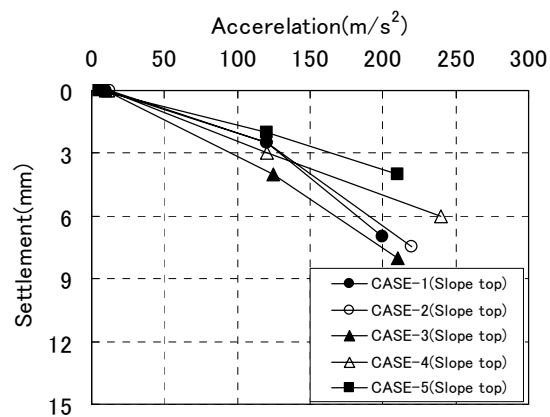
Figure 10 Vertical Displacement Comparison (Light side slope top)

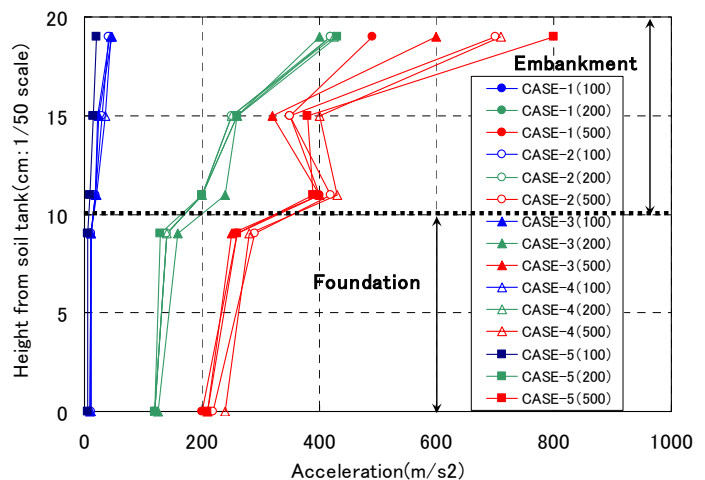
Figure 11 Acceleration Response of Basic Foundation and in Embankment

Figure 11 shows the set acceleration, and acceleration response in the basic foundation and embankments of Cases 1 to 5. The set acceleration (gal) is shown in the parentheses in the table.

It was confirmed that there was no increase of acceleration response in the foundations in all cases for the first vibration (set acceleration: 100 gal). In the embankment, there was a slight increase between the half-point in height and the embankment top. For the second vibration (set acceleration: 200 gal), as in the first vibration, there was no confirmed increase in the foundation. However, the acceleration response from the bottom of the embankment to the top greatly increased.

When the acceleration response of the embankment top reached 4 times that of the set acceleration, no great difference was observed in each case, whether with or

without the reinforcing strengthening, and with different reinforcing bar placement. This can be owned to some uniform rigidity of the embankment.

For the third vibration (set acceleration: 500 gal), the acceleration response from the foundation to the mid-point in height of the embankment were similar in all cases. However, the top of the embankment responses were different for each case.
