MONOTONIC TESTING OF UNREINFORCED AND FRP-RETROFITTED MASONRY WALLS PRONE TO SHEAR FAILURE IN AN EARTHQUAKE

H. Mahmood¹, A. P. Russell² and J. M. Ingham³

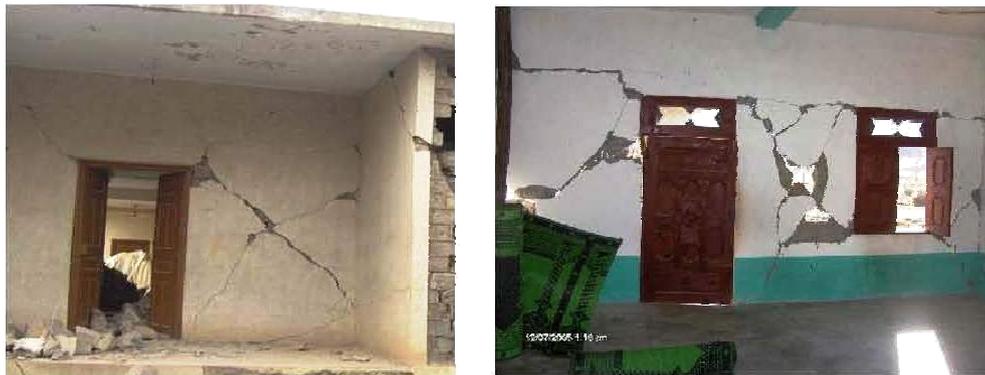
Figure 1 Diagonal shear cracks in earthquake-affected URM walls and piers (Javed et al. 2006)

This research investigates the performance of GFRP material as a seismic retrofit solution for in-plane URM walls, which are likely to fail by the formation of diagonal shear cracks in an earthquake. In an earthquake, the in-plane URM walls elements may fail/deform in one of the following modes: (i) rocking; (ii) shear sliding; (iii) diagonal shear or (iv) compression (Magenes and Calvi 1997). The latter two modes of failure are brittle modes of failure and, if any preference for failure modes exists, are the ones to be avoided. The diagonal shear failure in a URM wall is generally exhibited by the formation of 'X' type cracks and takes place due to the exceedance of tensile strength of masonry. It is a commonly observed mode of failure in the walls and piers of earthquake-damaged buildings (Figure 1) (Javed et al. 2006). The 'X' shape of cracks arises due to the cyclic nature of the earthquake motion. The cracks may pass through either bricks or masonry joints or partly through both bricks and masonry joints. The crack path is determined by the relative strength of bricks, the brick-mortar interface and mortar. In the case of heavy damage to URM walls, the vertical load carrying capacity of the walls drops significantly.
