POTENTIALLY ACTIVE FAULTS IN THE FOUNDATIONS OF LARGE DAMS PART I: VULNERABILITY OF DAMS TO SEISMIC MOVEMENTS IN DAM FOUNDATION

M. Wieland¹ R.P. Brenner² and A. Bozovic³

KEYWORDS: Active faults, concrete dam, rockfill dam, earthquake safety, vulnerability of dams

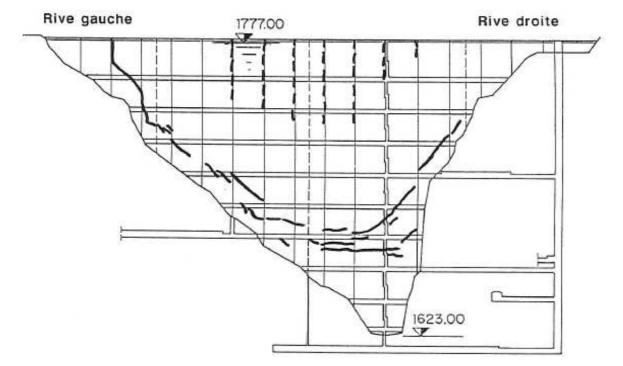
Fig. 1: Crack pattern in Zeuzier arch dam caused by non-uniform foundation movements of a few centimetres (solid line: cracks at downstream face; dotted line: cracks at upstream face) (Amberg and Lombardi, 1982)

Concrete dams are very vulnerable to non-uniform foundation movement as shown in the case of the 154 m high double curvature Zeuzier arch dam in Switzerland (Fig.1). Cracks formed in the dam body in 1978/1979 due to deformations of the abutments caused by movements in the dam abutments generated by the drainage of the rock. The latter resulted from the construction of a pilot tunnel for a highway, near the reservoir. Relative foundation movements of a few cm have caused severe cracking in the dam (Amberg and Lombardi, 1982).

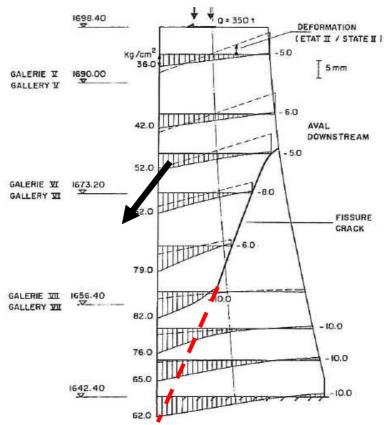
Fig. 2: Observed cracking in upper portion of Zeuzier arch dam and possible extension of crack under earthquake ground motion (dotted line) causing failure of the upper portion of the dam into the reservoir (assumed failure scenario) (Amberg and Lombardi, 1982).

As shown in Fig. 2 for the Zeuzier arch dam, it is quite straightforward to extend the main crack such that the detached top portion of the dam will fall into the reservoir under earthquake ground shaking. In order to show how a rigid concrete dam behaves under the combined action of non-uniform foundation movement and strong ground shaking, shaking table tests may have to be performed as present analyses methods used by dam engineers may not allow the prediction of crack patterns in a three-dimensional concrete dam.
