SEISMIC AND WIND DESIGN FOR SOLAR PANELS

J. M. Eiding¹ D. Pratt² F. Nikman³

The Pasadena Water and Power Department and EBMUD are aggressively upgrading their water system infrastructure to withstand earthquakes. As seismic-related upgrades are developed, we consider opportunities for addressing climate change. This paper examines the economics and pros and cons of constructing solar panel systems atop several water reservoirs that also require seismic upgrades. Pasadena and EBMUD serve progressive communities, and opportunities to address climate change and earthquake reliability are actively being addressed. California's Governor Schwarzenegger is requiring that coal power not to be used for base load purposes, and replacing coal with solar for power generation is viewed positively by the public. Given these important reasons to build new renewable electric generation, we examine the economics of installing solar panels atop water reservoirs. Our engineering studies show that the mix of solar and seismic concerns brings up many new engineering issues, having to do with the economics of renewable power as well as high wind speeds. The findings show that the normal code strategy

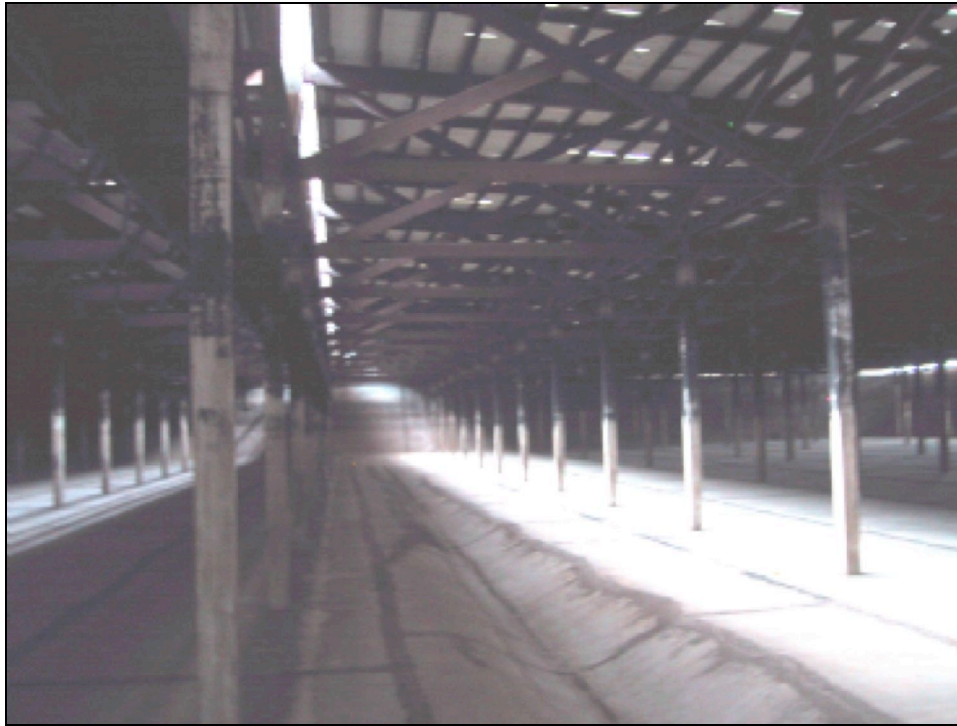
Figure 1. Interior View of Empty Water Reservoir

We examine the practical issues and economics of installing solar panels for a reservoir with light wood roof in Pasadena (10 miles from Los Angeles). Figures 1 and 2 show the existing condition of the reservoir in Pasadena. The roof sheathing is corrugated steel, the roof structure is redwood rafters atop redwood beams atop redwood columns, the liner is light reinforced concrete. The columns rest on the liner without positive attachment. Roof dead weight is about 8 psf. The roof was built in 1950, for an original seismic horizontal load of 10% times dead weight. The existing lateral load system is provided by lateral resistance of the roof beams and rafters being resisted by exterior concrete anchors. The current (2008) seismic design criteria is for an earthquake with $PGA = 0.60g$ (475 year return period). Seismic analysis of the roof shows that the interior connections between wood members are undersized for the seismic loads (seismic upgrade by modifying most bolted connections) and the exterior concrete anchor blocks are too small (seismic upgrade with new drilled piers). Accumulated corrosion, repair of the leaking liner and

We next looked for evidence of wind-damage for existing reservoirs. In Pasadena, one of eight reservoirs had its roof peeled off / damaged (moderate repair costs) in a prior wind event. In Fremont, one of six reservoirs (all similar to the one in Figures 1 and 2) had its roof peeled off (very high repair costs) in a recent winter storm. Both these reservoirs were located at or near the base of large mountains (1,500 to 4,000 feet higher than the roof) in exposure C type environments. It is readily apparent that the 50-year return wind speeds in the California code should not be considered "never to exceed" and in fact can be expected to be exceeded one or more times at reservoirs within a 50 year time frame. If the reservoir is strictly used for water retention purposes, then perhaps a \$2 to \$10 per square foot repair bill, due to high winds once every 50 years is acceptable. However, once a new solar panel array is installed, the repair bill would increase to perhaps \$35 to \$60 per square foot, and the loss of the power generated might become material to the community if solar power become a material portion of the total base load power generation.

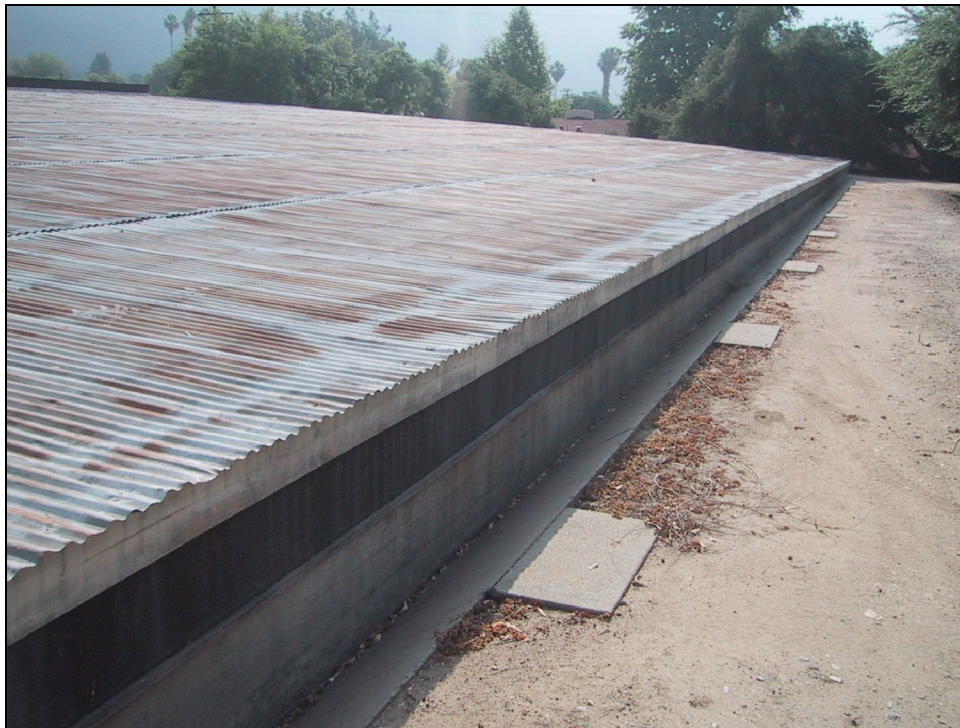
Figure 2. Exterior View of Water Reservoir Roof
