# ZONING FOR SURFACE FAULT RUPTURE MANAGUA, NICARAGUA

## SYNOPSIS

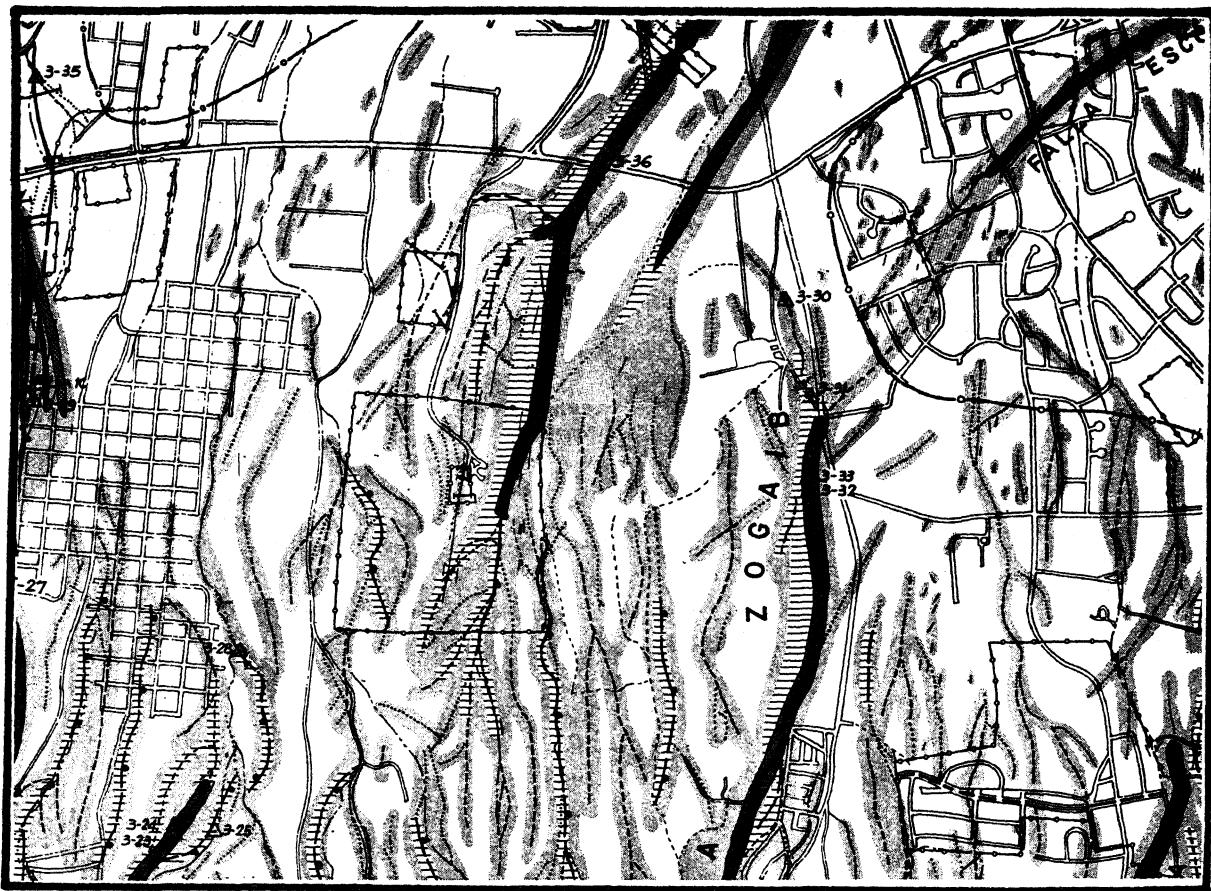
Figure 1. DETAIL OF THE SURFACE FAULT HAZARD MAP, MANAGUA, NICARAGUA  
FAULT HAZARD STUDY

The preliminary fault and lineament map was modified to produce the preliminary fault hazard map (Figure 1). The fault hazards were divided into five categories; two classifications of known faults, two classifications of postulated faults, and areas where there was no apparent evidence of a hazard due to faulting. Used together, the hazard map and the planning matrix constitute a basis for decisions regarding land-use planning, siting, and determining where additional geologic study should be a prerequisite to construction.

The planning matrix and the preliminary fault hazard map were released to the public by VMPU in 1975 (6). At that time, WCC had completed more than 16 km of exploratory trenches for fault hazard investigations in 28 separate property developments within the mapped area. The published map was reproduced at a larger scale and trench locations and trenching data acquired by WCC were plotted on it to evaluate the reliability and accuracy of the preliminary map and
