# Seismic Reinforcement of Existing Japanese Wooden Houses Using External Galvanized Thin Steel Plates

In order to accelerate the seismic reinforcement of wooden houses in Japan, a new strengthening method using external galvanized thin steel plates was developed. The method has the potential to improve various aspects of housing, including heat insulation and durability. Existing houses hold the current finish covered with galvanized thin steel plates, which function as both lateral load carrying elements and a new exterior architectural finish. The steel plates are screwed into newly placed wooden frames, which are connected to the existing frames via the existing finish. A connecting method between the existing and new wooden frames was developed and the bearing performance was experimentally examined. Furthermore, a shear wall test was also conducted to evaluate the lateral load carrying capacity. Applying this method, an existing two-story wooden house was strengthened.

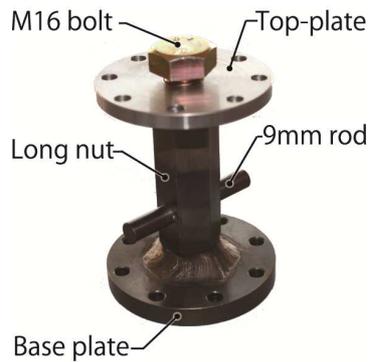
Figures 3.1. and 3.2. show the steel connection between existing and new frames. An M16 long nut is welded to a 9mm thick round plate (base-plate) and a 9mm diameter rod penetrates the long nut. Another 6mm thick round plate (top-plate) is tied onto an M16 bolt. Figures 2.1. and 3.3. show the placement and lateral load transfer system of the connection. The base-plate is screwed onto the existing beam via a hole in the existing finish and a hole with two diameter sizes along with the hole length is drilled into the new beam. The two hole sizes are slightly larger than the top-plate and long nut. The top-plate is bolted to the nut and screwed onto the new beam. The 9mm rod functions to maintain the gap for the existing finish. The seismic lateral load is transferred from the existing beam to the new beam and the eccentricity of the two beams induces moment in the connection (Figure 3.3.). The moment between the connection and beams is carried by pull-out tensile force by screws and compressive contacting pressure.

**Figure 3.1.** Steel connection **Figure 3.2.** Connected beams

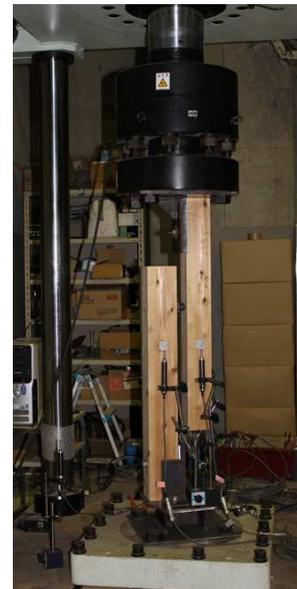
In order to investigate the bearing performance of the connection, a monotonic loading test was conducted. Figures 4.1. and 4.2. illustrate the steel connection specimens, whereby existing and new beams connected with two steel connections were vertically set in the loading machine. The top of the new beam was pushed down by the actuator and relative vertical displacements were measured between existing and new beams. Two specimens were tested under similar conditions.

**Figure 4.2.** Test in Lab

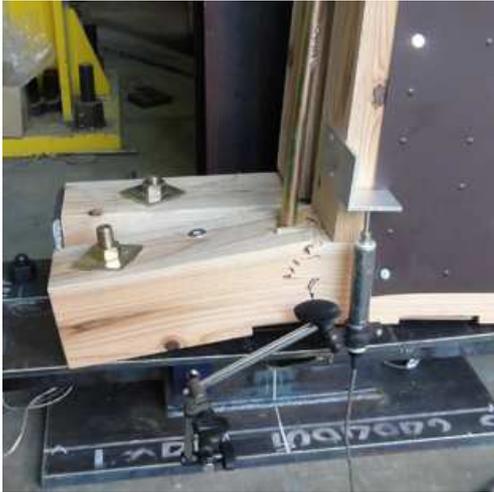
**Figure 5.3.** Rupture near anchor

Figure 5.2. shows the envelope of the lateral load-displacement relationships. The maximum ( $P_{max}$ ) lateral load of 11.7kN was observed with rotation deformation of 4.7% and the test load was significantly decreased below 80% of maximum load ( $0.8P_{max}$ ) by the rupture of the new ground sill near the anchor (Figure 5.3.), although, the limit state was designed with breakage at the screws between the galvanized thin steel plates and the new frame. One possible reason for this failure mechanism is that the strength of the screw connection may be greater than the calculated value. Moreover, the test load was gradually increased until 6.6% (Figure 5.4.). The lateral strength for the shear wall design was identified at about 5.8kN per meter based on the statement of operating procedures. Also, the rupture of the new ground sill considered attributable to the high aspect ratio of the specimen and the lateral strength may be higher in the actual design mechanism.

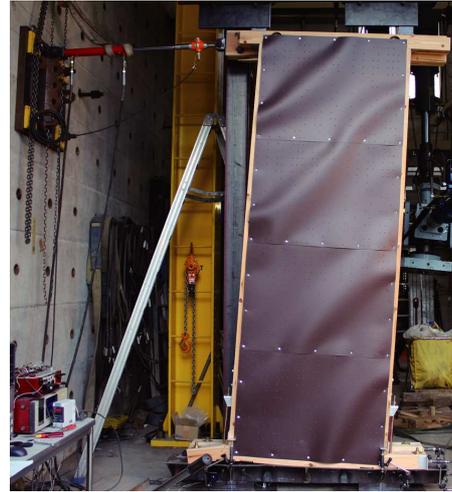
**Figure 5.4.** Limit state ( $R=1/15$ )

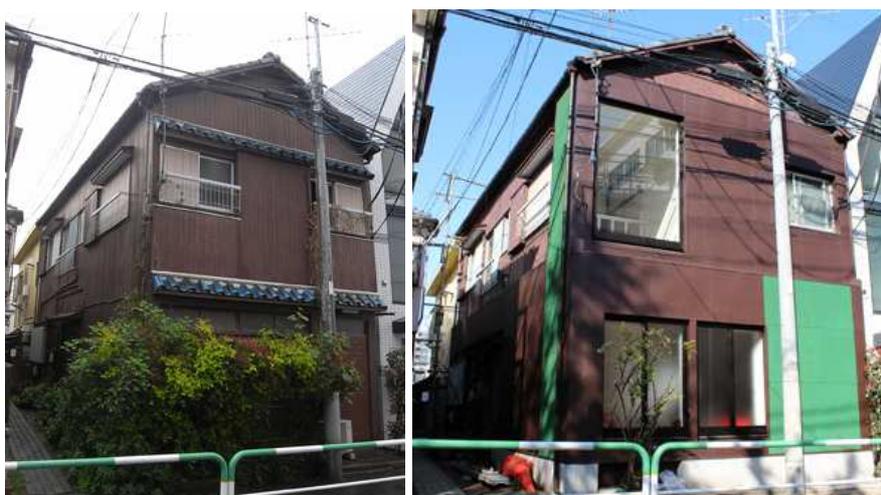
The reinforcing method was applied to an existing two-story wooden house. The lateral strength of the wall reinforced using this method was evaluated based on the shear wall test. Consequently, the seismic resistance of this house was improved and verified by conducting a simple seismic performance evaluation of the building before and after the strengthening. Figure 6.1. shows this house before and after strengthening. Because of practical and financial reasons, only a part of the exterior walls of the existing house was covered with the galvanized thin steel plates. The seismic strength of the house was improved with the covered part as indicated in Figure 6.2. The existing architectural finish is wooden board painted in brown. Harmonizing the color, steel plates in brown with round emboss patterns were primarily used with secondary use of green plates as shown in Figure 6.1. During the construction, it appeared that the house was slightly tilted and gaps between the right vertical new wooden frames varied on the height. Also, the levels of the existing beams on the second floor were not uniform. Difficulty was found in adjusting these irregularities and flexibility in the connecting mechanism is needed for future improvement of the method. In addition, fabrication of 0.8mm thick steel plate on site was not possible and use of thinner plates is to be studied.

Before strengthening

After strengthening

Reinforced part

**Figure 6.1.** Reinforcing method application
