# Behaviour of Full-Scale Reinforced Concrete Frame Under Simulated Post-Earthquake Fire

## SUMMARY:

This paper provides an experimental insight of a single storey sub-assembly, which is part of a G + 3 floors RC building subjected to simulated post-earthquake fire. In first part of the experimental program, a pre-decided initial damage was induced to the test frame through cyclic lateral loads in quasi-static. While in the second part, a compartment fire of 60 minutes duration was applied to the pre-damaged test frame for simulating the post earthquake fire scenario. The development of cracks and their patterns were recorded during each push and pull phase of cyclic lateral loading. Recorded strain data and the first observed cracks depict that the yielding of rebars at roof level in beam occurred prior to the yielding of the rebars in the column. Subsequently, the pre-damaged test frame was subjected to a compartment fire. Thermal and displacement histories of various components were obtained during the fire test.

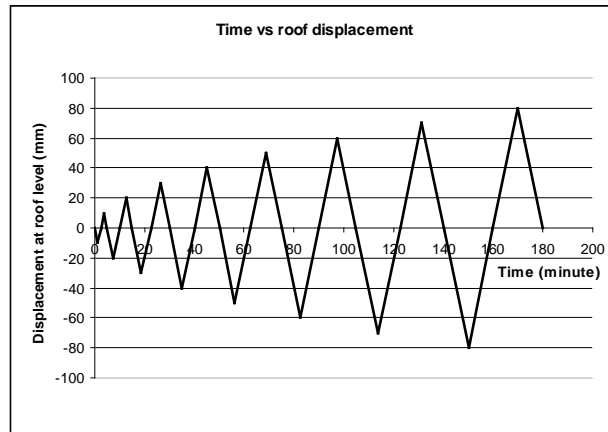
**Figure 3.** Proposed loading history of the test frame

Cyclic lateral loads on the test frame were applied in a quasi-static manner in load-controlled mode using a pair of double acting hydraulic jacks. Push and pull mechanism as shown in Figure 3, was imparted. The lateral load in each cycle was 10 mm and incremented by 10 mm in successive loading cycles. In this way of loading, a final target displacement of 76 mm was induced as mechanical pre-damage to the test frame, and that corresponded to Life safety of structural performance per FEMA [FEMA356:2000]. The similarity between the measured loading and displacement histories of the test frame can be seen in Figures 4 (a-b).

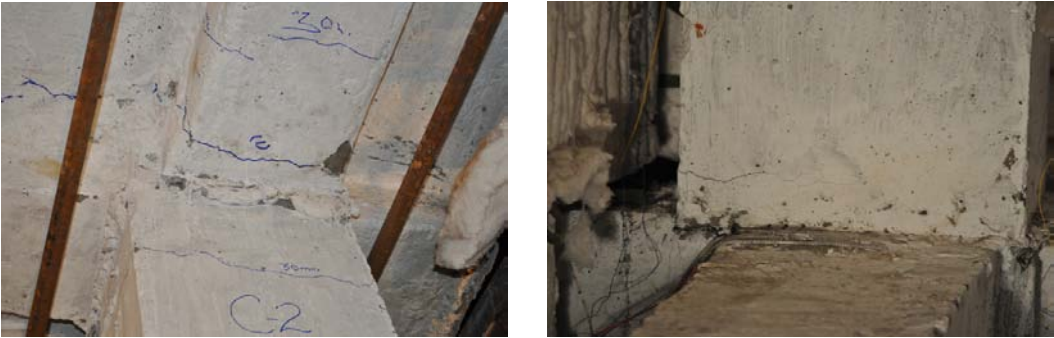
**Figure 5 (a).** Tension cracks in roof beam B7 (b). Flexural cracking in a column C1

The development of cracks and displacement was monitored through dedicated instrumentation in the sub-assembly of the test frame. No surface cracks in the sub-assemblages were observed up to a roof level of displacement 20 mm to the test frame. The first crack was seen near the joints of the roof beams oriented along the lateral loading direction N-S at a roof level displacement of 35 mm and that corresponds to a base shear of 185 kN as shown in Figure 5(a). Several cracks were observed at different locations of the sub-assembly in the successive cycles of lateral loading. Some flexural cracks in the columns (Figure 5 (b)) were visualized near the joints of the plinth beam at a lateral displacement of 52 mm. Concrete spalling near the joints of the roof beam spanning along the N-S direction was observed at a roof drift ratio of about 2 %. The test was terminated at a roof displacement of 80 mm corresponding to a base shear of 267 kN. The base shear-roof displacement relationship for the test frame plotted in Figure 6(a) shows no deterioration in the lateral strength of the frame at Life Safety structural performance level. Figure 6(b) shows the hysteresis curve of the test frame which shows that a maximum displacement of 95 mm in the “push” cycle and 85 mm in the “pull” cycle was registered corresponding to base shears of 316 and 267 kN respectively. Stiffness degradation and pinching of the hysteresis loops between successive cycles of loading is seen in Fig. 10 though the hysteresis loops continued to remain stable without any significant degradation in strength. The results of the strain analysis show that plastification of the test frame was initiated before “Life Safety” structural performance level. The test frame did not suffer any significant structural damage.

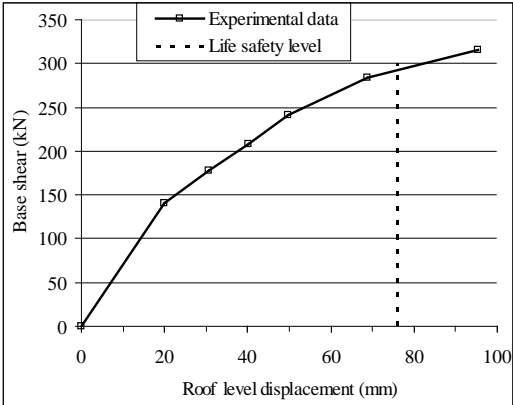
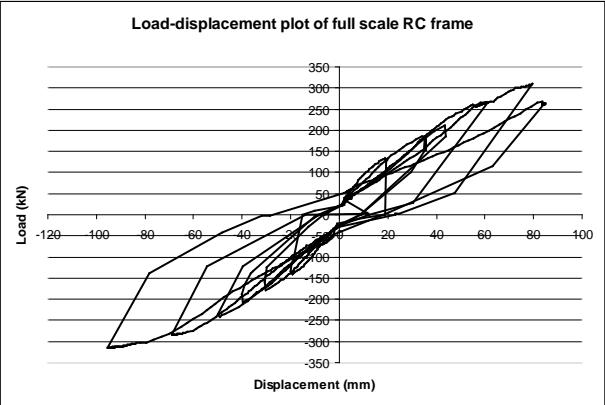
**Figure 6(a).** Base shear vs roof displacement (b) Hysteretic curve of the test frame

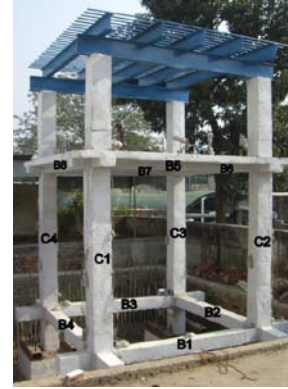
**Figure 8 (a).** Time-temperature plots for the compartment fire (b) Sub-assembly nomenclature

Before exposing the pre-damaged frame to fire, mock fire tests were conducted in a brick masonry fire compartment. Figure 8(a) shows a typical gas temperature history recorded inside the fire compartment during one hour fire followed by a cooling phase. Figure 8(b) depicts the nomenclature used for identifying the locations in the RC frame. However, a gas temperature of above 1000 °C was attained within 5 minutes after ignition of fire indicating the flashover with a maximum temperature of 1289 °C as shown in Figure 9(a). The sound of concrete spalling off from the roof slab was heard after 5 minutes of ignition, which continued for another 15 minutes. The spalling sound corresponded to a compartment temperature between 300 to 400 °C. The structure showed no signs of collapse during and after the fire test. Unfortunately, the data acquisition of vertical displacements at various locations of slab became unsuccessful due to instrument malfunctioning in a high temperature environment. A maximum vertical residual displacement of 46 mm was later measured in the roof slab with the help of leveling. Figure 9(b) shows the beams and columns after the fire test and depicts the signature of the structural stability exhibited by the RC frame sub-assembly after the fire test. Extensive damage was seen in the roof slab in terms of spalling of concrete and resultant exposure of reinforcement. This was mainly due to the movement of fire plume towards the ceiling causing a rapid flow of hot gases in the radial direction termed as a ceiling jet. Despite this, the test frame withstood one hour fire exposure without losing its structural integrity in terms of complete collapse.

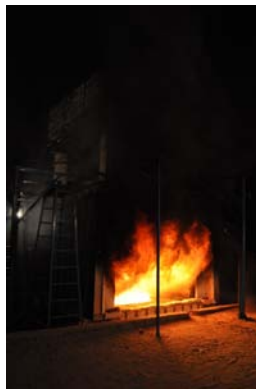
**Figure 9. (a)** Fire test in progress

**(b)** Frame sub-assembly after fire test
