# A Centrifugal Model Test on Seismic Reinforcement for Embankments on Peaty Ground

**Shin'ichi Kajitori, Satoshi Nishimoto, Hirochika Hayashi, Hijiri Hashimoto**  
*Civil Engineering Research Institute for Cold Region (CERI)*

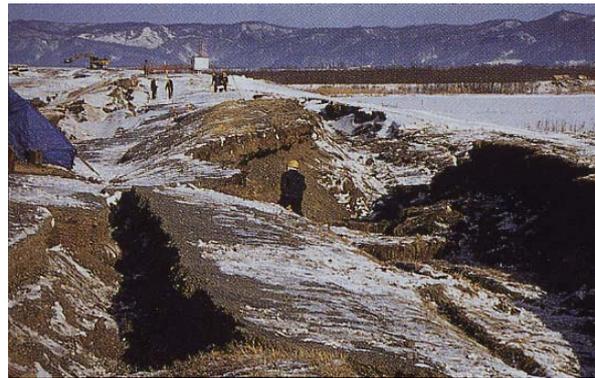
Photo 2. Liquefaction damaged caused by the Kushiro-oki Earthquake of 1993 (river embankment)

The Hokkaido Kushiro-oki Earthquake of 1993 caused significant deformation of an embankment along the Tokachi River (Photo 2). The crown and the top of the fore land-side slope settled by 2 to 3.5 m, and large cracking affected the embankment body. A post-disaster survey revealed that, although the surface layer of the foundation was peaty ground unaffected by liquefaction, traces of sand boils were found near the crown.

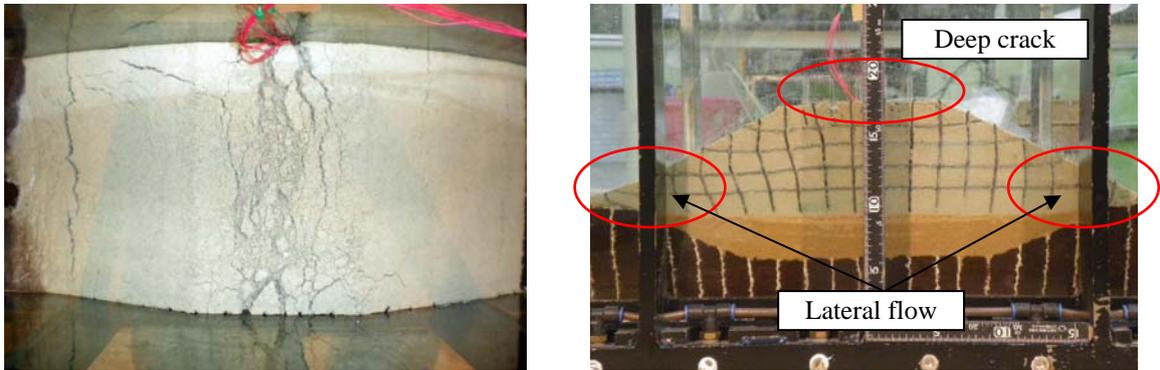
Photo 3. Case 3 without countermeasures (input acceleration:  $275 \text{ m/s}^2$ )  
(Left: situation at the top of the embankment; right: situation as seen from the side)

Cases 3 and 7, which had almost the same input acceleration ( $275 \text{ m/s}^2$ ), are discussed here to highlight examples of the conditions seen after excitation. Photos 3 and 4 show these cases, respectively, and Figure 5 shows the amounts of settlement at the slope shoulder and the center of the crown.

As shown in Photo 3, countless cracks were observed in the embankment crowns in Cases 3 to 5 without countermeasures and with large input acceleration. The cracks became deeper with higher levels of input acceleration. The view from the side shows that the sections near the embankment slope toe had moved considerably toward the outside. The embankments had an appearance of having been crushed, as seen with the embankment damage seen after the Great East Japan Earthquake of 2011 and the Kushiro-oki Earthquake of 1993. It was presumed that their bottom parts lost shear force and underwent significant deformation due to the generation of excess pore water pressure.
