# Seismic Risk and/or Real Estate Risk for the Bucharest Heritage Buildings

**D. Lungu, C. Arion**

*Technical University of Civil Engineering, Bucharest*

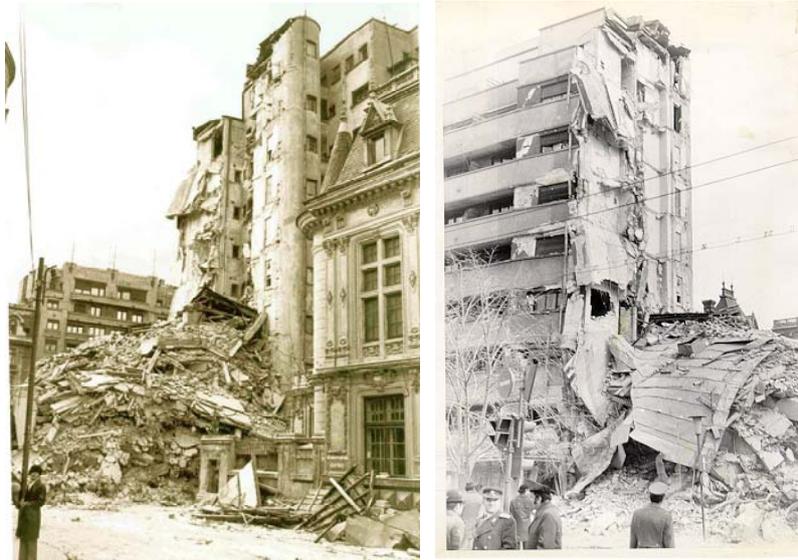
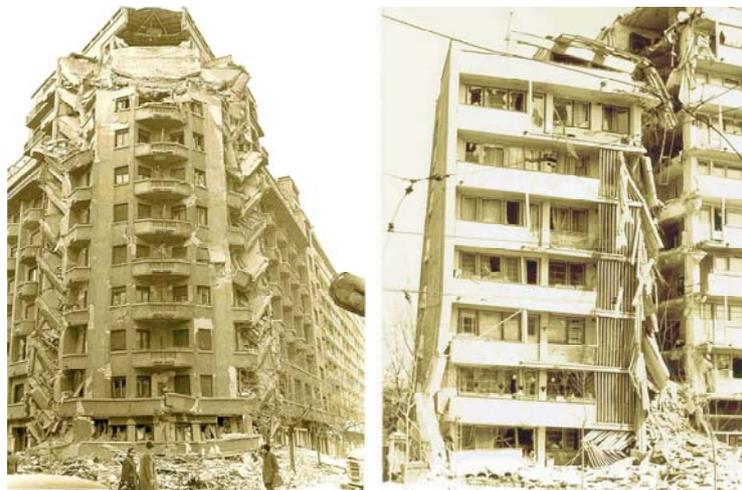
(i) Typical total collapse of pre-war tall reinforced concrete buildings

(i) Wilson building built in '30s

(ii) Lizeanu building, built in '60s

(ii) Collapse of the building soft story at the ground level

**Figure 2.** Total (i) and partial (ii) collapse of the Bucharest RC tall buildings in 1977 earthquake

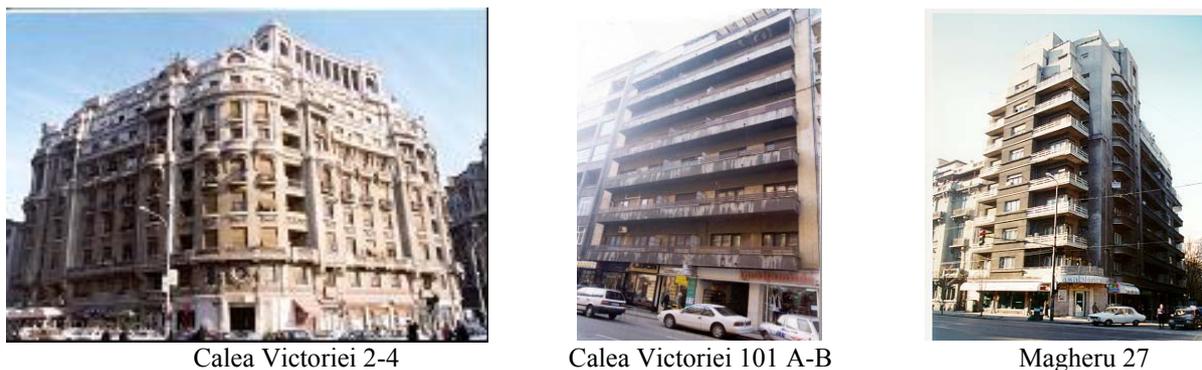
**Figure 3.** Architectural heritage tall buildings in Bucharest: RC buildings built from 1920 to 1940 in city center

1977 one, Figure 3. The number of fragile high-rise RC buildings in the city centre of Bucharest is certainly larger than the existing number of identified buildings having "seismic risk class 1". Many of those vulnerable buildings in the city centre are still not yet identified.

After 12 years from the start-up of the building strengthening program for the Bucharest vulnerable buildings included in Class 1 of seismic risk less than 16 buildings has been completely retrofitted! from the initial number of 127 entries on the list- buildings over GF + 4F. It is also emphasized that from the 127 tall RC vulnerable buildings, 19 are located on Calea Victoriei and Magheru/ Bălcescu central boulevards, Figure 3. Most of them are considered city architectural heritage.

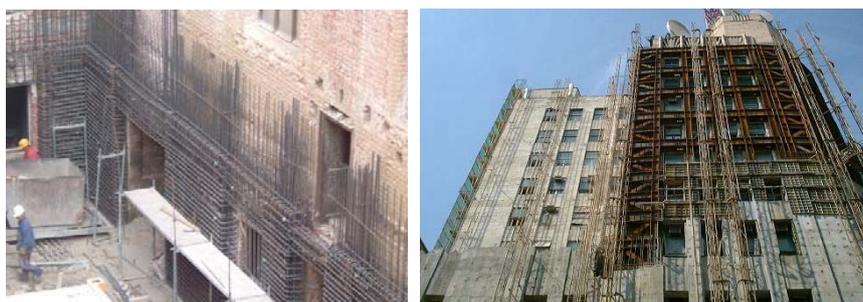
**Figure 4.** Retrofitting of the Palace of Justice - left (2006) and Telephone Palace - right (2002)

The *Historical Monuments List* prepared by the *INMI, National Institute for Historical Monuments*, contains more than 25 cultural heritage palaces in Bucharest. From those, the several "seismic risk class 1" palaces were considered for priority strengthening: (i) Multistory steel structures: *Ministry of Transport, Constructions and Tourism*; (ii) Multistory reinforced concrete structures: *Romanian Government Palace* (under strengthening) and *City Hall of Sector 1* (under strengthening), Bucharest; (iii) Combined masonry and RC buildings: *Royal Palace i.e. National Museum of Art of Romania* (central building) etc. Only the *Palace of Justice* and *Telephone Palace* are now fully retrofitted, Fig. 4.

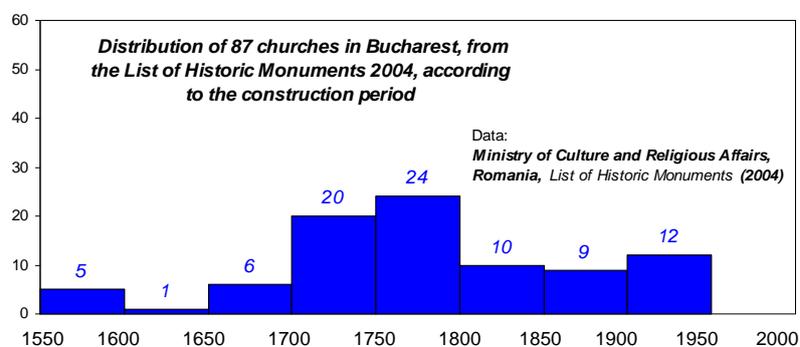
**Figure 5.** Distribution by age of the churches listed as architectural heritage

There are more than 200 orthodox churches in Bucharest and from those almost half are listed as architectural heritage, Figure 5. Most of the old churches still need structural strengthening and immediate rehabilitation. In the case of seismic upgrading of architectural heritage buildings, the central role of the state (or the church) has to be replaced by new partnership models with private sector and international donors and banks.

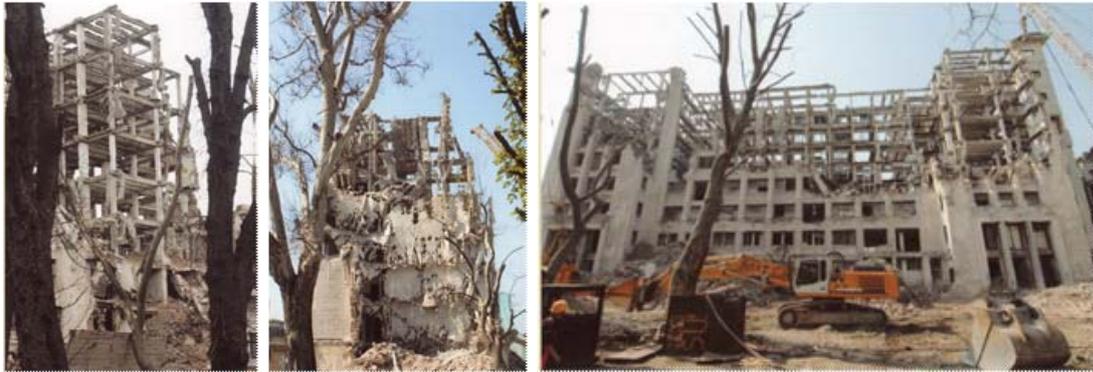
**Figure 6.** MICM building, Calea Victoriei, Bucharest

The tall RC structure of the former Ministry of Industry (MICM) has been demolished in 2007 due to seismic fragility of its RC framed structure. The building was the most impressive Art Deco building in Bucharest listed as Historic Monument.

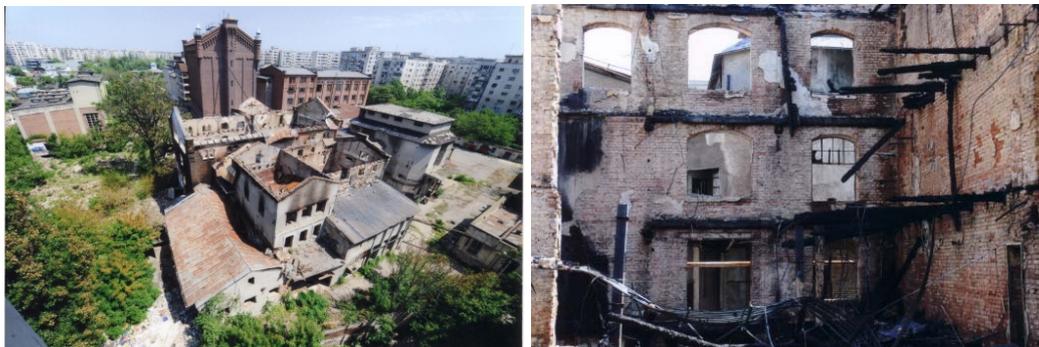
**Figure 7.** Present-day destruction for “encouraging” self-collapse of the Asan Mill (*Moara lui Asan*), industrial heritage in Bucharest

Asan Mill, built in 1853, is the first steam mill in Romania. It is an industrial architectural monument under category A, the List of Historic Monuments, code B-II-m-A-19692. The building is made of masonry walls with wooden boards. The mill was set on fire on May 14th, 2008 for a thorough and rapid extermination of the wooden boards and roof ridge. The masonry walls show signs of local degradation of bearing walls, deliberately caused by man, Figure 7.

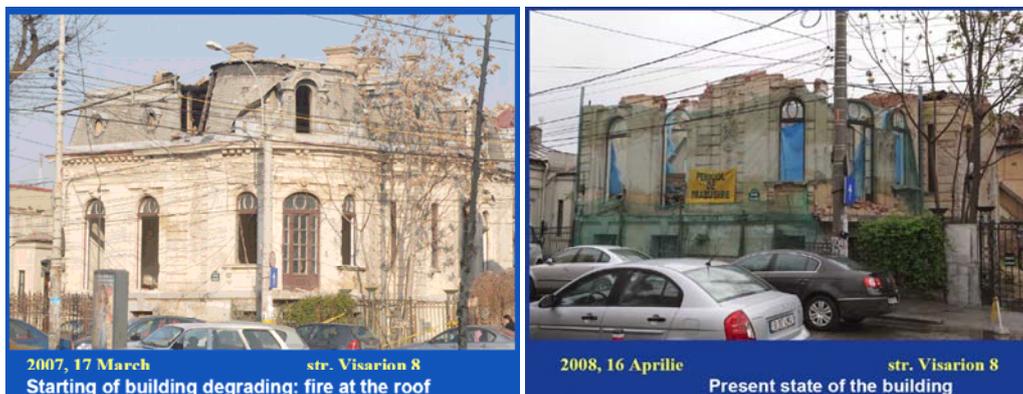
**Figure 9.** Bucharest heritage building in the city center intentionally prepared for demolition

Visarion 8, building was finished in 1911, and the urban renewal plan for Lascar Catargiu Blvd., between Piata Romana (the Roman Square) and Piata Victoriei (Victory Square), was implemented in the period 1895 – 1899, in the French Academy spirit, according to design delivered by architect I.D. Berindei. The building is also part of the protected area of Dinu Lipatti House, 12 Lascăr Catargiu Blvs., a historic monument, the List of Historic Monuments 2004, entry no. 615/B-II-m-B-18330. The building is located in a "protected area" yet, it has benefited from no protection at all. The roof burnt at the beginning of 2007 and man, to the present state of utter ruin, has systematically damaged the building, Figure 9. The „Collapse Hazard” sign placed on the facade of the building in March 2007 made a clear statement with respect to the destined end of that elegant building from the very heart of Bucharest. The application to declare the building a historic monument filed by the National Institute for Historic Monuments (no.351/23.03.2008) was rejected by the National Commission for Historic Monuments. Unfortunately, existing law on protected areas in Romania cannot legally prevent the demolition of the buildings located in such areas.
