# Reconsidering Urban Planning in Spain after the Lorca Earthquake (11<sup>th</sup> May 2011)

A. Aretxabala Díez & C. Sanz Larrea

School of Architecture, University of Navarra, Spain

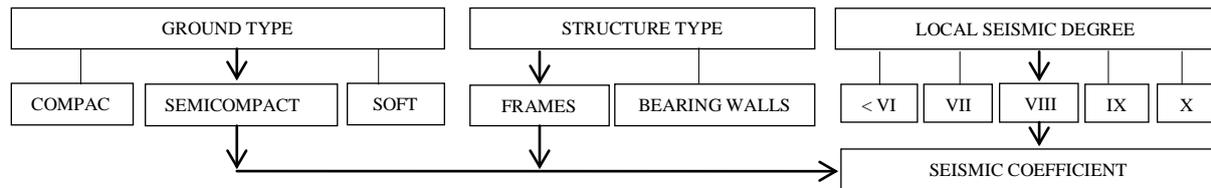
**Figure 1.** Seismic coefficient for buildings with reinforced concrete structure (MV 101)

The Structural Concrete Code from 1939 was the first Spanish building standard. Design building actions, dead and live loads, and snow and wind actions, were defined two years later in Steel Use Restriction Regulations Article 2. Seismic action was not defined until the 1962 Building Actions Standard MV101, whose Seismic Risk Zoning Map of the Iberian Peninsula was based on the seismic intensity degree (Mercalli Scale)  $G > VII$ , VIII, IX and X. The map general information required “*further knowledge about ground properties, local geological structures, seismic active sources, focus and faults status and location*”, in accordance to the importance of the building, recommending the consultation of local maps, drafted by the Geological Institute. A simplified design method for building was presented, assimilating the seismic action to horizontal static equivalent forces. These could be obtained multiplying the resistant elements' vertical loads by a seismic coefficient  $s_i$ , equal to the ratio between horizontal ground and gravity accelerations (Fig.1). This coefficient considered the influence of the structure type (frames or bearing walls), ground type (dense, compact or soft) and local seismic intensity degree. The map of PGS 1 Part A (1968), the first Earthquake-Resistant Construction Standard, divides the Spanish territory into zones A, B and C (Fig.2.a) depending on the seismic intensity  $G$  (MSK Scale): Low ( $A < VI$ ), medium ( $VI < B < VIII$ ) and high ( $VIII < C$ ), its general information always to be completed when designing buildings of special importance. The seismic coefficient is more complex  $s_i = C R \eta_i \beta \delta$ , derived from seismic basic factor  $C$  (associated to a 0.5 second period  $T$  and dependent on  $G$  values), a seismic risk factor for 50 years  $R$  and foundation factor  $\delta$ .

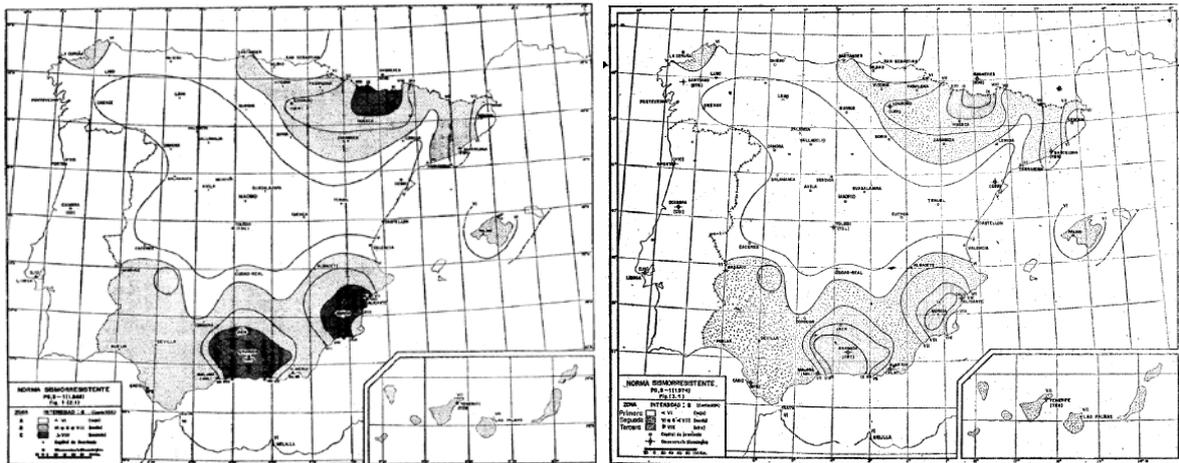
**Figure 2.** Seismic Risk Zoning Maps a) PGS 1 (1968) b) PDS 1 (1974)

The Permanent Commission for Seismic-Resistant Construction Standards was constituted in 1974, at the same time PDS 1, Part A substituted the former PGS 1. Its revised Seismic Risk Zoning Map maintains three zones (Fig. 2.b): First ( $G < VI$ ), Second ( $VI \leq G \leq VIII$ ) and Third ( $G > VIII$ ). In the latter "*it is required to consult additional local information for buildings whose destruction after an earthquake would disrupt an essential service or lead to catastrophic effects.*". The Seismic Coefficient changes to  $s_i = C R \eta_i \beta \delta$ . Structural response factor  $\beta$  is redefined and foundation factor  $\delta$  values are adjusted. Regarding other aspects, the criterion to determine minimum width between adjacent buildings remained unchanged, but building displacement increased by multiplying the former value for a new factor  $k$ , (1.25 for braced structures and  $k = 1.10$  for unbraced). Requirements regarding partitions, cantilever masonry walls and facade walls were the same, but the Seismic Coefficients involved increased ( $s_c = C + 0.20$  and  $s_f = C + 0.10$ ).

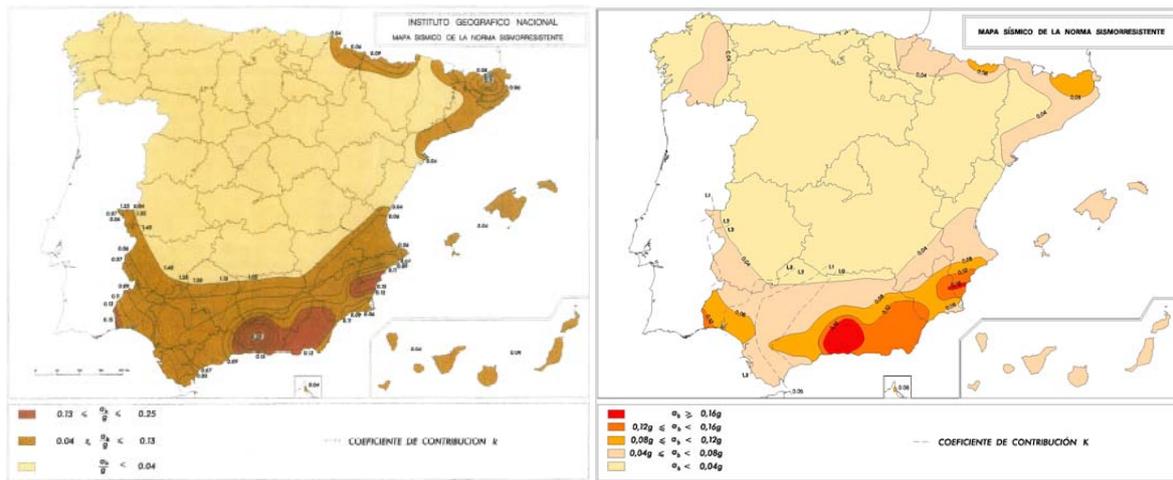
**Figure 3.** Seismic Risk Maps. a) NCSE 94 b) NCSE 02

Design acceleration  $a_c = S \rho a_b$  could be obtained from the basic  $a_b$  (values according to a new Map, Fig.3.b), multiplied by the Risk Factor  $\rho$  and a new ground coefficient  $S$ , considering the amplifying ground effect due to its characteristics, responsible for the reduction or increase of the seismic action, values between 1 and  $C/1.25$ . In the simplified method, action combination in the main building planes requires a 30% increase in the seismic action considered in the normal plane. The significant increase of the structure cost derived can only be prevented by designing high or very high ductility structures, reducing the masses with floor slabs of minor height, girder beams instead of flat ones and increasing cross-sections of pillars. NCSE 02 underlines the need to reduce the economic losses and fatalities resulting from damage due to façade walls' and parapets' or sills' collapse in the event of an earthquake, but no specific measures to be taken to prevent it are detailed.

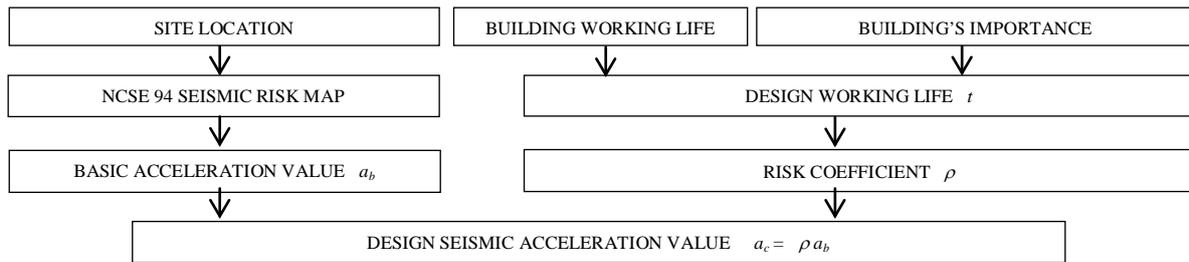
**Figure 4.** Relationship between Basic and Design Seismic Accelerations (NCSE 94)

In 1975, Spanish Technological Standard Foundations and Geotechnical Reports NTE CEG laid out the bases to draft Ground Reports, establishing the geotechnical campaign extent (function of site surface and building importance), the number of tests and results interpretation as well as the minimum content of the final report. One year later, NCSE 94 replaced PDS 1. Its Seismic Risk Map determined the Basic Seismic Acceleration characteristic values  $a_b$  (ratio between horizontal ground surface acceleration and  $g$ ) for a 500 year return period (Fig.3.a) and the Ground Contribution Factor  $k$ . The Design Seismic Acceleration  $a_c$  can be obtained by multiplying the Basic Seismic Acceleration by a Risk Coefficient  $\rho$  (1 for residential buildings), adapting the return period to the possibility of an earthquake's recurrence and the building's importance and design working life (Fig.4).

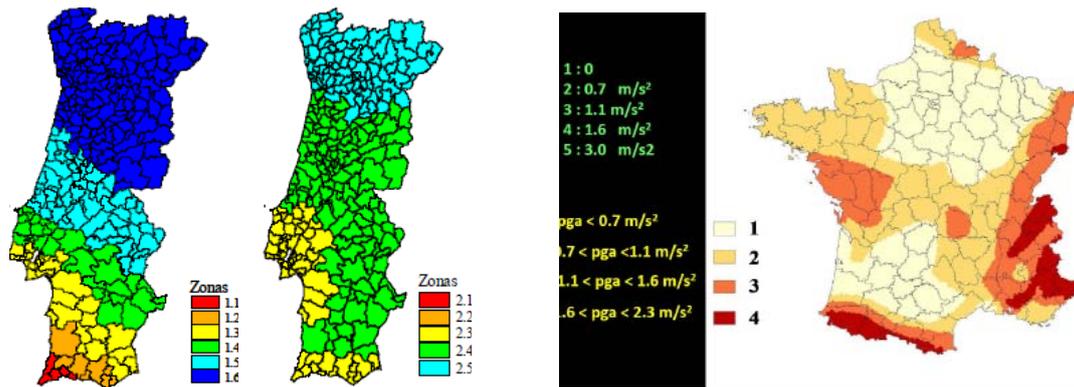
Figure 6. EN 1998-1 Eurocode 8 National Application Documents Seismic Risk Maps a) Portugal b) France

Parts 1, 2 and 3 of EC 7 (General Rules/Ground investigation and testing) and Parts 1 and 5 of EC 8 (General rules, seismic actions and building rules/Foundations, retaining structures and geotechnical aspects) are in force in Spain. Recently, a report on the proposal for UNE EN 1998-1 National Application Document, drafted with the collaboration of experts from Portugal, Italy and France, and having also analyzed working papers from other countries, such as Belgium and Germany, has been published. This report includes NCSE 02 Map, highlighting the urgent need to modify its content in order to adapt Basic Seismic Acceleration values to the maps of other countries around Spain, specifically in border areas like the Pyrenees (Fig. 6).
