Corner Beam-Column Joints Seismic Retrofitting With High Performance Fiber-Reinforced Concrete Jacketing

SUMMARY:

The experimental results on full-scale corner beam-column joints tests are presented herein, with the aim of studying the effectiveness in strengthening existing RC existing structures of the application of a HPFRC jacket. The specimens subassemblies have been designed with structural deficiencies typical of the Italian construction practice of the 60's-70's: absence of any capacity design principle, use of smooth bars, inadequate reinforcement detailing, such as total lack of stirrups in the joint panel and hook-ended anchorage. Both unretrofitted and retrofitted specimens have been tested under simulated seismic loads. The results underline the significant vulnerability of the joint panel region and the critical role of the slippage phenomena related to the use of smooth bars and show that, with the application of a HPFRC jacket, it is possible to increase the bearing capacity of the columns, reaching also an adequate level of ductility and strength of the beam column joints.

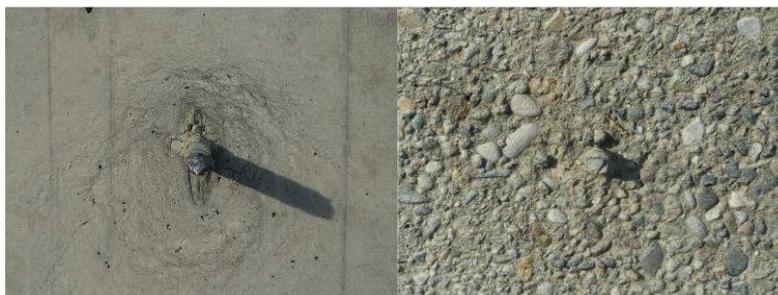
Figure 2.2. Specimens RCJ1 surface before and after sandblasting

After casting and a curing period of one month, the specimens surface was sandblasted for the successive jacketing. The column was encased in a HPFRC jacket 40 mm thick while for the beam a U-shaped solution 30 mm thick was adopted (Figures 2.2 and 2.3).

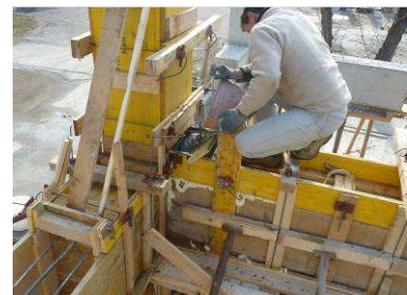
Figure 2.3. HPFRC jacket casting

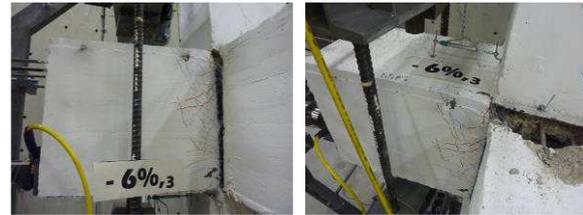
Figure 2.12. Damage in the secondary beam of specimen RCJ2 at the end of the test: (a) outer side of the joint; (b) inner side of the joint

Finally it is evident that no damage was observed in the outer side of the joint panel in correspondence with the secondary beam, while some cracks developed in the secondary beam at the inner side of the joint as shown in Figures 2.11(a) and 2.12(a) for RCJ1 and RCJ2 respectively. As shown in Figure 2.11(b), for specimen RCJ1 the detachment of the HPFRC jacket in the secondary beam was evident, while for specimen RCJ2 the detachment between the HPFRC and the host concrete happened in the column inside the joint and no detachment could be observed in the HPFRC jacket of the secondary beam (Figure 2.12(b)).
