## **CHANGING PERCEPTIONS OF THE EXTENT OF DAMAGE TO WELDED STEEL MOMENT FRAMES IN THE NORTHRIDGE EARTHQUAKE**

**Terrence F PARET<sup>1</sup> And Mourad R ATTALLA<sup>2</sup>**

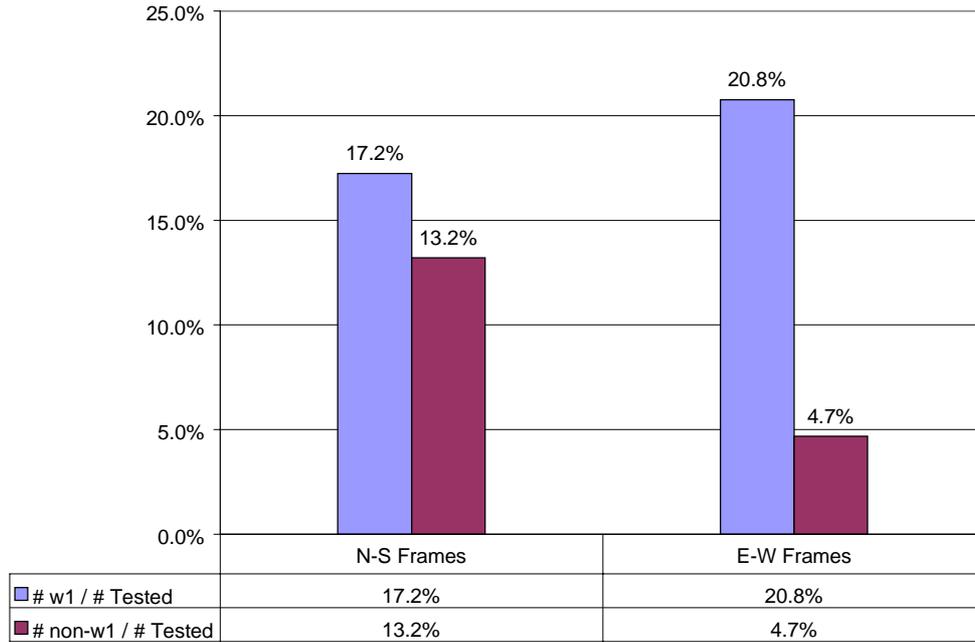
**Figure 1A. Frequency of Occurrence of W1 and non-W1 Relative to Total Number of Connections.**

The frequency of occurrence of W1 and non-W1 conditions was computed as a ratio between the number of occurrences of each found, and either the total number of connections in the respective frames in the building or the total number of connections inspected in those frames. The choice of which method to use depends upon whether or not one assumes that the inspection methodology used successfully located all or nearly all occurrences of W1 and non-W1, even in those instances in which the inspection program was terminated prior to each and every connection having been inspected. For this study both possibilities have been explored and are presented in Table 2 and in Figures 1A and 1B, where it can be seen that the reported frequency of occurrence for non-W1 conditions is far higher in the north-south oriented frames than in the east-west oriented frames, while the reported frequency of occurrence for W1's is approximately equal in the two directions, regardless of the method of calculation assumed. Table 2 also summarizes for both W1's and non-W1's the ratios between the reported frequency of occurrence in the north-south oriented and east-west oriented frames (N-S/E-W). The differences between these ratios are so extreme that there does not appear to be any reasonable explanation for this other than the obvious---that non-W1 conditions are related to earthquake motions while W1 conditions are not.

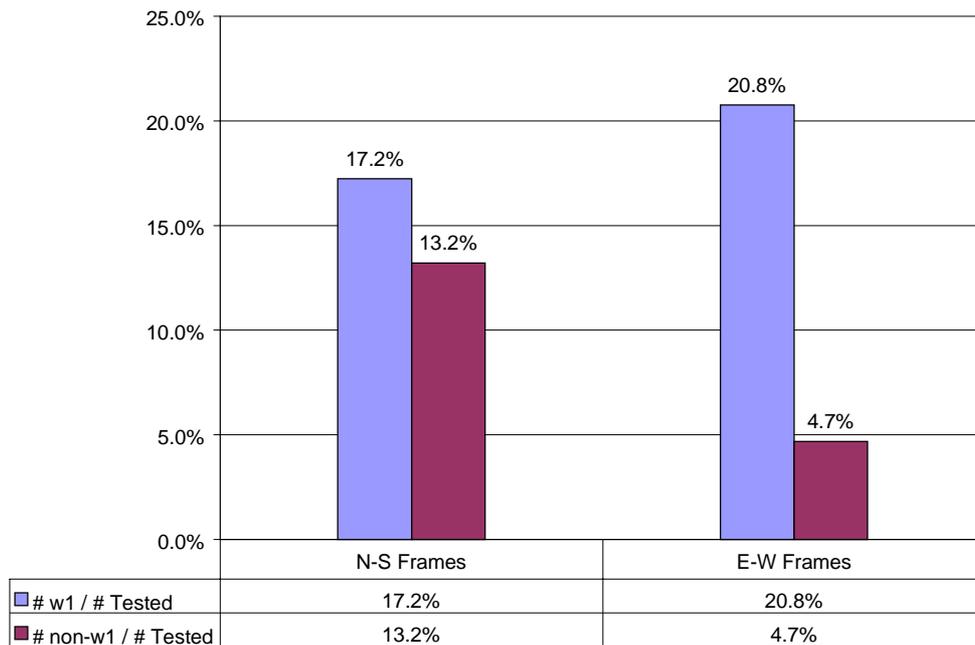
**Figure 1B. Frequency of Occurrence of W1 and non-W1 Relative to Number of Inspected Connections.**

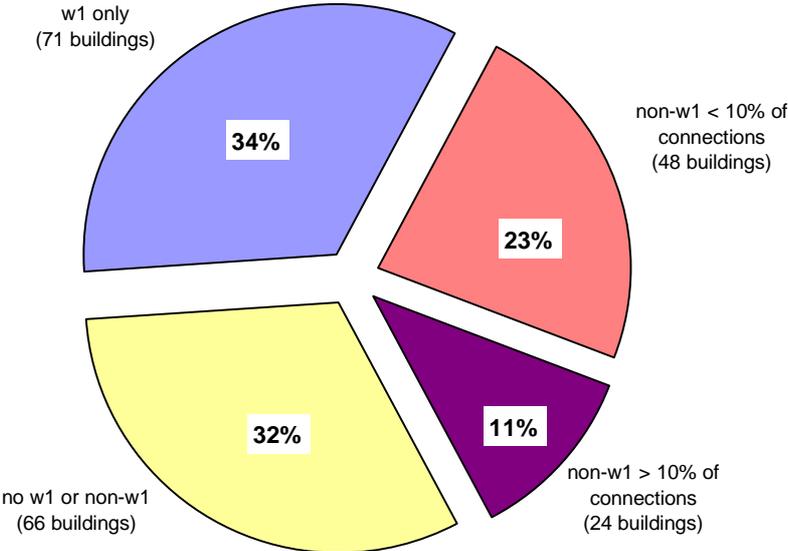
**Figure 2. Pie Chart Depicting Distribution of Buildings with W1s and non-W1s**

The entire data set was sorted by building and by category of damage found in each building. These sorts revealed that about one-third of the buildings in the City of Los Angeles sample contained no reported occurrences of either W1 or non-W1; about one-third of the buildings in the sample contained W1 occurrences only with no reported non-W1's; and about one-third of the buildings in the sample contained one or more reported non-W1's. The actual percentage of buildings found in each category is shown in the pie chart in Figure 2. Considering that the buildings in the sample are those that were located in the region of strongest shaking, the fact that two-thirds of the buildings inspected experienced no reported non-W1 occurrences whatsoever is striking. More striking is the statistical breakdown of the subgroup of buildings that were found to have non-W1 occurrences. Figure 2 shows that of the buildings in this subgroup, two-thirds were reported to have fewer than 10% of their connections fractured and only one-third was found to have a non-W1 frequency of occurrence greater than 10%. Therefore, in the region of strongest ground shaking only 24 buildings (11% of the total sample) were found to have more than 10% of their connections damaged by the earthquake. For many engineers, a 10% threshold of damage is considered to be the point at which damage might be characterized as considerable. In accordance with this characterization therefore, the scope of the "welded moment frame problem"---previously characterized as having resulted in many scores of severely damaged buildings---appears to be greatly reduced.

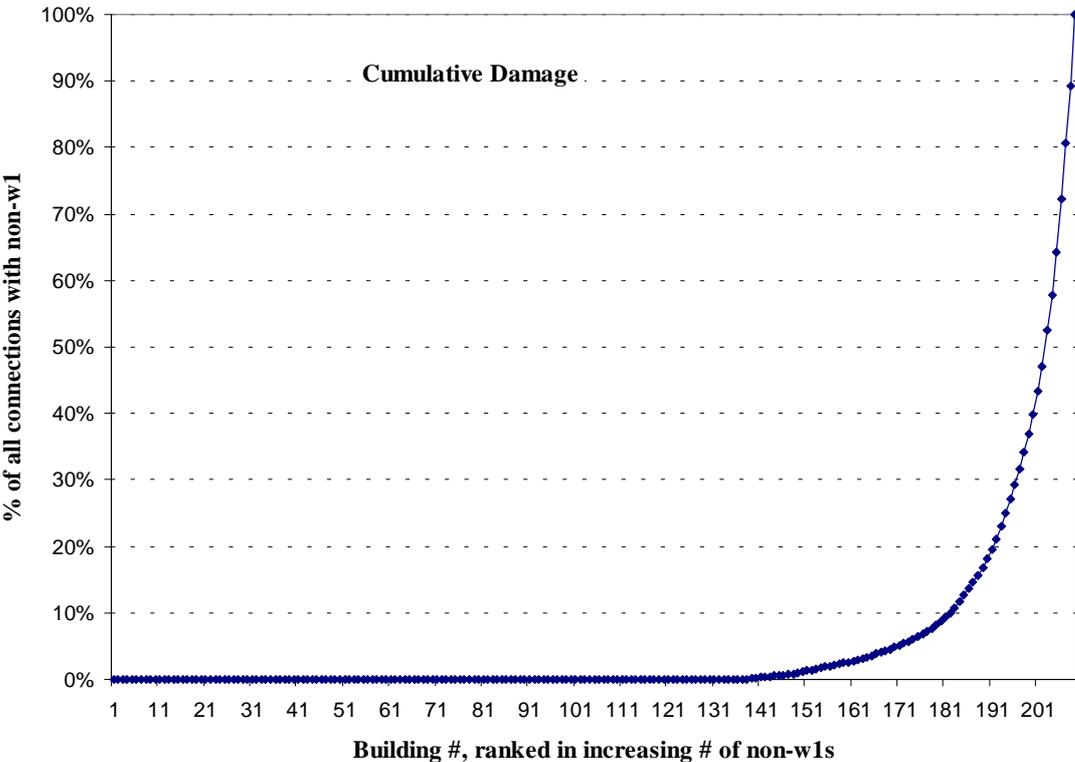
Based upon the above sort, Figure 3 was generated which displays a curve characterizing the cumulative occurrence of non-W1's in the City of Los Angeles inventory of buildings. On the horizontal axis, the building inventory is ranked by increasing number of non-W1's found in each building, and on the vertical axis the cumulative number of non-W1's found in the inventory is recorded. The curve reflects some of the values reported in Figure 2, namely that 137 buildings (66 with no reported W1 or non-W1 occurrences and 71 with only W1, but no non-W1 occurrences) did not experience any reported non-W1 occurrences. The right-most portion of the curve where the slope increases dramatically is especially enlightening. It can be seen for example that relatively few buildings account for most of the non-W1 occurrences in the inventory. In fact, analysis of the data on which this curve is based shows that only seven buildings in the total inventory (i.e., 3% of the total buildings) account for 53% of all the non-W1 occurrences reported in the City of Los Angeles files. In other

words, 53% of all the weld fractures reported in all the buildings required to be inspected by the City of Los Angeles ordinance was found in only seven buildings. The data further shows that only 27 of the buildings in the total inventory (i.e., 13% of the total buildings) account for 90% of all the reported non-W1 occurrences. Again, in other words, 90% of all the weld fractures reported in all the buildings required to be inspected by the City of Los Angeles ordinance was found in only 27 buildings. With this data, it can be seen that the true extent of the weld fracturing phenomenon reported after Northridge is not nearly as great as has been previously thought.

Figure 3. Cumulative Occurrence of non-W1s in City of Los Angeles Inventory
