REHABILITATION OF RC BUILDINGS USING STRUCTURAL WALLS

Ahmed GHOBARAH¹ And Maged YOUSSEF²

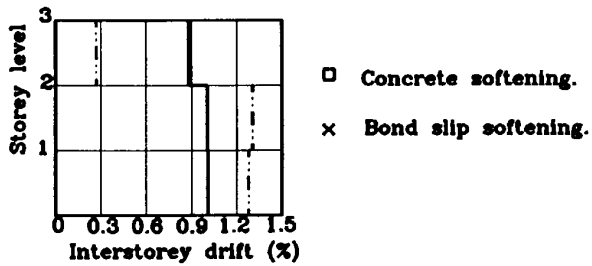
Figure 7 Storey drift and interstorey drift due to pushover analysis.

Figures 7 shows the distribution of storey drifts and interstorey drifts along the height of the building for both the existing and rehabilitated frames. For the existing frame, the interstorey drift in the first two floors is much
