SEISMIC BEHAVIOR OF RC COLUMN-S BEAMMOMENT FRAMES

SUMMARY

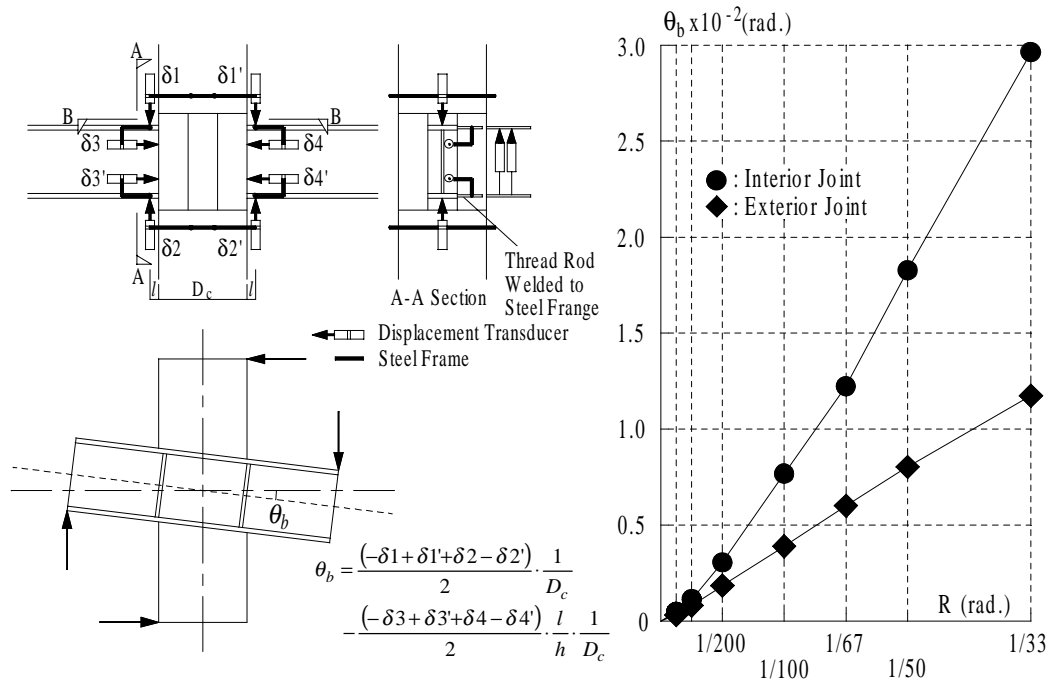
Fig. 6 Bearing Distortion-Drift Angle Relation

The relationship between bearing distortion θ_b and drift angle R of the interior and exterior joint at the 2nd floor is shown in Fig. 6. Bearing distortions were small at the cycle of $R = 0.00125$ rad. and $R = 0.005$ rad.. However, bearing distortions increased with drift angle. Bearing distortions of the interior joint were approximately two times as large as those of the exterior joint. This result corresponds to the progression of the concrete crushing caused by bearing above and below the steel beam at the joint as mentioned above.

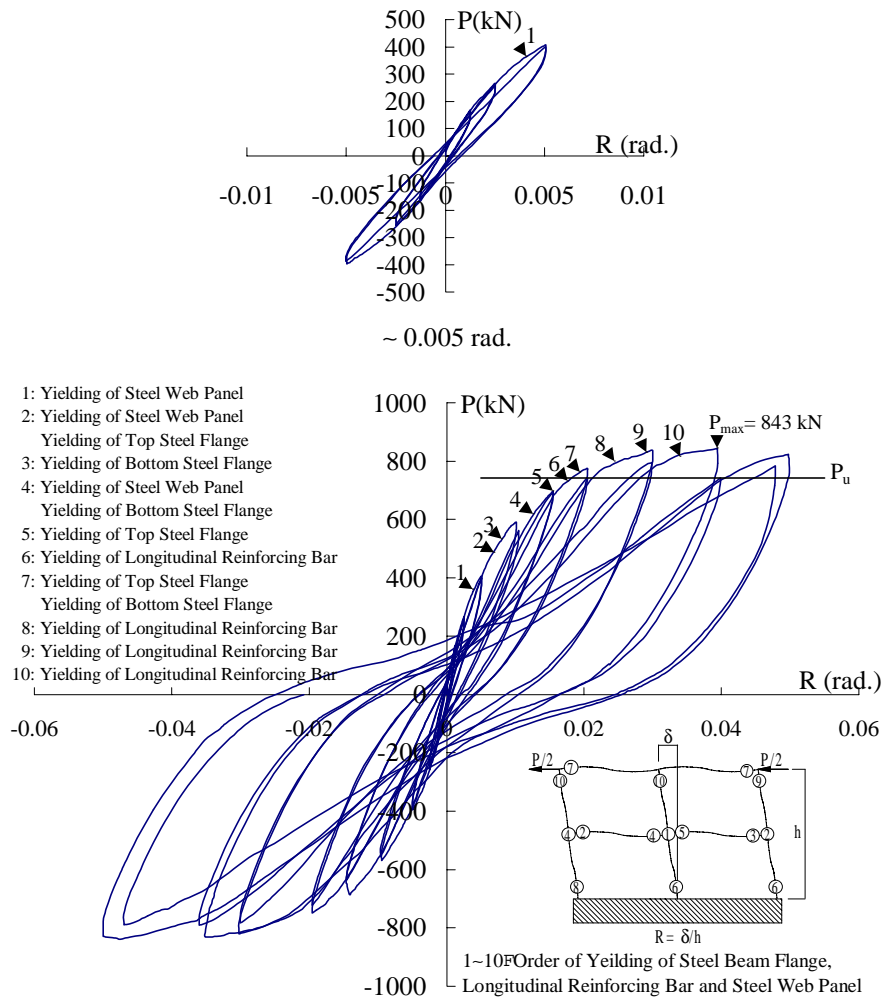
Fig. 7 Hysteresis Characteristics

The relationships between the applied lateral load at the roof floor and drift angle are shown in Fig. 7. The vertical axis represents the applied lateral load P . Horizontal axis gives the overall drift angle R . P_u is the plastic collapse load of the frame calculated by assuming beam mechanism (total collapse mechanism). Numbers on the figure indicate the order of yielding of the steel flange, steel web panel and longitudinal reinforcing bar obtained by the measured strains. The yielding occurred in the following order: interior steel web panel at the 2nd floor, exterior steel web panel and the steel flange at the 2nd floor, longitudinal reinforcing bar of the column base at the first story, the steel flange at the roof floor and longitudinal reinforcing bar of the top of the column at the 2nd story. Although slight pinching was observed during initial loading cycle of $R=0.0025$ rad., the overall behavior was almost elastic. In subsequent loading, pinching behavior was remarkably observed.

However, the overall frame behavior was stable although yielding of the steel web panel and concrete crushing caused by bearing above and below the steel beam were observed at early loading cycle. The specimen reached its maximum strength at $R=0.04$ rad.. Beyond this point, large strength degradation was not observed. The maximum strength was about 10% larger than the calculated plastic collapse load.
