## Prediction of seismic damage patterns of buildings

**ABSTRACT:** An object-oriented knowledge base has been developed for inferring potential causes of seismic damage to a building from the data in the Project Database. Fuzzy pattern matching is then performed with the causes for historical seismic damage to buildings stored in the Seismic Damage Database, SDD, to identify those cases which are strongly correlated with the data on the building. These cases then serve as a basis for predicting the type and level of seismic damage that the given building is most likely to experience.

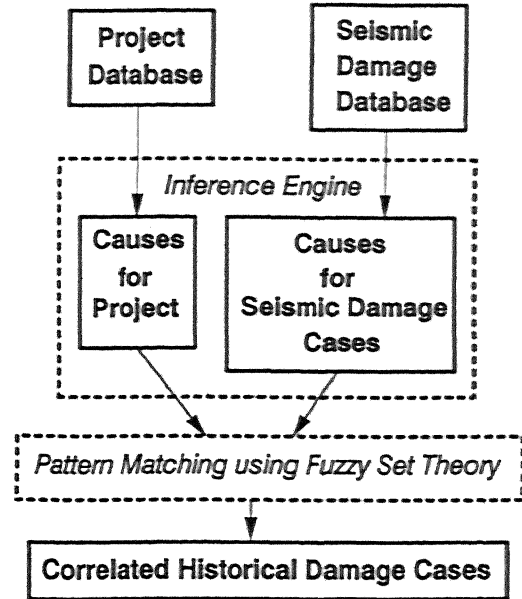
Figure 2. Flow for the pattern matching.

By carrying out a pattern matching between the inferred cause set of the building and the cause set of each damaged case in the SDD, the correlated damage cases are identified. The outline of the pattern matching is shown in Figure 2. The contribution of each cause in the SDD to the observed damage has been classified into four grades (large, medium, small or none) by experts. In order to deal with the vagueness of the amount of contribution of the causes, fuzzy set theory is applied in the pattern matching. When all causes of a historical damage case in the SSD belong to the cause set of the building, the coherence value between the two cause sets is 100%, i.e. there is a total match. For such a case the fuzzy vector ( $C_V$ ), which is a discretized membership function, represented by  $C_{V_0}$  is written as (see Figure 3).

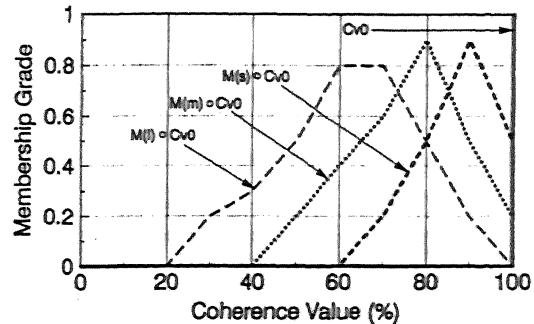
Figure 3. Transition of the membership function by missing causes.

For the case when the building checked lacks some causes, the coherence value is decreased. We utilize the transmission matrices  $M(l)$ ,  $M(m)$  and  $M(s)$  which correspond respectively to the large, medium and small levels of contribution of the causes (Tatsumi et al. 1990). When  $i$  large,  $j$  medium, and  $k$  small causes are missing in the building, the fuzzy vector  $C_V$  is calculated as shown below (see Figure 3).
