The racking behaviour of curtain wall glazing during simulated earthquake

Andrew B. King & Stuart J. Thurston

Building Research Association of New Zealand (BRANZ), New Zealand

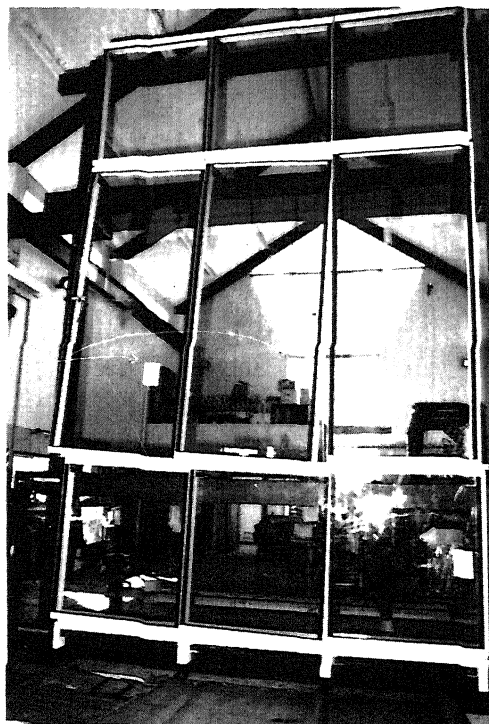
Figure 6: Four sided unitised panels.
