Behavior and retrofit of bridge outrigger beams

C.R.Thewalt & B.I.Stojadinović
University of California, Berkeley, Calif., USA

ABSTRACT: Many older elevated freeways in California were designed considering lateral seismic loads, but the effects of longitudinal bridge response were in some respects ignored. Consideration of longitudinal response has a significant impact on outrigger beams, which are used when columns cannot be located directly beneath the superstructure. These outrigger beams were designed for shears and flexure resulting from gravity and lateral loads. However, longitudinal bridge excitation introduces biaxial flexure and shear as well as torsion into these members. In addition to problems carrying torsion, the outrigger-column joint connection is often poorly detailed. In this experimental study, three half scale specimens are used to investigate the as-built behavior of the outrigger beam and joint as well as the behavior of two retrofit schemes.

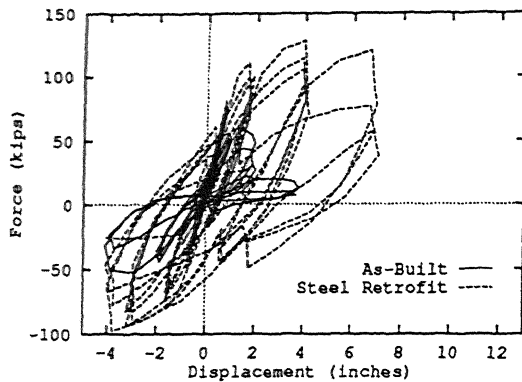
Figure 9: Transverse Response at Top of Column

As can be seen in Figure 9, the flexural response of the system was already decreasing by the second six inch cycle. The torsional response shown in Figure 10 appears to dissipate more energy than the loops for the concrete retrofit. This is because the dissipation in the steel specimen is emanates from the column hinging flexurally. The test was terminated after the six inch cycles because of extensive damage at the base of the column.
