THE POSSIBLE INFLUENCE OF SOILS CONDITIONS ON EARTHQUAKE EFFECTS: A CASE STUDY

J. C. CASTANO¹, J. L. ZAMARBIDE², I. ARANGO³ and M. A. BUFALIZA¹

Copyright © 1996 Elsevier Science Ltd
Paper No. 1068. (quote when citing this article)
Eleventh World Conference on Earthquake Engineering
ISBN: 0 08 042822 3

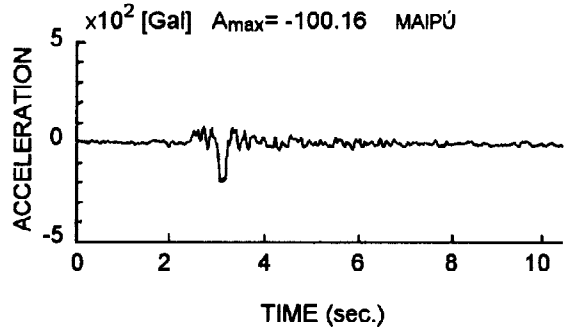
Fig. 1. Strong motion instruments locations within the Gran Mendoza area and accelerograms of the January 26, 1985, Mendoza earthquake

Several accelerographs recorded this event, five of them located within the Gran Mendoza area. Peak accelerations ranged from 100.0 to 408.5 gal. Although high values of peak acceleration were recorded, the duration of the significant portion of the records ($a_{max} > 50$ gal) did not exceed 4 sec. (Fig. 1). In addition to this, several seismoscope records were obtained, from which the maximum seismic coefficients were computed.
