AN INTEGRATED PROGRAM TO IMPROVE THE PERFORMANCE OF WELDED STEEL FRAME BUILDINGS

STEPHEN A. MAHIN¹, RONALD O. HAMBURGER² AND JAMES O. MALLEY³

ABSTRACT

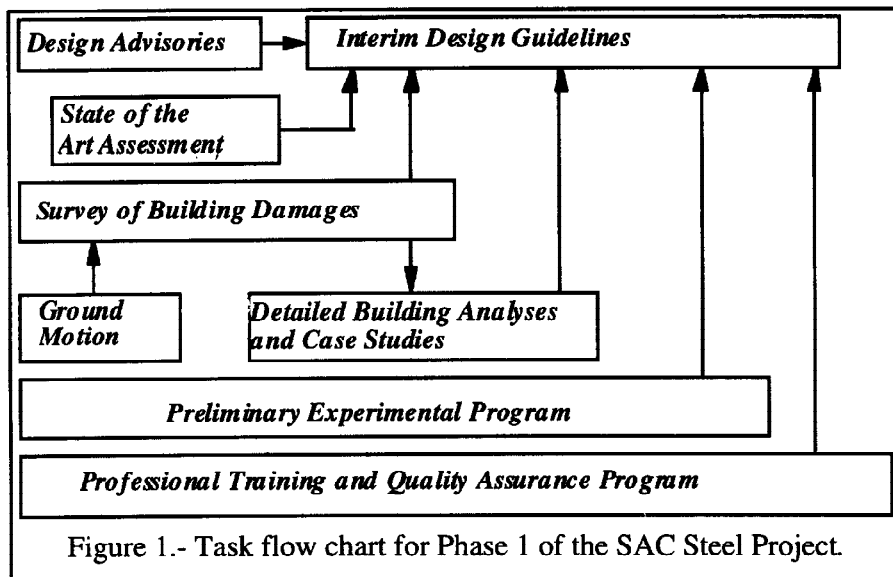
A systematic effort has been undertaken to assess the actual performance of steel buildings the Northridge earthquake. Three levels of survey were conducted. In the first, a brief questionnaire was sent to more than two hundred, randomly-selected owners of steel buildings. This preliminary survey was used to estimate the overall scope of damage to steel buildings and to help identify geographic areas where steel buildings were damaged. Based on this and other more detailed, the *Interim Guidelines* recommended detailed inspection of steel buildings where ground motions exceeded 0.2g.
